**Report on the ‘Soil Pipe’ beneath the house of
Mr. T.S Bhasi, Survey No. 352/4, Pambavalley, Kollamula, Ranni,
Pathanamthitta District**

(Reference: 34758/K1/2012/DMD dated 15-06-2012)

Hazard, Vulnerability and Risk Assessment Cell
Department of Revenue and Disaster Management, Govt. of Kerala
2nd Floor, Institute of Land and Disaster Management
PTP Nagar, Thiruvananthapuram 695038
Tel/Fax: 0471-2364424
Email: hvracell.gok@gmail.com

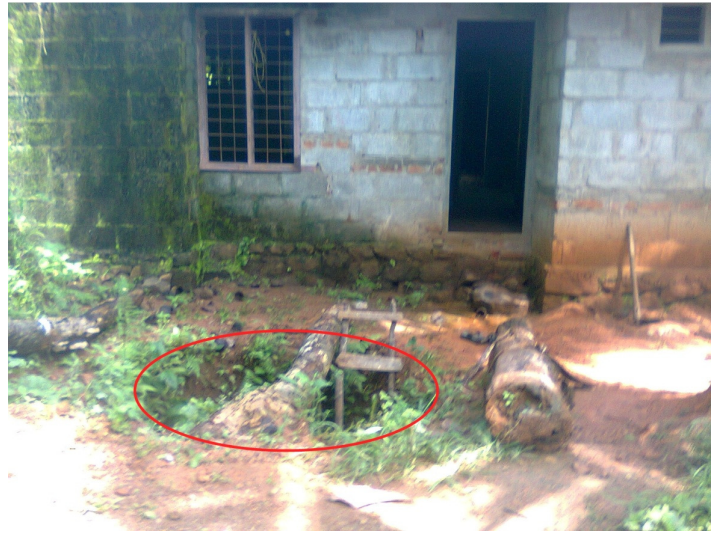
Mr. T.S Bhasi constructed a new house in survey no. 352/4 in Kollamula village, Ranni Taluk, Pathanamthitta district. As he dug a well he encountered a large cavity and it was found that the cavity extended below his newly constructed house (Figure 1). The entity was noticed first on 6 April 2011. He reported the event to the concerned village officer and to the District Collector. The Collector in turn informed the Addl. Chief Secretary, Revenue and Disaster Management with a proposal for

Figure 1: Cavity leading to the soil pipe near the house of Mr. Bhasi

Mr. Bhasi’s house is located in a $>25^\circ$ slope. The house is constructed on a terraced platform cut out of the natural hill slope. The soil in general was reddish and showed indications of laterization. The house itself is a reasonably well constructed concrete structure (cf. Figure 1). About 300 meters from Mr. Bhasi’s house, a soil piping incident was reported about 25 years ago in the plot of Mr. Gopi

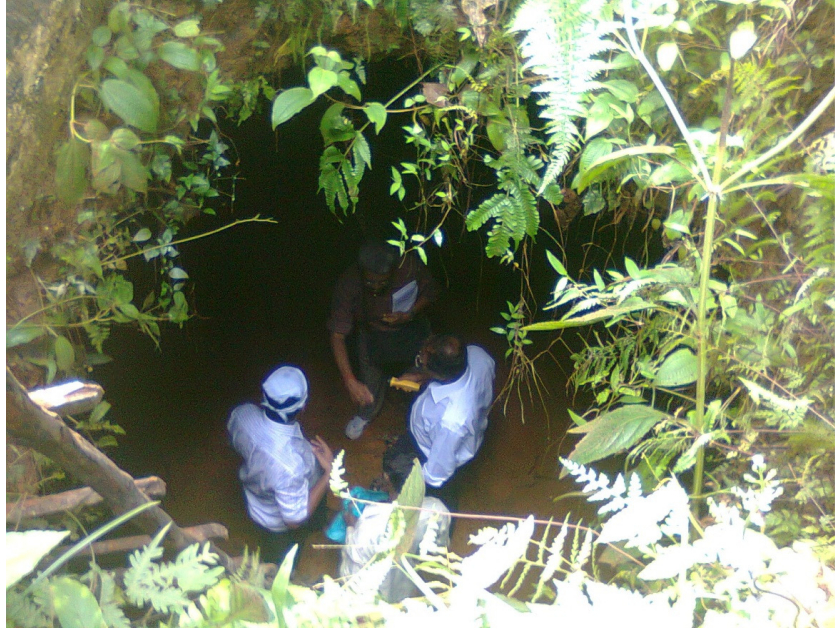
Figure 2: Inside the pipe in Mr. Bhasi's property

The team conducted an investigation inside the pipe (Figure 2). The loose material inside was clayey loam. Sodium molting was observed along the roof of the pipe.

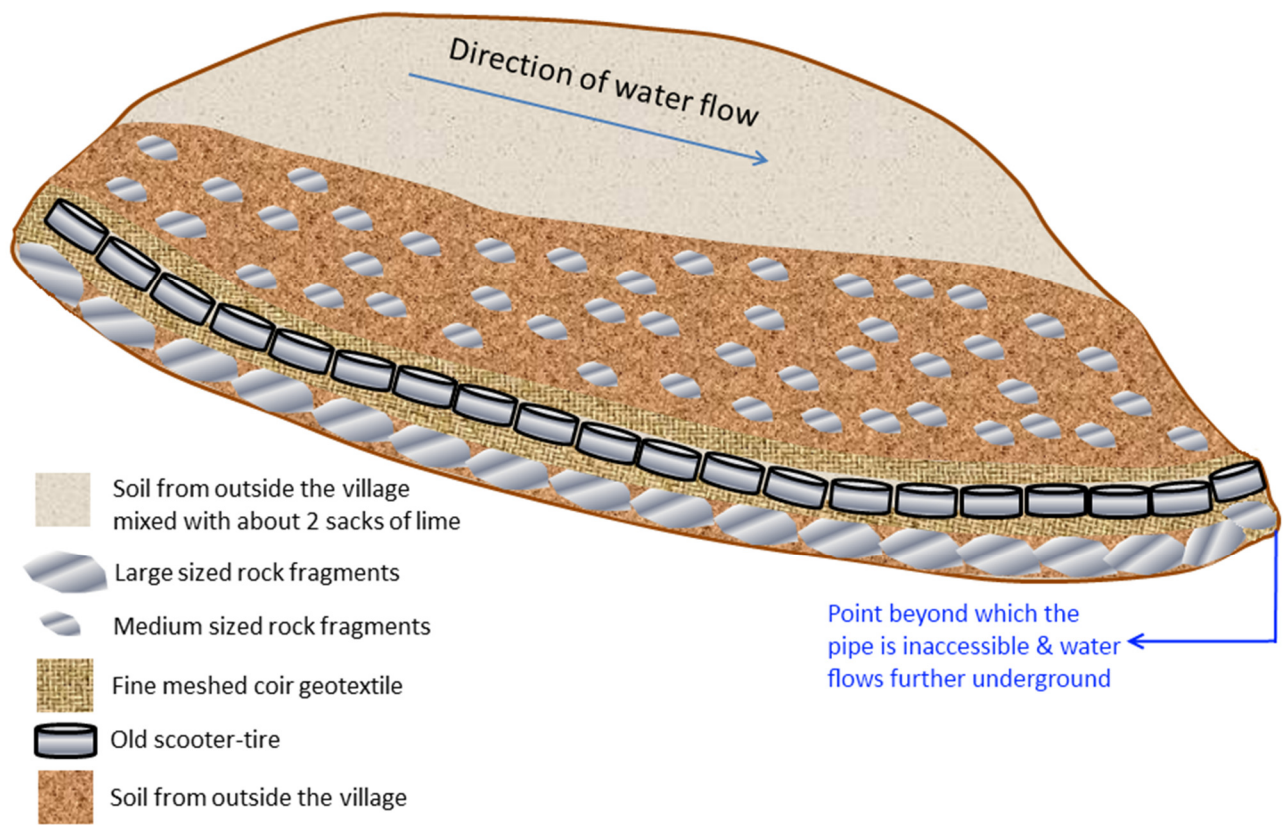
Figure 3: Illustration for filling up the soil pipe

4. A method of filling up the sink hole is illustrated in figure 3 which may be used by the PWD Executive Engineer concerned as a guide
5. Loose debris inside the sink hole must be removed before filling up the sink hole

6. After removal of the debris from the sink hole, three to four sacks of lime (kummayam) shall be applied inside the sink hole
7. Stone paving must be made on the floor with large size rock fragments and soil from outside Kollamula village must be spread over these rock fragments by a thickness of about 0.5 m

8. Atop this a layer of fine meshed coir geotextile must be laid. Ensure that this geotextile covers the 'point beyond which the pipe is inaccessible and the water flows further underground'

9. On top of the this geotextile layer, old scooter-tires must be laid horizontally and soil from outside Kollamula village must be spread over the tires by a thickness of about 0.5 m. Ensure that the space inside the tires are also filled with soil

10. Atop this a layer of fine meshed coir geotextile must be laid
11. Over this geotextile layer, soil from outside Kollamula village mixed with medium size rock fragments must be used for filling up the sink hole up to $\frac{3}{4}$ the depth of the sink hole

12. Atop this layer, soil from outside Kollamula village mixed with 2 sacks of lime (kummayam) must be used for filling up the sink hole to the top
13. The filling must be compacted at all stages
