NOTE ON POST DISASTER STUDIES FOR LANDSLIDES OCCURRED IN JUNE 2018 AT IDUKKI DISTRICT, KERALA

Field Season 2018-2019
FSP No: M4SI/NC/SR/SU-KRL/2018/21108

Sulal N. L., Senior Geologist
Archana K. G., Senior Geologist

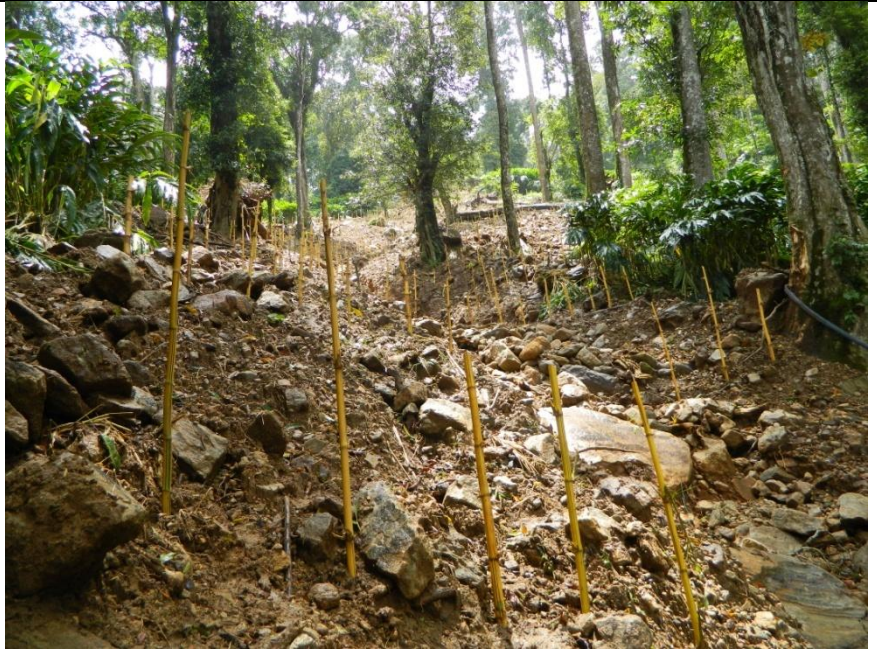
15	Run out distance	:	<i>70m</i>
16	Type of Material	:	<i>Rock-cum- debris</i>
17	Type of movement	:	<i>Flow</i>
18	Rate of movement	:	<i>Very Rapid</i>
19	Activity	:	<i>Active</i>
20	Distribution	:	<i>Advancing</i>
21	Style	:	<i>Single</i>
22	Failure mechanism	:	<i>Shallow planar ($\leq 5m$) failure</i>
23	History	:	<i>Date of initiation: 09th June, 2018</i>
24	Geomorphology	:	<i>Moderately Dissected Slope, Slide direction is towards S7°W</i>
25	Geology/Lithology	:	<i>Pink Granite Gneiss</i>
26	Structure	:	<i>-</i>
27	Landuse/ Landcover	:	<i>Low Height Plantation (Cardamom)</i>
28	Hydrological condition	:	<i>Flowing</i>
29	Triggering Factor	:	<i>Rainfall</i>
30	Death of persons	:	<i>Nil</i>
31	People affected	:	<i>2 persons got injured</i>
32	Livestock Loss	:	<i>Nil</i>
33	Communication	:	<i>NH – 49 (Kochi – Dhanushkodi Road) damaged and blocked for hours.</i>
34	Infrastructure	:	<i>One house partially damaged, one culvert completely damaged.</i>

35	Agriculture/forest/Barren	:	<i>Agriculture: Cardamom, mixed cultivation.</i>
36	Geo-scientific Causes	:	<i>Loosening the overburden for cardamom plantation, adverse cultivation pattern, defective maintenance of drainage systems along with reduction of strength on super saturation due to continuous shower. The natural course of the drainage was blocked for cardamom plantation.</i>
37	Remedial measures	:	<i>As an immediate measure the loose unsorted debris should be removed retaining the natural course of the nala and construction of a proper culvert for the free flowing of water across the road. The next step is the restriction of unscientific hill slope modification. The hill slope modification if required may be carried out after considering the slope stability and engineering aspects. Proper land use practice must be followed along the vulnerable slopes. Terracing and contour bounding should not be allowed along the slope. People must be educated about the importance of proper land use practices to minimise the risks. Afforestation of the slope with suitable plant species has to be done.</i>

Fig: The upper part of the failed surface.

38	Remarks, if any	:	<i>If immediate remedial measures not taken, the chances are very high for reactivation.</i>

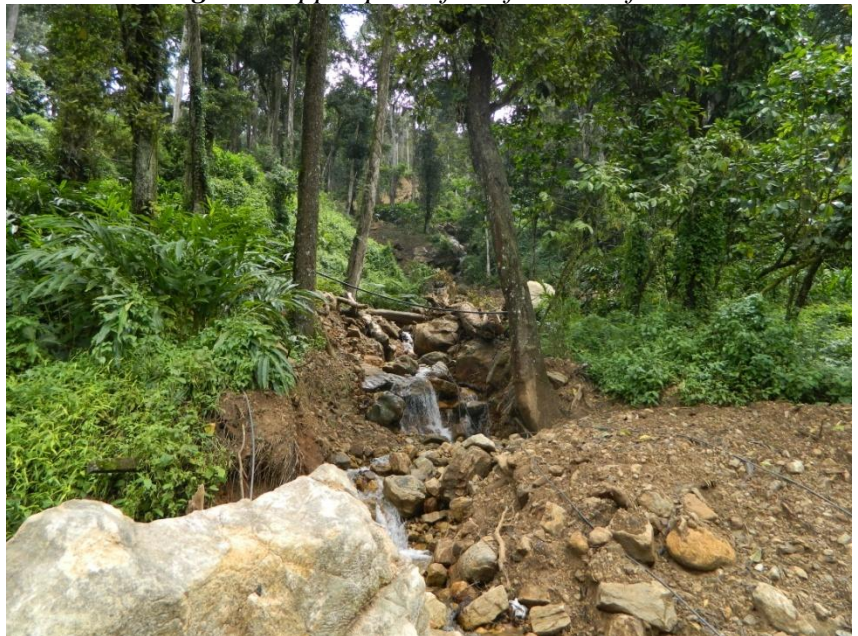
Fig: The run out path.

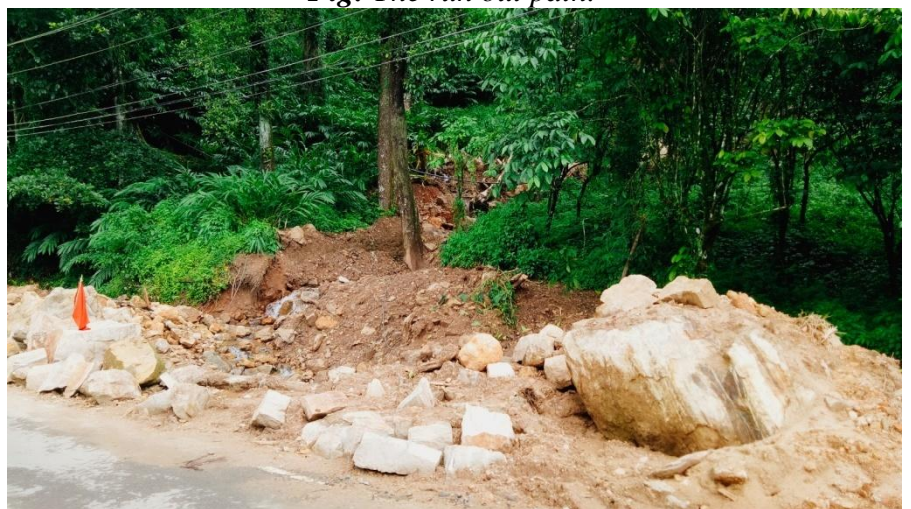
Fig: Accumulation of failed mass on the slope break.

40	Summary/Abstract	:	<i>A debris flow occurred in Kallar-Vattiyar area, Pallivasal Village, Devikulam Taluk, Idukki district at about 1900hrs on 9th June, 2018. Two persons got injured; the material with huge boulders caused partial damage to one house and the National Highway 49. The length, width and depth of the slide are about 60m, 30m and 4m respectively. The material comprising a complex mixture of fine clay and sand and coarse gravel, cobbles and boulders with a variable water quantity has been dislodged and moved down to about 70m and disrupted traffic in the Kochi-Dhanushkodi road. Part of the debris has accumulated on the road and part moved down up to the bottom of the slope damaging one house in its path. The adverse cultivation pattern by modification of slope, defective maintenance of drainage systems and nature of slope forming material are the preparatory factors. Increase of pore pressure due to infiltration and accumulation of rain water along the loose debris is the triggering factor for the slide.</i>

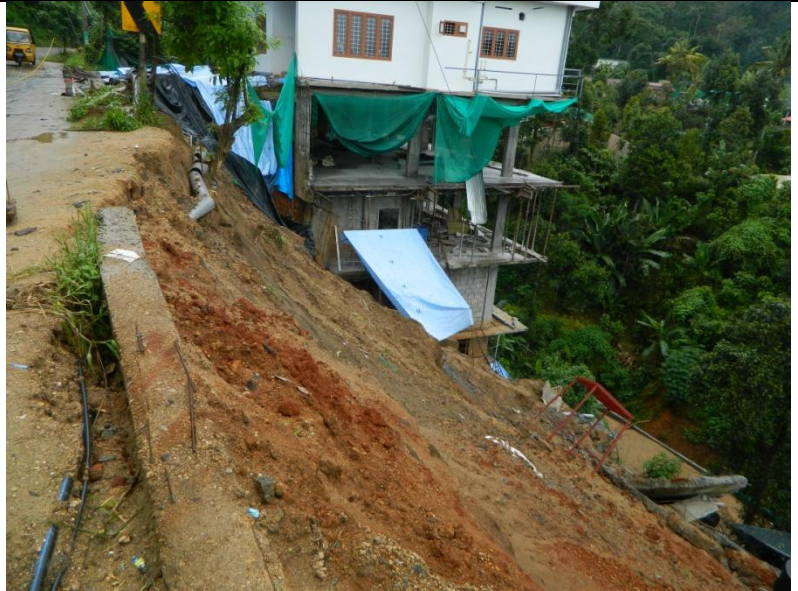
21	Style	:	<i>Single</i>
22	Failure mechanism	:	<i>Shallow planar ($\leq 5m$) failure</i>
23	History	:	<i>Date of initiation: 11th June, 2018 (1400hrs)</i>
24	Geomorphology	:	<i>Lowly Dissected Slope, Slide direction is towards N40°E</i>
25	Geology/Lithology	:	<i>Pink Granite Gneiss</i>
26	Structure	:	-
27	Landuse/ Landcover	:	<i>Settlement</i>
28	Hydrological condition	:	<i>Wet</i>
29	Triggering Factor	:	<i>Rainfall</i>
30	Death of persons	:	<i>Nil</i>
31	People affected	:	<i>Nil</i>
32	Livestock Loss	:	<i>Nil</i>
33	Communication	:	<i>Nil</i>
34	Infrastructure	:	<i>Newly constructed four storied building completely collapsed.</i>
35	Agriculture/forest/Barren	:	<i>Nil</i>
36	Geo-scientific Causes	:	<i>Construction of building (four storied) in loose overburden material without proper strengthening of foundation which in turn resulted in loading at the head of the slope break. Improper maintenance of drainage system: As the culverts in the road were blocked, the excess water has accumulated besides the building in the road corridor as that part of the road is having a slight depression. This excess water seepage through the loose overburden material increased the pore water pressure which in turn initiated the slide.</i>

Fig: The crown of the slide

37	Remedial measures	:	<i>As an immediate remedial measure remove the accumulated remains of collapsed building and the slided materials from the slope, open all the culverts and divert the water through culverts without allowing it to settle in the vulnerable slopes. In future, before initiating any construction, carry out the site feasibility study in order to understand the characteristics of subsoil. Remove and replace the undesirable in situ soil or soil stabilization may be done to improve soil strength and increase the resistance to its softening by water through bonding the soil particles together.</i>
38	Remarks, if any	:	<i>Another five storied building, situated adjacent to the collapsed building, is in the brim of danger.</i>

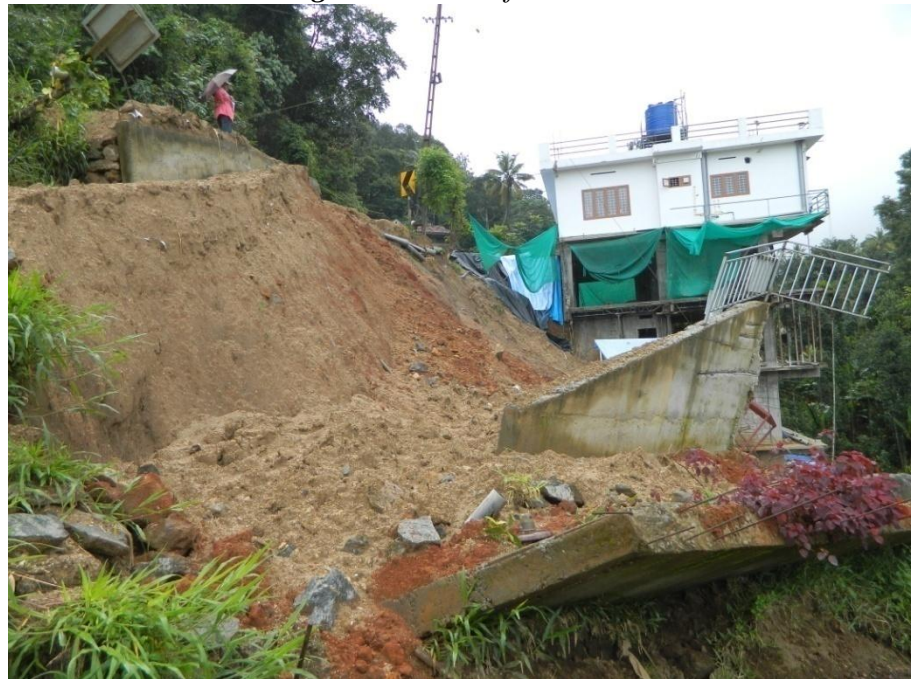
Fig: Accumulated remains of building and debris.

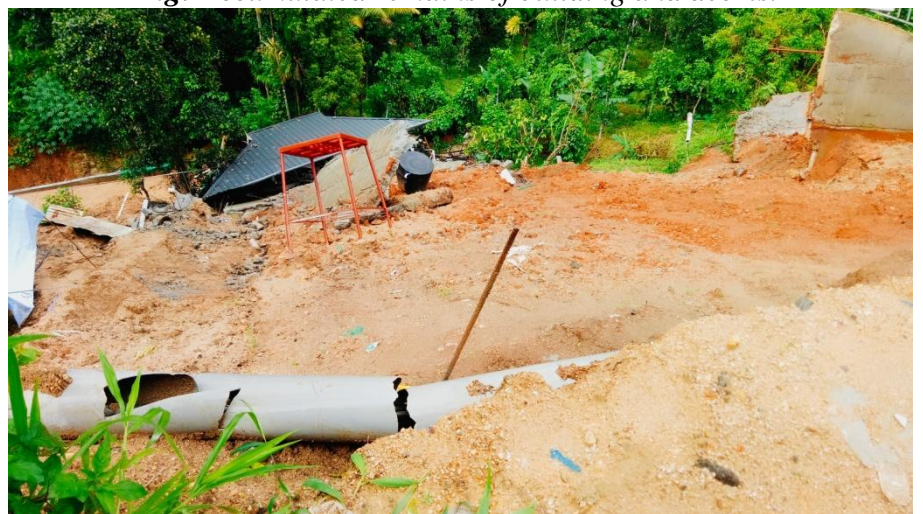
Fig: A view from the crown of the slide depicts the collapsed building.

40	Summary/Abstract	:	<i>A debris slide occurred in Anachal, Pallivasal Village, Devikulam Taluk, Idukki district at about 1400hrs on 11th June, 2018. Newly constructed four storied building got completely devastated during the slide. The length, width and depth of the slide are about 20m, 30m and 3m respectively. The material there was very loose coarse-grained in-situ soil. The slide occurred on a very steep slope of about 60°-70°. The building with its base built on this loose soil added a head loading to the break in slope. All the culverts beside the road were blocked which cause the accumulation of water besides the building in the road corridor. This resulted in increase of pore pressure due to infiltration along the loose overburden material which in turn initiated the slide.</i>
41	Date of Reporting	:	<i>29th June, 2018</i>
42	Landslide Category	:	<i>Category II</i>

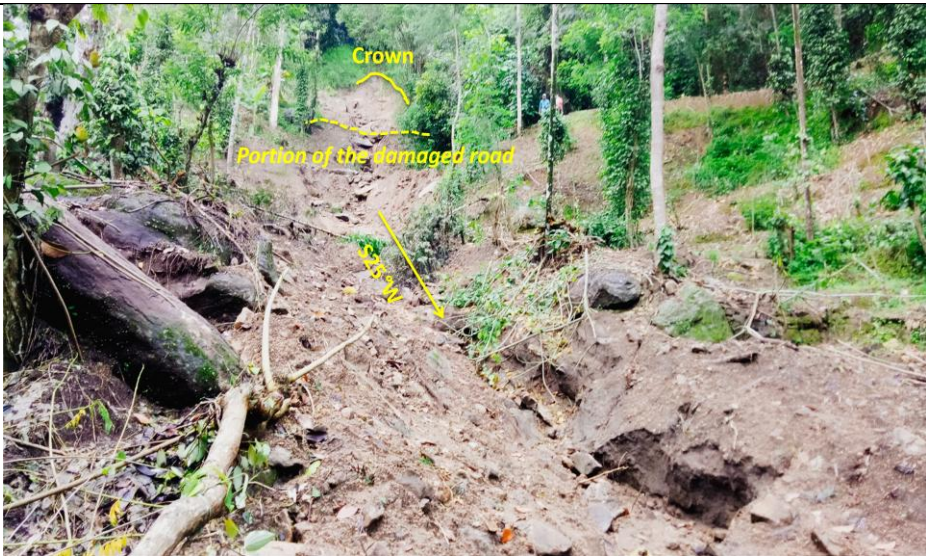
25	Geology/Lithology	: <i>Charnockite</i>
26	Structure	: -
27	Landuse/ Landcover	: <i>Moderate Vegetation</i>
28	Hydrological condition	: <i>Flowing</i>
29	Triggering Factor	: <i>Rainfall</i>
30	Death of persons	: <i>Nil</i>
31	People affected	: <i>Nil</i>
32	Livestock Loss	: <i>Nil</i>
33	Communication	: <i>Unmetalled road partly damaged.</i>
34	Infrastructure	: <i>Nil</i>
35	Agriculture/forest/Barren	: <i>Destroyed 1.5 acre agriculture land (Pepper)</i>
36	Geo-scientific Causes	: <i>Pore water pressure, presence of unsorted overburden materials, unplanned cultivation obstructing the natural course of drainage, slope modification for the construction of road.</i>
37	Remedial measures	: <i>As the area is devoid of any settlements and anthropogenic presence, removing the unsorted loose overburden and reducing the slope angle along with proper maintenance of drainage system will serve the purpose.</i>
38	Remarks, if any	: -

</p> <p data-bbox="810 689 1273 719">Fig: A view from the toe of the slide</p> <p data-bbox="571 725 1501 1249">   </p> <p data-bbox="788 1252 1295 1281">Fig: A view from the crown of the slide</p>
40	Summary/Abstract	<p data-bbox="571 1281 1530 1655"> <i>The slide occurred in the western slope of Ponnudi reservoir. The slope and the natural course of the river were modified for cultivation and for the construction of an unmetalled road. The excavated material after the formation of road was dumped in the crest of the slope and the incessant shower prevailed from 08th June, 2018 initiate the sliding. The length, width and depth of the slide are about 45m, 8m and 7m (approx.) respectively. The direction of the slide is S25°W with a slope angle varying from 25°-35°. Smoothing the topography by removing the unsorted loose overburden material with proper maintenance of drainage system is the suggested immediate remedial measures.</i> </p>

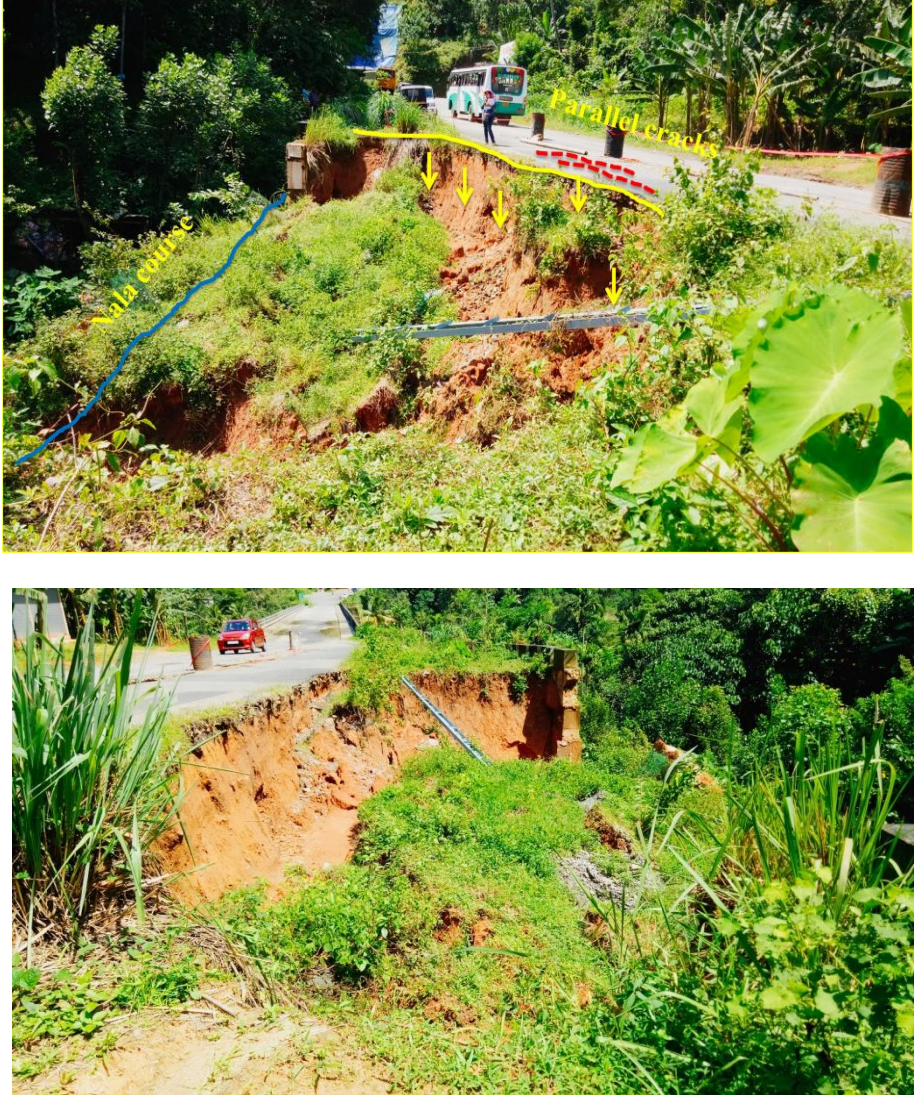
35	Agriculture/forest/Barren	:	<i>Agriculture (pepper)</i>
36	Geo-scientific Causes	:	<i>As there was a column of soil between the road and the newly constructed retaining wall the water perched through the column resulted in soaking of the material mass & caused increase in weight along with the pore water pressure created an additional stress towards the retaining wall. This along with the removal of lateral support due to erosion by nala initiated the subsidence.</i>
37	Remedial measures	:	<i>Remove the collapsed retaining wall and loose overburden material. Construction of concrete reinforced gravity wall with proper drainage conduits. Proper maintenance of road drainage system through construction of impermeable side ditches and culverts.</i>

<p style="text-align: center;">Fig: Subsidence in Kallarkutty approach road.</p>
40	Summary/Abstract	<p><i>The subsidence occurred beside the Kallarkutty approach road at 1400hrs on 09.07.2018. The subsidence occurred as a result of the toe erosion by one of the tributaries of Mutira Puzha along with the weight of the retaining wall constructed beneath the approach road. Some parallel cracks were also observed in the approach road which will fall eventually if any retaining wall was not constructed.</i></p>
41	Date of Reporting	: 01 st June, 2018
42	Landslide Category	: Category III

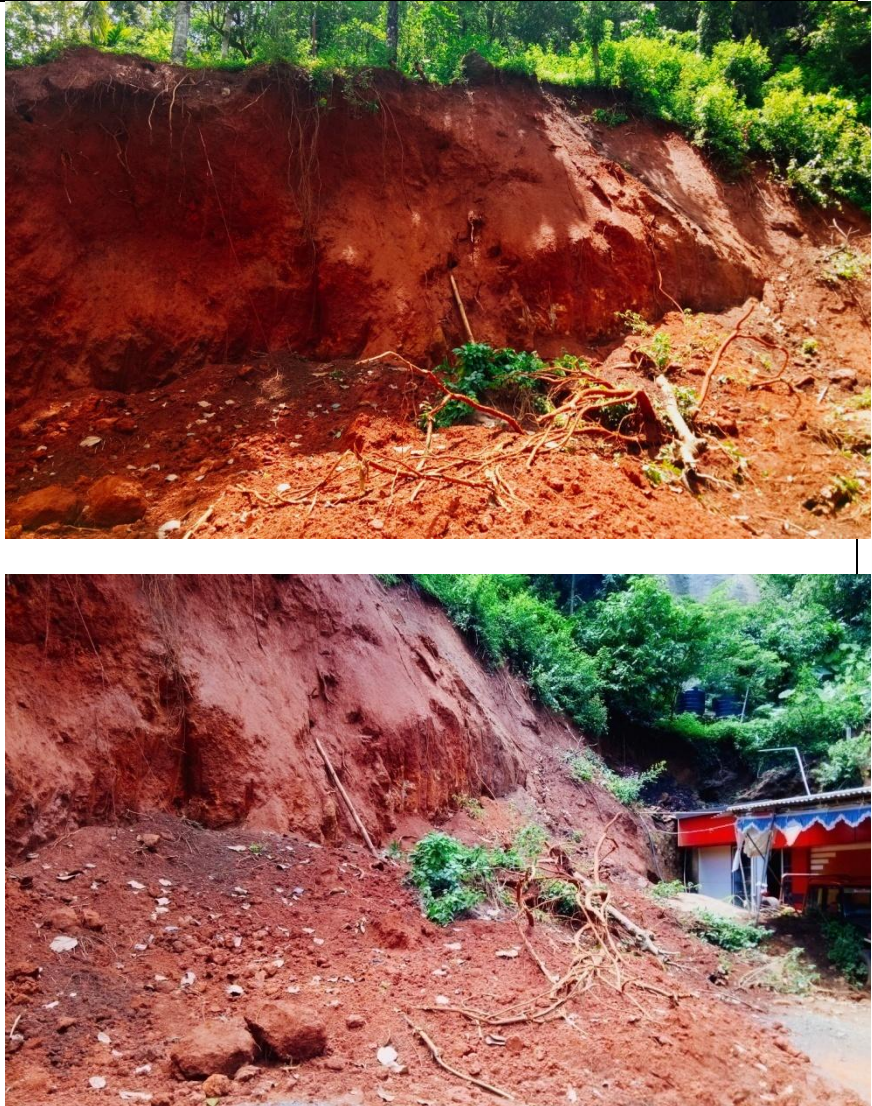
33	Communication	:	<i>Nil</i>
34	Infrastructure	:	<i>One house partly affected.</i>
35	Agriculture/forest/Barren	:	<i>Nil</i>
36	Geo-scientific Causes	:	<i>The slope was modified for the construction of one house and left behind the cut slope without construction of any retaining wall. The weight of the trees at the edge of the excavated slope along with the infiltration of rain water initiated the movement.</i>
37	Remedial measures	:	<i>Removal of trees from the edge of the cut slope, removing material from the area driving the landslide and reducing general slope angle.</i>
38	Remarks, if any	:	<i>As water is still dripping out of the failed surface, the chance of</i>

40	Summary/Abstract	:	<i>The slope was modified for the construction of one house and left behind the cut slope without construction of any retaining wall. The weight of the trees at the edge of the excavated slope along with the infiltration of rain water resulted in sliding. As water is still dripping out of the failed surface, the chance of recurrence is there. Removal of trees from the edge of the cut slope, removing material from the area driving the landslide and reducing general slope angle can slow or stop further sliding.</i>
41	Date of Reporting	:	<i>01st July, 2018</i>
42	Landslide Category	:	<i>Category III</i>

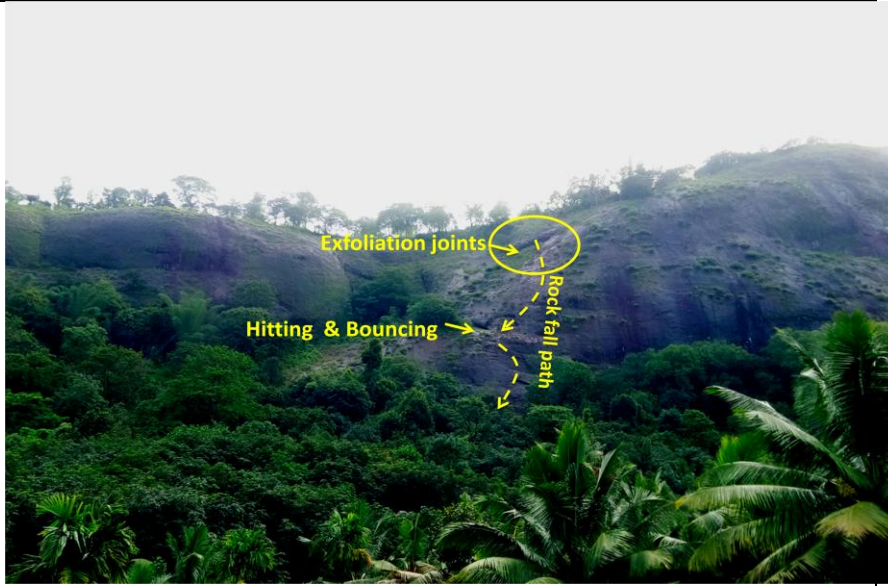
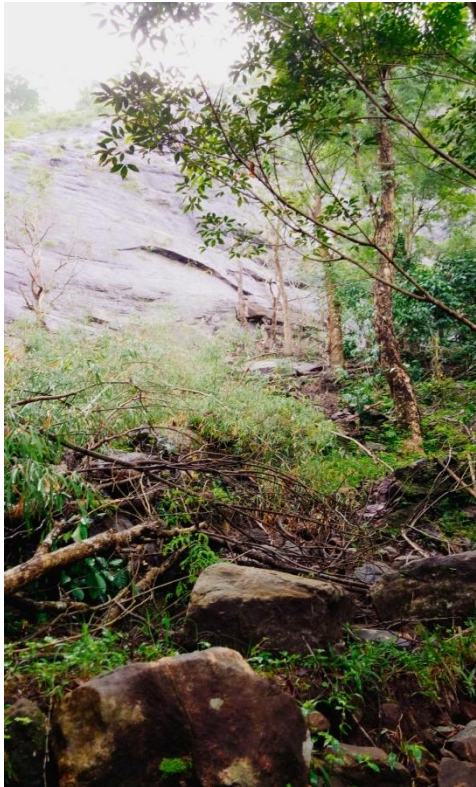
35	Agriculture/forest/Barren	:	<i>Agriculture (Rubber)</i>
36	Geo-scientific Causes	:	<i>After site inspection it was concluded that weathering and erosion have resulted in the development of fractures parallel to the surface (sheet joints). Over long periods, daily temperature variations and extreme heat along with water flowing through fractures decomposes the bedrock, loosened bonds that hold rocks in place which created large slabs of rock by the process of exfoliation. Vegetation growth along with the triggering factor of</i>

40	Summary/Abstract	:	<i>Two successive rockfalls occurred in Valara on 03rd May, 2018 and 09th June, 2018. A fragment of rock detached by falling along the sub-vertical ridge faces and proceeded down slope by bouncing along the thick high height plantations (Rubber) below. After site inspection it was concluded that weathering and erosion have resulted in the development of fractures parallel to the surface (sheet joints). Over long periods, daily temperature variations and extreme heat along with water flowing through fractures decomposes the bedrock, loosened bonds that hold rocks in place which created large slabs of rock by the process of</i>

<i>rainfall finally forced the unstable rock to fall.</i>
37	Remedial measures	:	<i>Removal of protrusions and overhangs (exfoliated rock slabs) retained in the top by scaling (manual or mechanical) if possible.</i>
38	Remarks, if any		-
39	Photos. Sketch of Plan & section of the slide	:

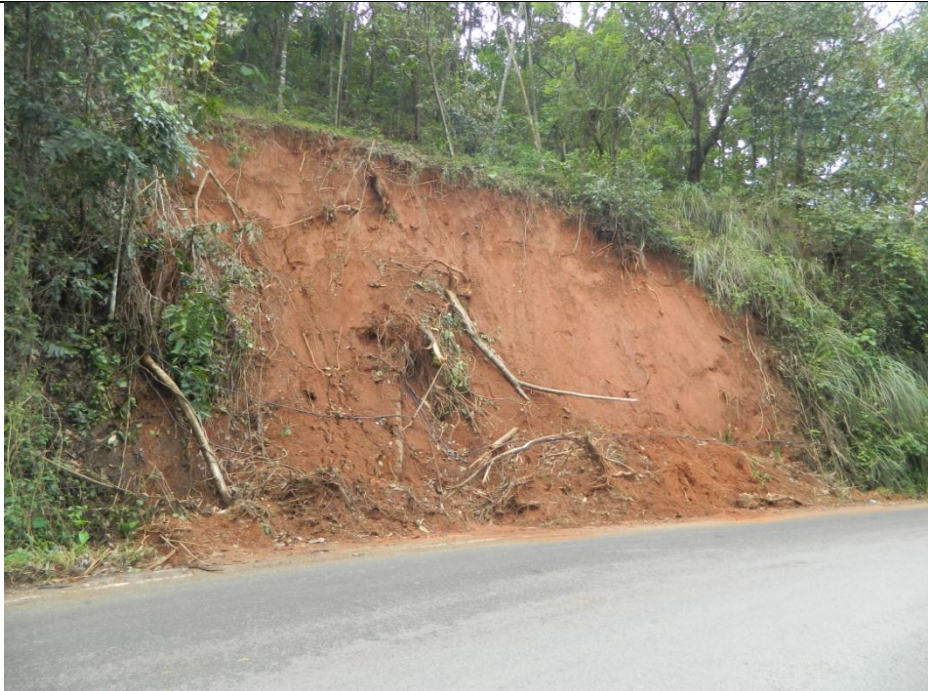
29	Triggering Factor	:	<i>Rainfall</i>
30	Death of persons	:	<i>Nil</i>
31	People affected	:	<i>Nil</i>
32	Livestock Loss	:	<i>Nil</i>
33	Communication	:	<i>Road blocked- NH – 49 (Kochi – Dhanushkodi Road)</i>
34	Infrastructure	:	<i>Nil</i>
35	Agriculture/forest/Barren	:	<i>Forest</i>
36	Geo-scientific Causes	:	<i>Unplanned cutting of slope for the construction of NH – 49 (Kochi – Dhanushkodi Road). Saturation of loose overburden due to incessant rainfall.</i>
37	Remedial measures	:	<i>Construction of gabion retaining wall.</i>
38	Remarks, if any		<i>Slope failures are common along the road corridors as the roads are constructed by vertically cutting thick column of old debris/soil mass and leaving the cut slope untreated making them highly susceptible to failure.</i>
39	Photos. Sketch of Plan & section of the slide	:

40	Summary/Abstract	:	<i>A cut slope failure occurred in Anaviratty, Devikulam Taluk, Idukki district on 9th June, 2018. As a result of the failure the NH – 49 (Kochi – Dhanushkodi Road) was blocked for hours. The length, width and depth of the slide are about 7m, 10m and 1m respectively. Part of the dislodged material was accumulated on the road disrupting the traffic in Kochi – Dhanushkodi Road. The unplanned cutting of hill slope for the construction of NH - 49 along with the oversaturation of loose overburden due to incessant rainfall triggered the slide.</i>

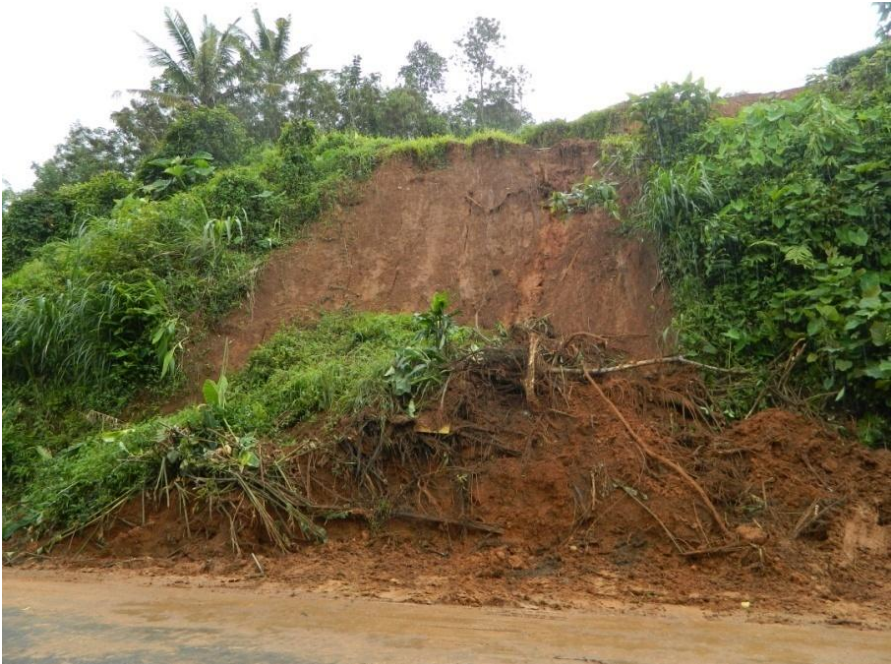
34	Infrastructure	:	<i>Nil</i>
35	Agriculture/forest/Barren	:	<i>Moderate vegetation with settlement.</i>
36	Geo-scientific Causes	:	<i>Unplanned cutting of Ambazhachal hill slope for the construction of Thottapura – Selliampara road. Saturation of loose overburden due to incessant rainfall.</i>
37	Remedial measures	:	<i>Construction of gabion retaining wall.</i>
38	Remarks, if any	:	<i>Slope failures are common along the road corridors as the roads are constructed by vertically cutting thick column of old debris/soil mass and leaving the cut slope untreated making them highly susceptible to failure.</i>
39	Photos. Sketch of Plan & section of the slide	:

40	Summary/Abstract	:	<i>A cut slope failure occurred in Ambazhachal, Pallivasal Village, Devikulam Taluk, Idukki district on 9th June, 2018. As a result of the failure the Thottapura-Selliampara road was blocked for hours. The length, width and depth of the slide are about 3.5m, 5m and 1m respectively. Part of the dislodged material was accumulated on the road disrupting the traffic in the Thottapura-Selliampara road. The unplanned cutting of Ambazhachal hill slope for the construction of Thottapura - Selliampara road along with the saturation of loose overburden due to incessant rainfall triggered the slide.</i>
