# GEOTECHNICAL IMPACTS OF AUGUST 2018 FLOODS OF KERALA, INDIA

Event: August 2018

**Geotechnical Extreme Events Reconnaissance**  
*Turning Disaster into Knowledge*  
**Sponsored by the National Science Foundation**  
**GEER Association Report NO - 058**

**Date: 10-17-2018**

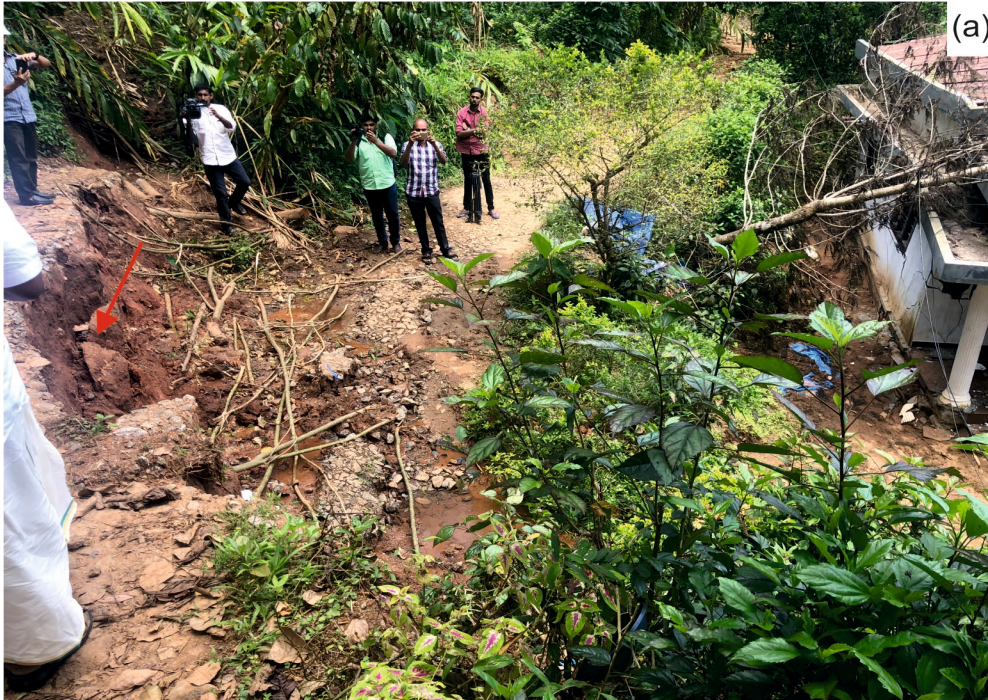
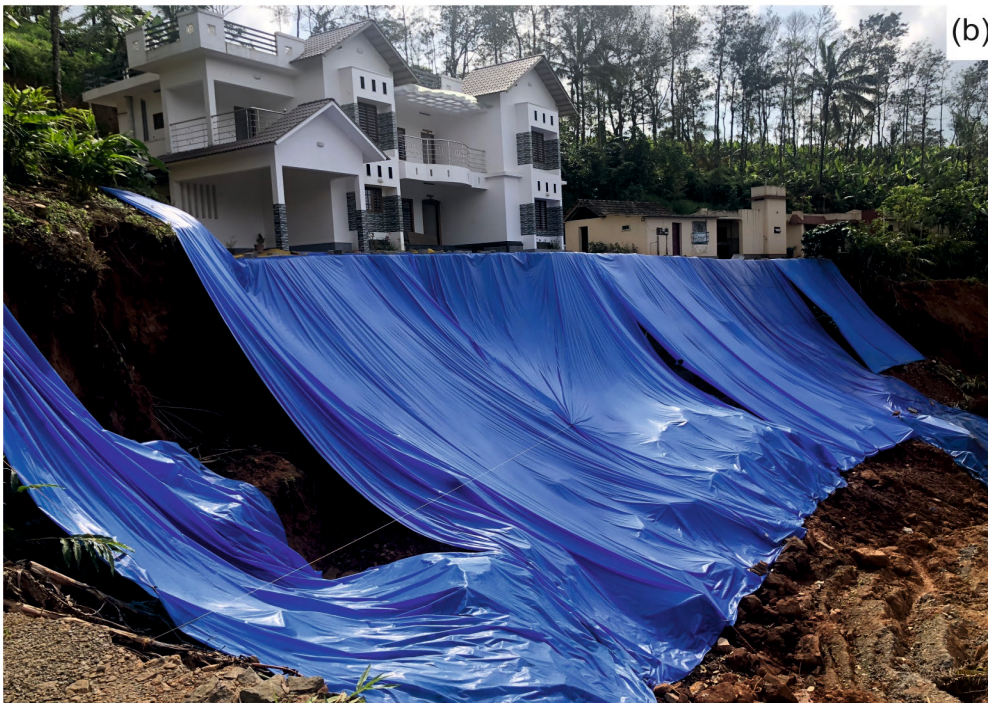
**1. Nirmala City landslides (9.7925061°N; 77.0680952°E):** Several landslides have occurred in Nirmala City near Kattappana that resulted in destruction of 10 houses. Most of the landslides fall in two categories: (a) Partially failed landslide and (b) Cut-slope failure. The partially failed landslide was confined to a gully of a lower order seasonal stream. Such features are called topographic hollows. The constructional activities along such natural paths blocked the excess water from discharging. Moreover, the hill consists of a shallow abandoned dug well that was meant for domestic purposes. All these facilitated the percolation of rain water and subsequent increase in pore-water pressure. About 10 houses, wholly or partially, was destroyed in this event. A metalled road was displaced for about 1 m (Fig 2.2a).

The cut-slope failure occurred in a slope modified for constructing a house. Almost 6 m thick overburden was excavated for the construction of a house. This facilitated the water percolation and caused the landslide. A further 3 m thick soil, downhill of this excavation, was removed by this landslide (Fig 2.2b). This landslide has made the area/house unoccupied. Further possibility of landslide, with a head-ward retreat, is possible in an anomalous rainfall such as this.

Figure 2.2: (a) Displaced road due to partially failed landslide  $9.7968615^{\circ}$   $77.0675334^{\circ}$  (b) Cut-slope failure at Nirmala City  $9.7925061^{\circ}$   $77.0680952^{\circ}$ . Note the modified slope behind the house.

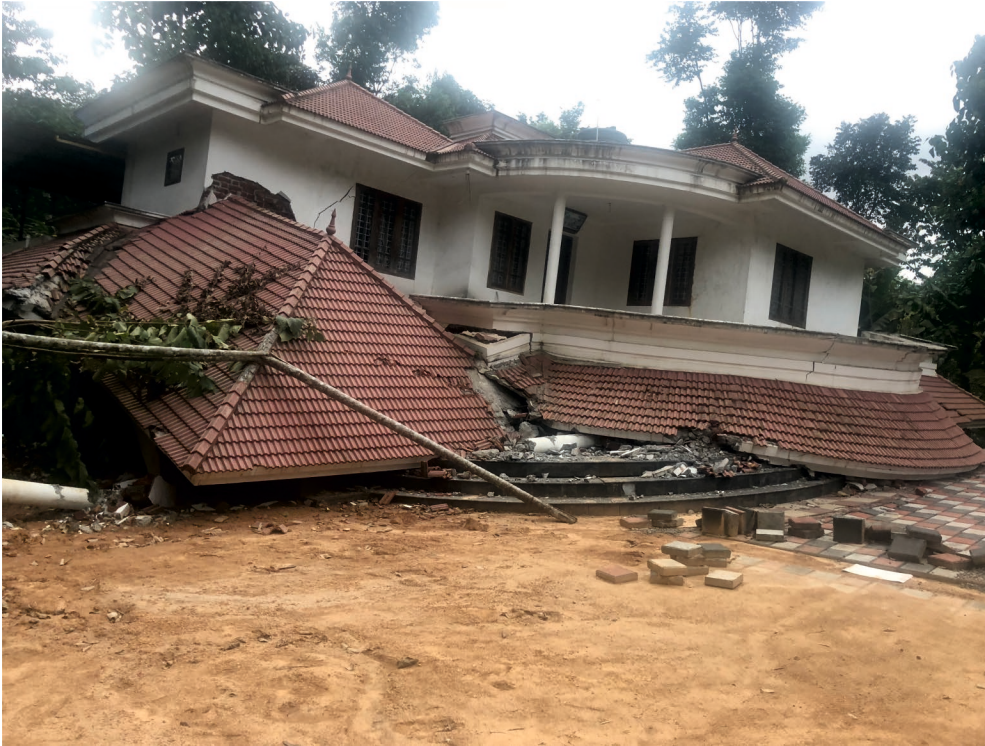
*Figure 2.3: Collapse and submergence of one storey near Mavadi 9.8747275°N; 77.1194017°E.*

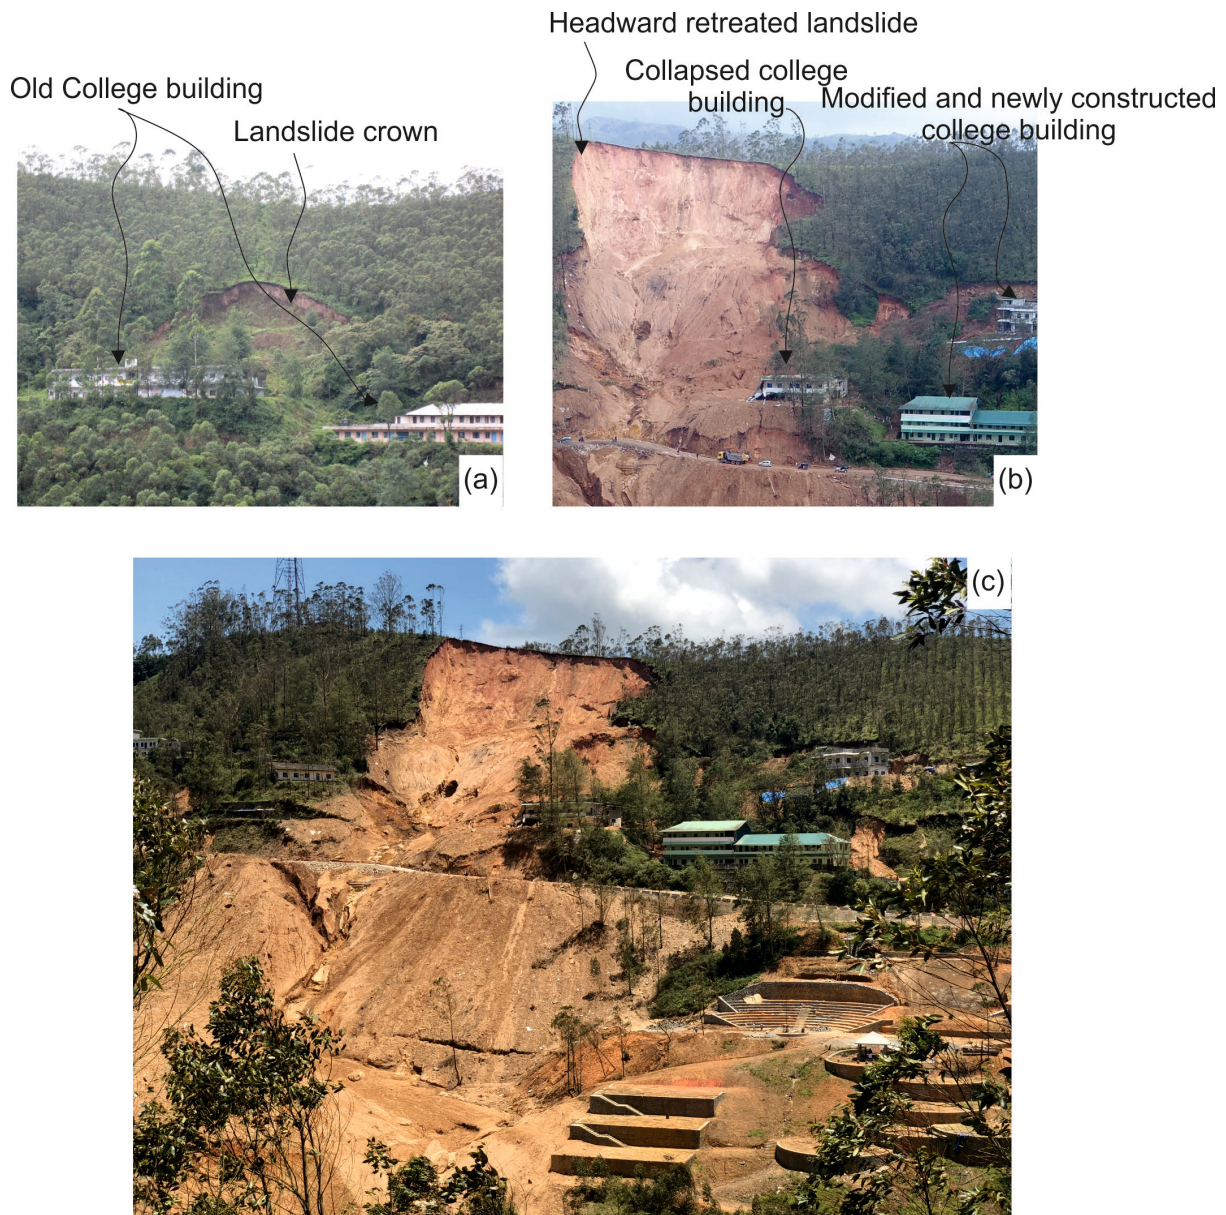
Figure 2.4 (a) Landslide scar of 2004 in the vicinity of Government College Munnar. Note the sagging of the crest line. (b) 2018 landslide uprooting the College building (c) Enlarged view of (b)  $10.0822468^{\circ}N$ ;  $77.0734293^{\circ}E$

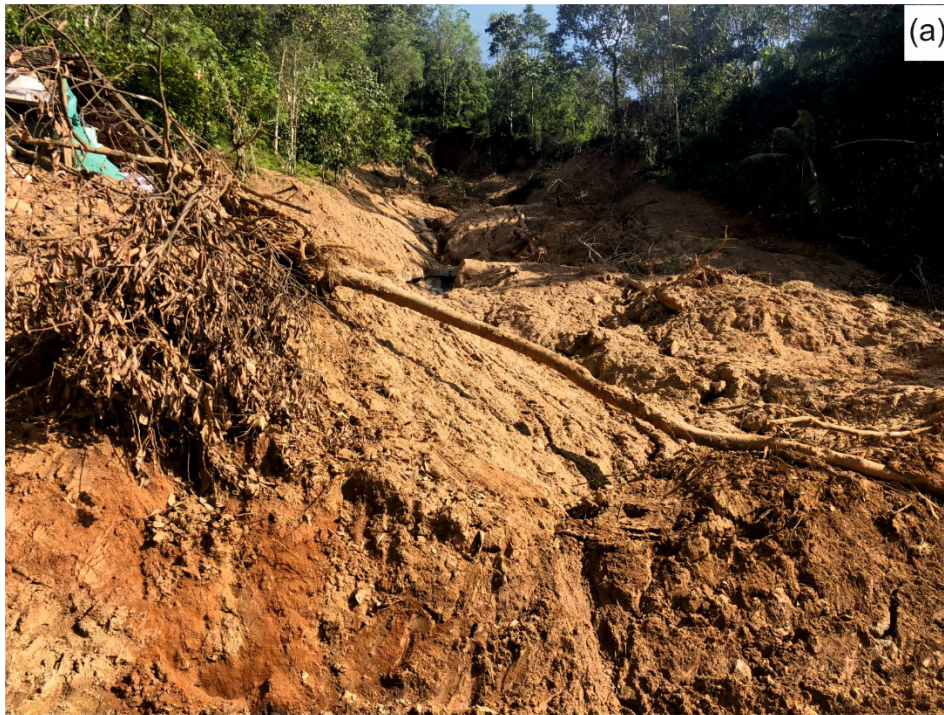
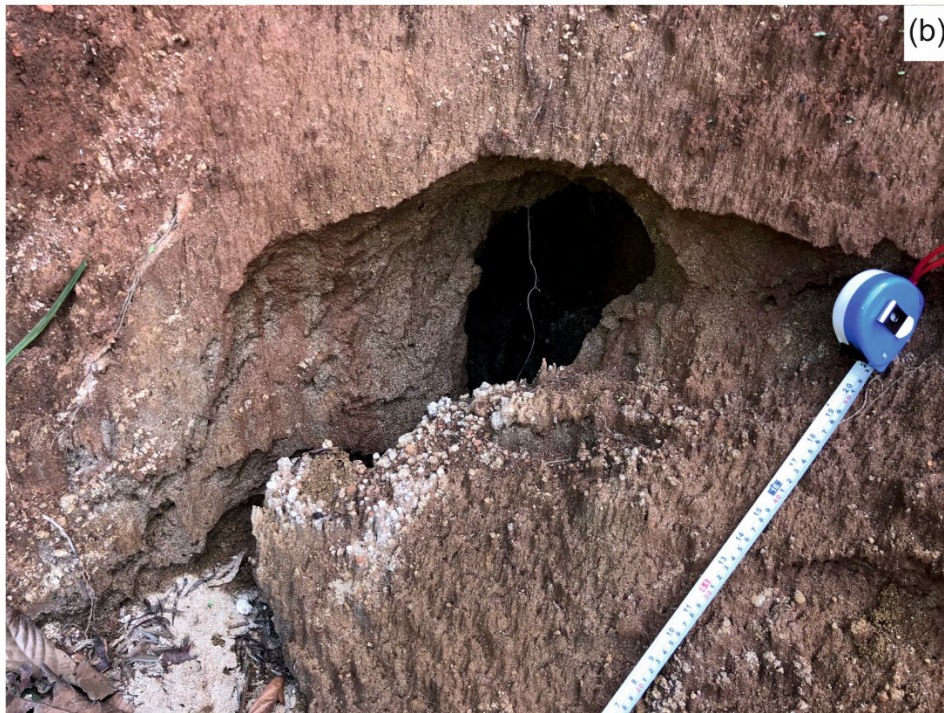
- 3. Vellathooval landslide (10.0088136°N; 77.0257626°E):** The landslide at Vellathooval is a classic example of piping (Fig 2.8a). Small conduits of varying dimensions (10-30 cm) are quite obvious in this area (Fig 2.8b). These subsurface conduits carry water and the dimension of the conduits changes with change in the velocity and discharge. The civil structures resting above such conduits will be under threat.

Piping has initiated the landslide and has developed into typical debris flow with approximately 20 m (width), 500 m (length) and 2 m (thick). All the debris was debouched into an adjacent river. This landslide has resulted in 5 deaths and destruction to 5 buildings. Three bodies are yet to be recovered.

*Figure 2.8 (a) Landslide at Vellathooval (b) Surface manifestation of a conduit in piping phenomena  
10.0088136°N; 77.0257626°E*

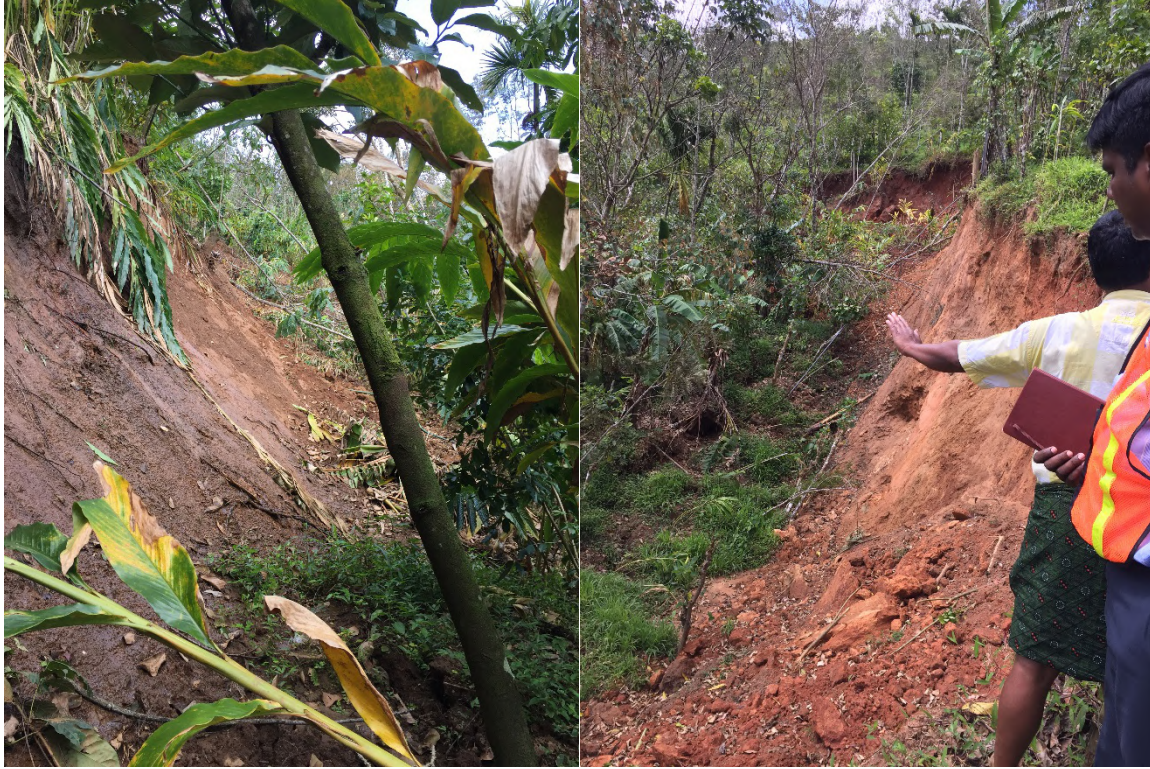
**Figure 2.14:** Photographs of the main headscarp of the largest landslide in Idukki ( $9.7964191^{\circ}\text{N}$ ;  $77.0682762^{\circ}\text{E}$ ).

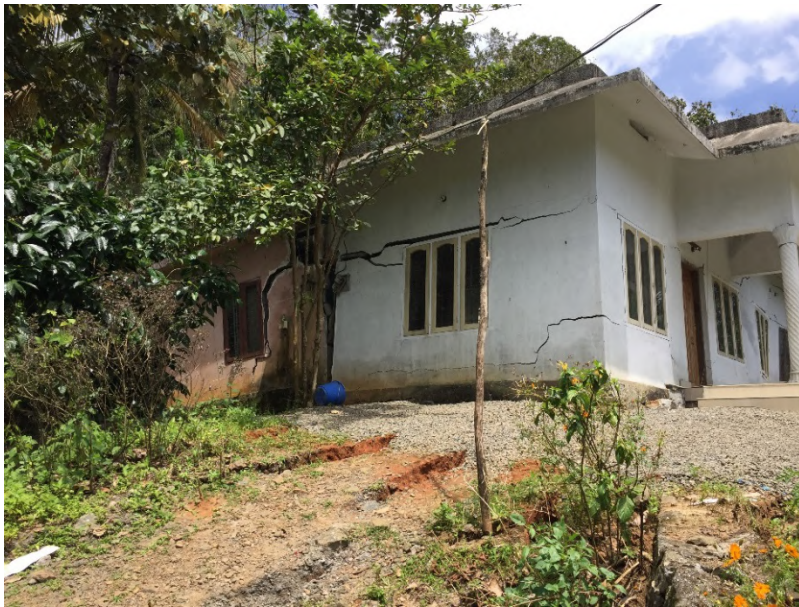
**Figure 2.15:** Photograph of one of the damaged houses within the Idukki Landslide. Using multiple photographs of this house, this geometry of this house was reconstructed using Photoscan ( $9.7962622^{\circ}\text{N}$ ;  $77.0681814^{\circ}\text{E}$ ).

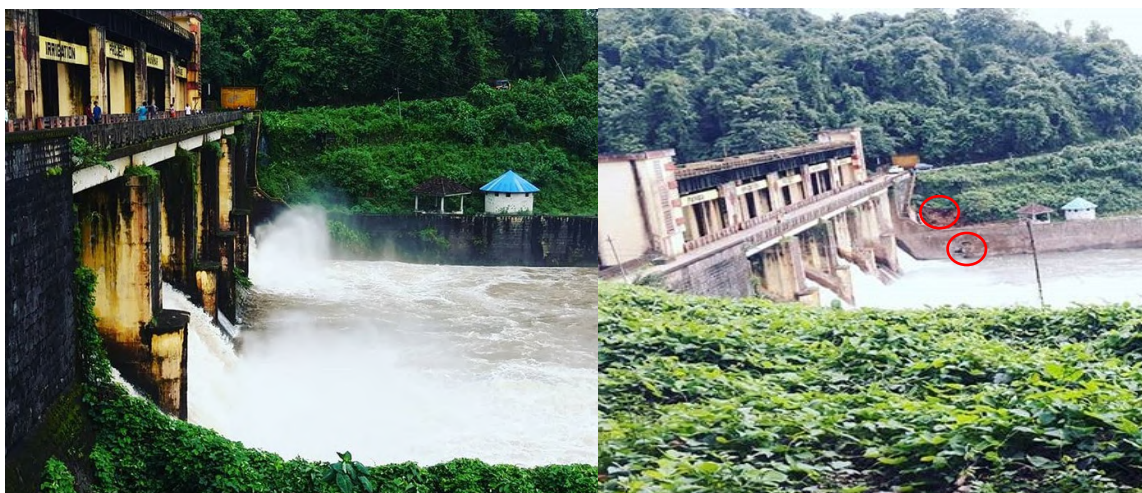
Reviewing the photographs from Instagram shows that the downstream side of the Maniyar dam beside the retaining structure has experienced some failure between August 10<sup>th</sup> and the 25<sup>th</sup>, 2018 (Figure 3.8). A closer view of the slope failure obtained from onmanorama indicate that the slope and the retaining structure had failed and material was eroded away (Figure 3.9). It is also evident from these photographs that there is some seepage occurring at the location where the slope failed. It is not clear whether this is seepage of groundwater or water from the upstream reservoir. From the pictures (Figure 3.10 & 3.11), it is also evident that the downstream side of the shutter-2 has experienced damage and the surface blocks have been displaced.

Figure 3.8: (Left) Downstream side of the Maniyar Dam with the shutters open on August 10th. (Right) Similar view as the left image taken on August 25<sup>th</sup> showing minor slope failure and damage to the retaining structure (failures are circled in red). Source of photograph: Instagram

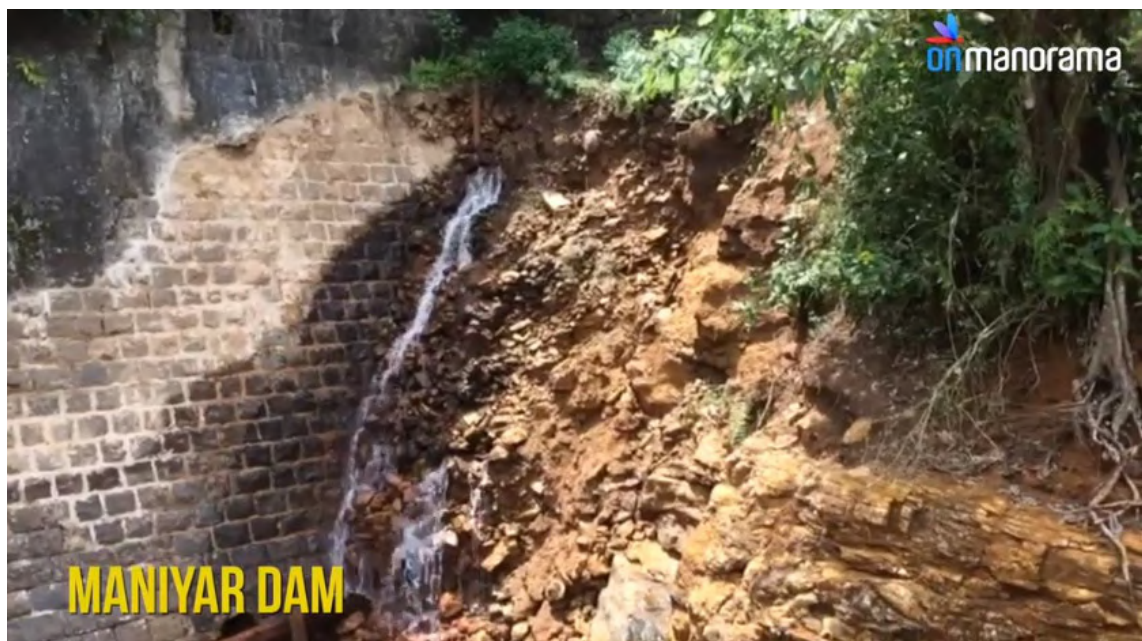
Figure 3.9: Closer view of the slope failure and seepage at the downstream side of the Maniyar dam (Source: manoramaonline.com).

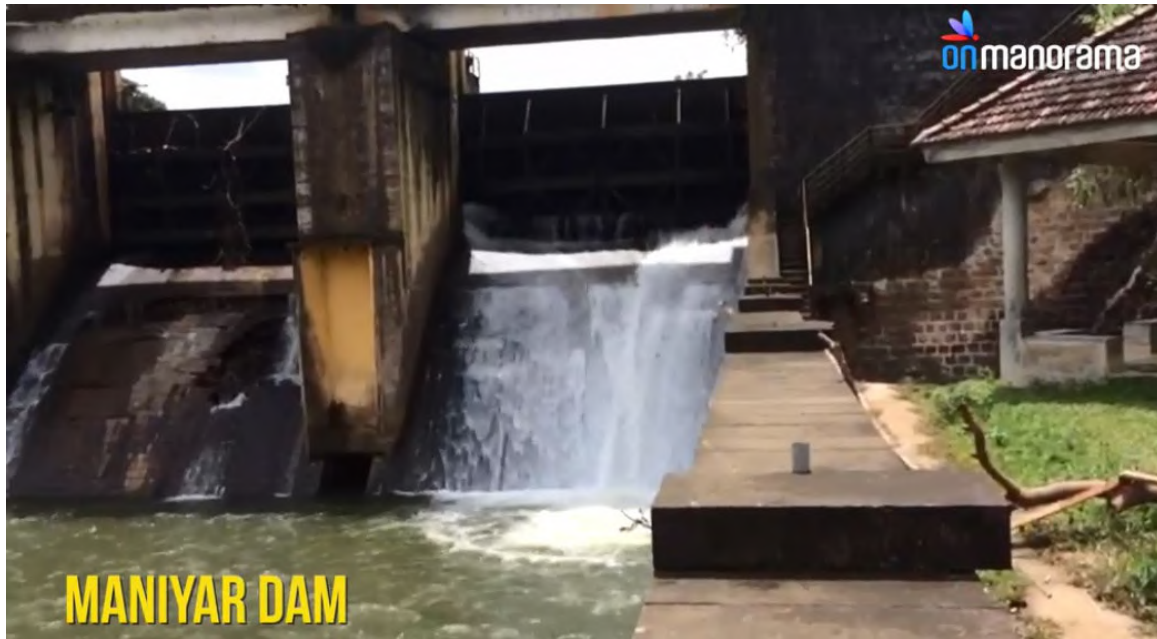
Figure 3.10: Photograph showing one shutter of the dam being closed and the surface concrete blocks been damaged (Source: manoramaonline.com).

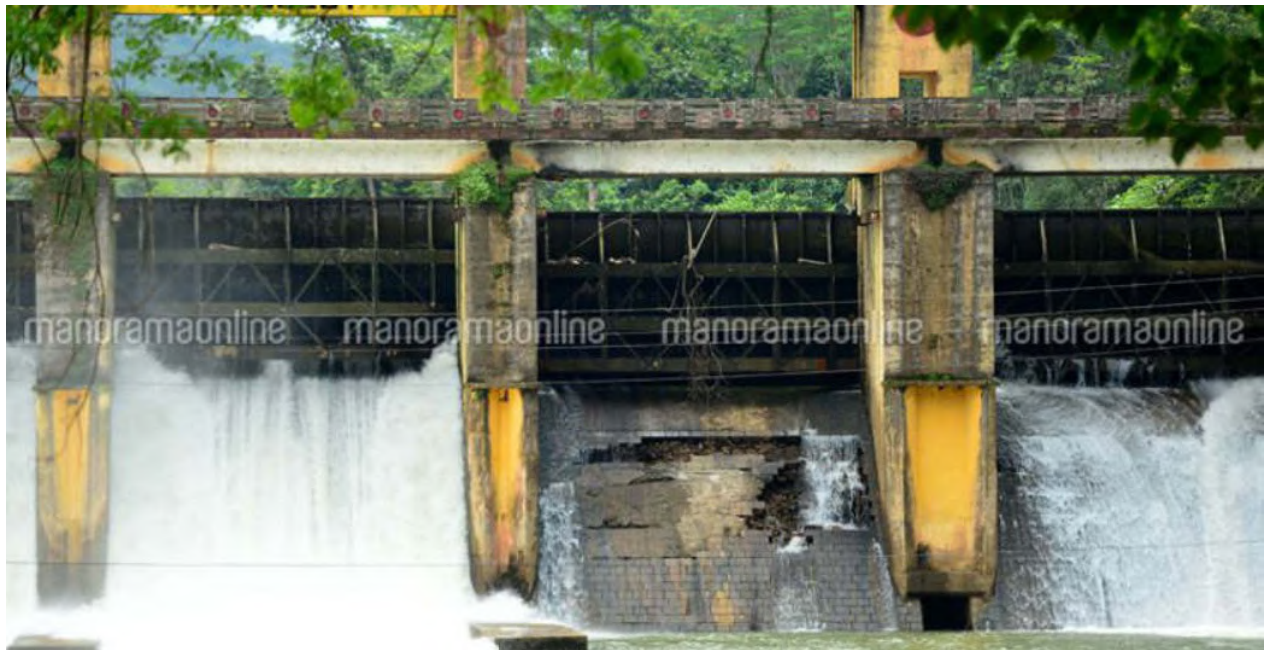
Figure 3.11: Different view of the damage to the downstream surface of shutter-2 at Maniyar Dam (Source: manoramaonline.com).

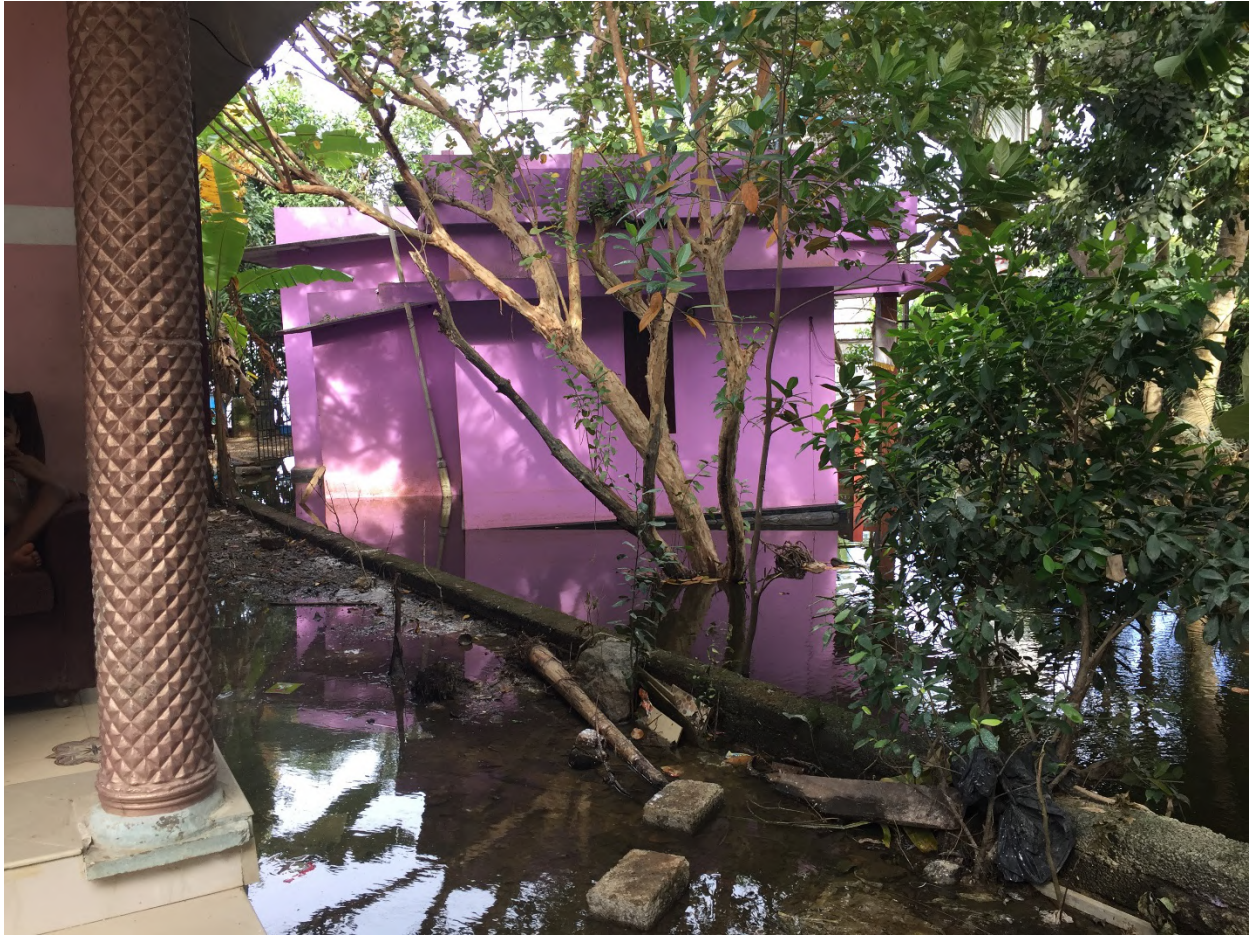
*Figure 4.1: Photograph of the subsided purple house located at coordinates Latitude=9.4626°, Longitude=76.3659°.*

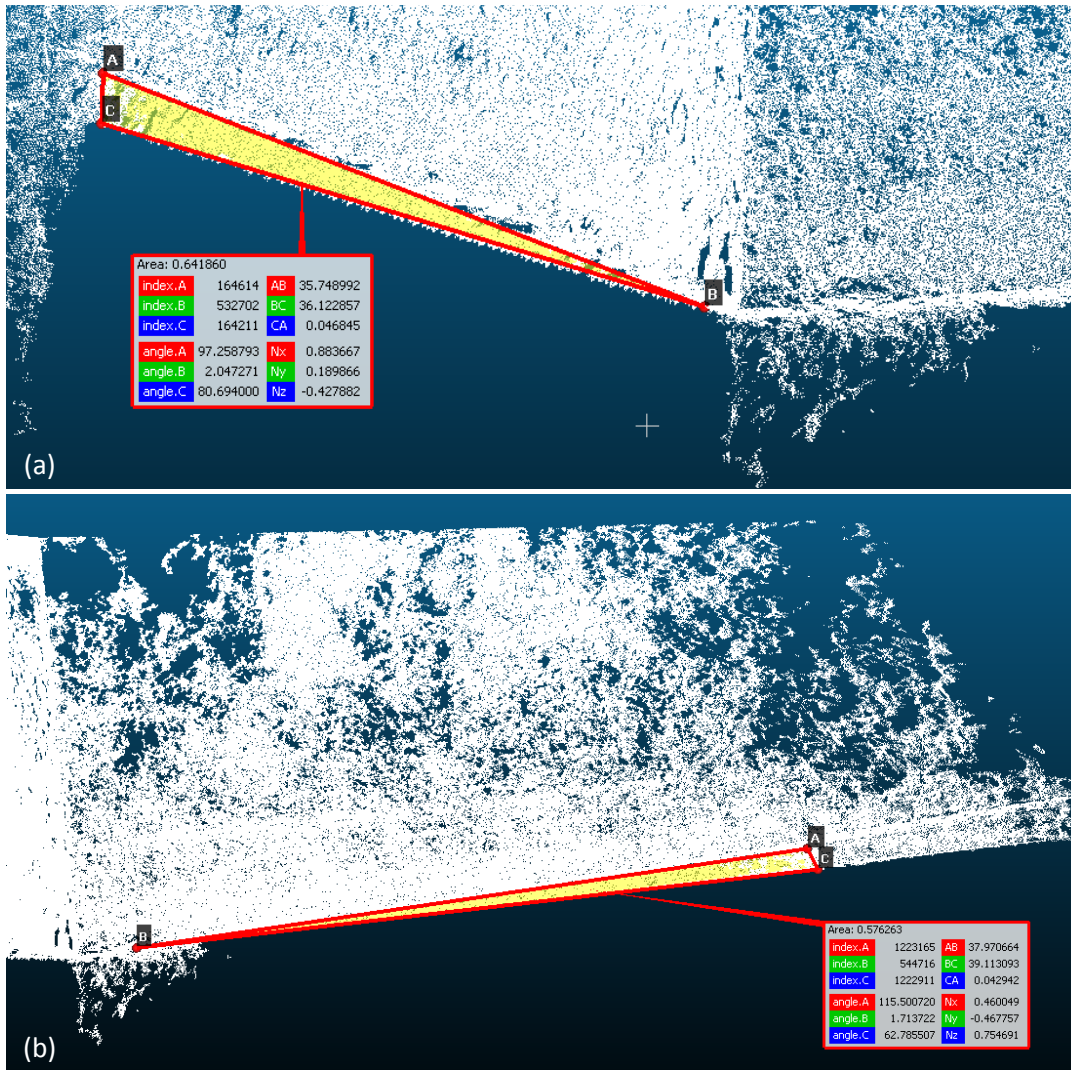
*Figure 4.6: PhotoScan rendering of three-dimensional point cloud data used to determine rotation of the foundation associated with differential settlement for a) North wall (1.7° tilt), b) West Wall (2.0° tilt).*

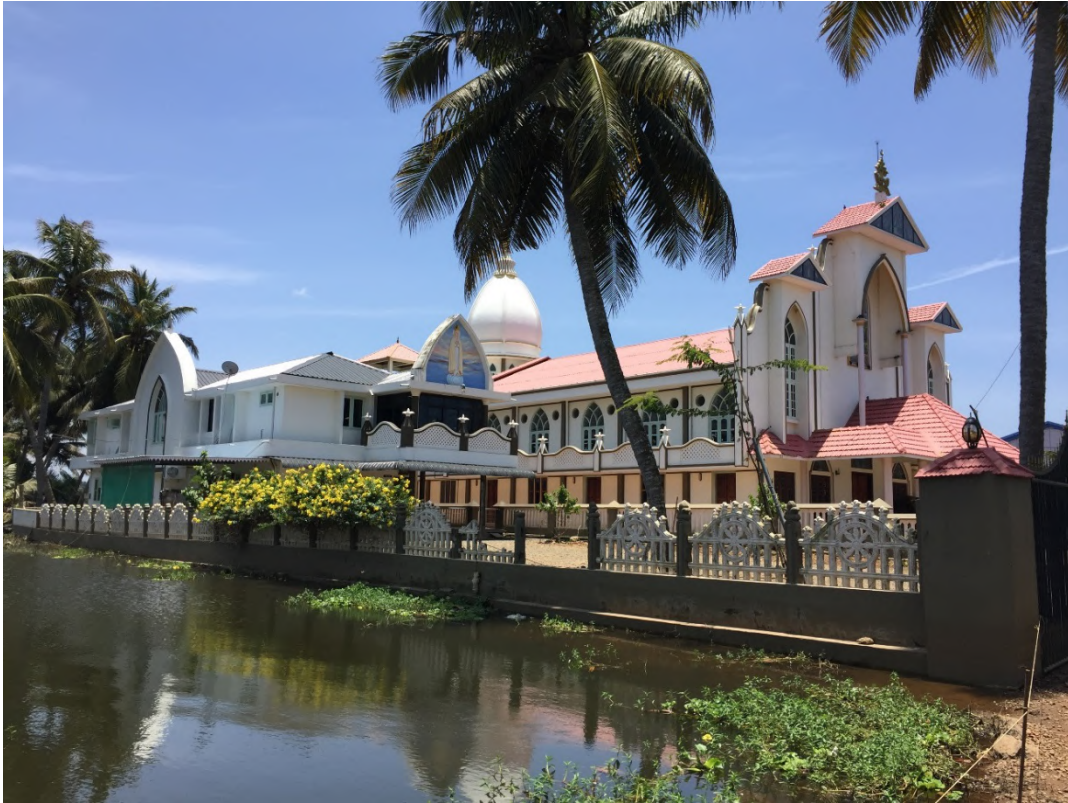
**Figure 4.11:** Mar Sleeva Church. Original Church constructed on 30-foot long concrete piles; ancillary building constructed on six- to eight-foot long sections of coconut trees placed in nine-pile groups (Latitude=9.450352°, Longitude=76.389449°).

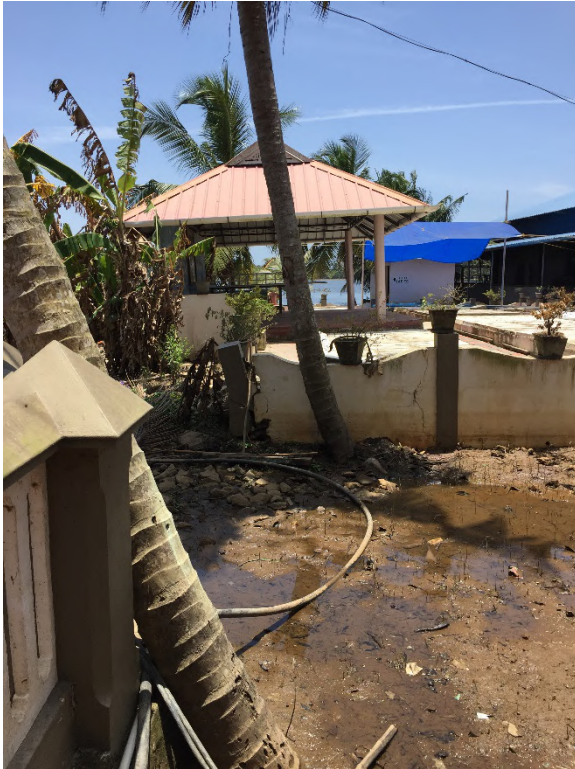
*Figure 4.15: Photograph of rotated pavilion located behind the Mar Sleeve Church of Ponga (Latitude=9.449777°, Longitude=76.389598°).*

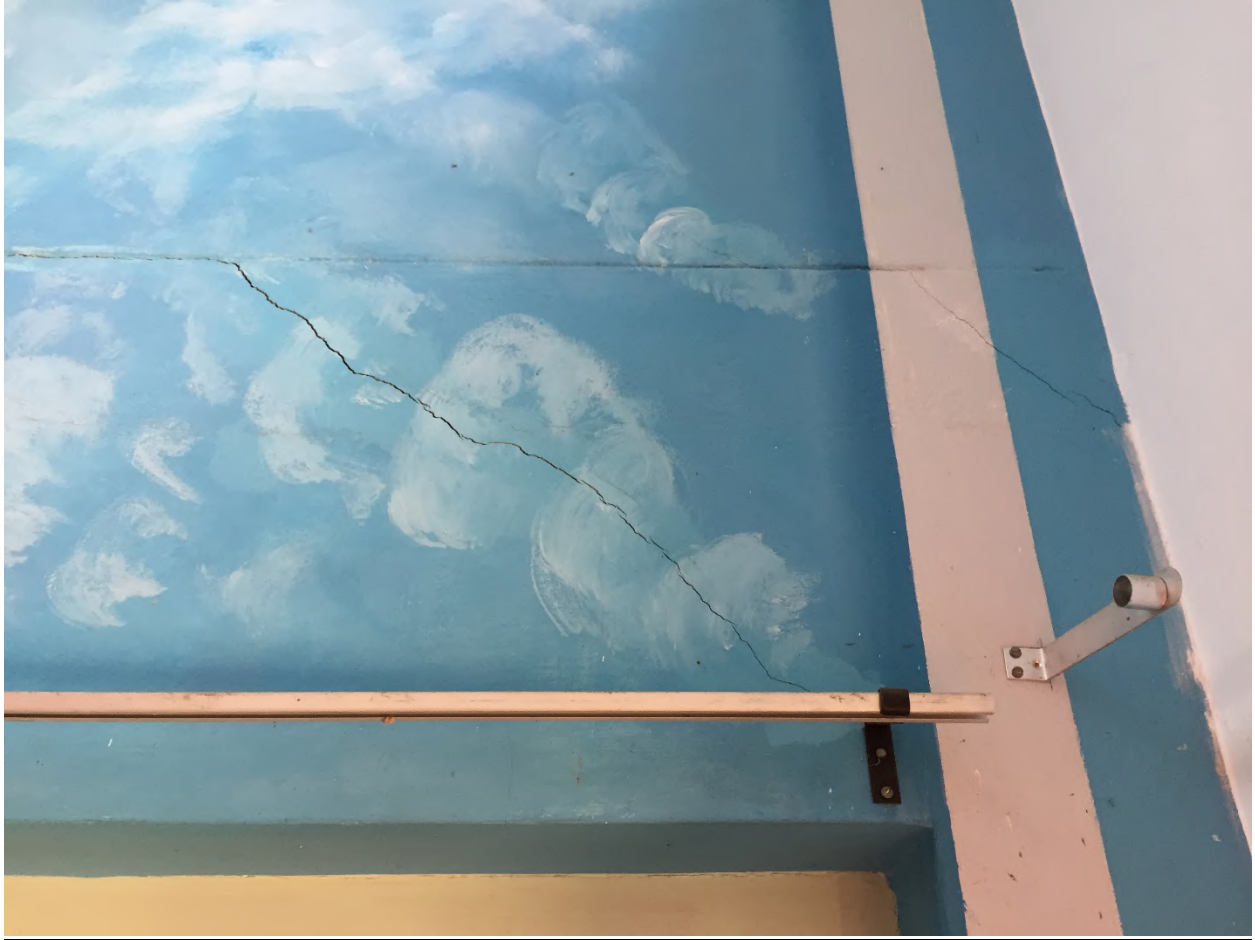
*Figure 4.17: Photograph of cracking observed within the back wall of the Mar Sleeva Church or Ponga.*

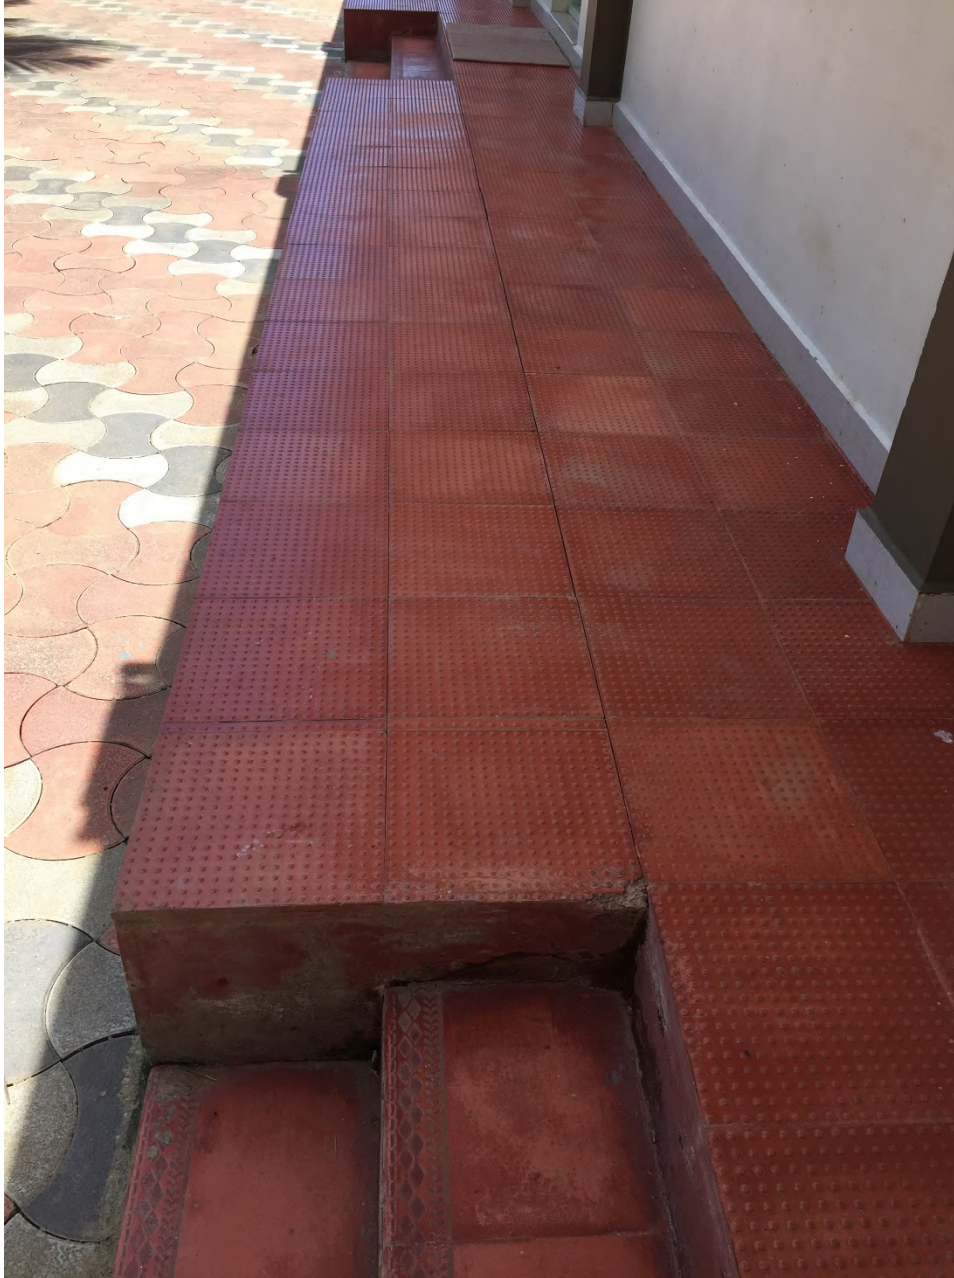
*Figure 4.18: Photograph of cracking occurring in the concrete pavers surrounding the pile supported Mar Sleeva Church of Ponga building.*

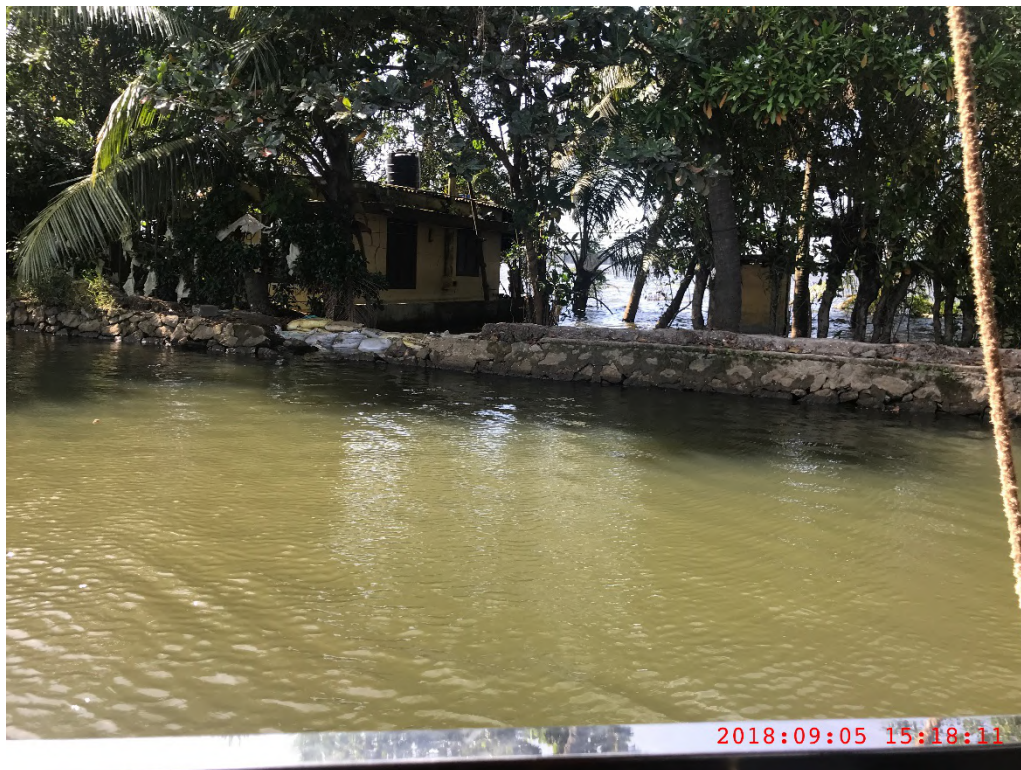
*Figure 5.4: A minor bund failure @ 9.5032131<sup>0</sup>N 76.3768638<sup>0</sup>E.*

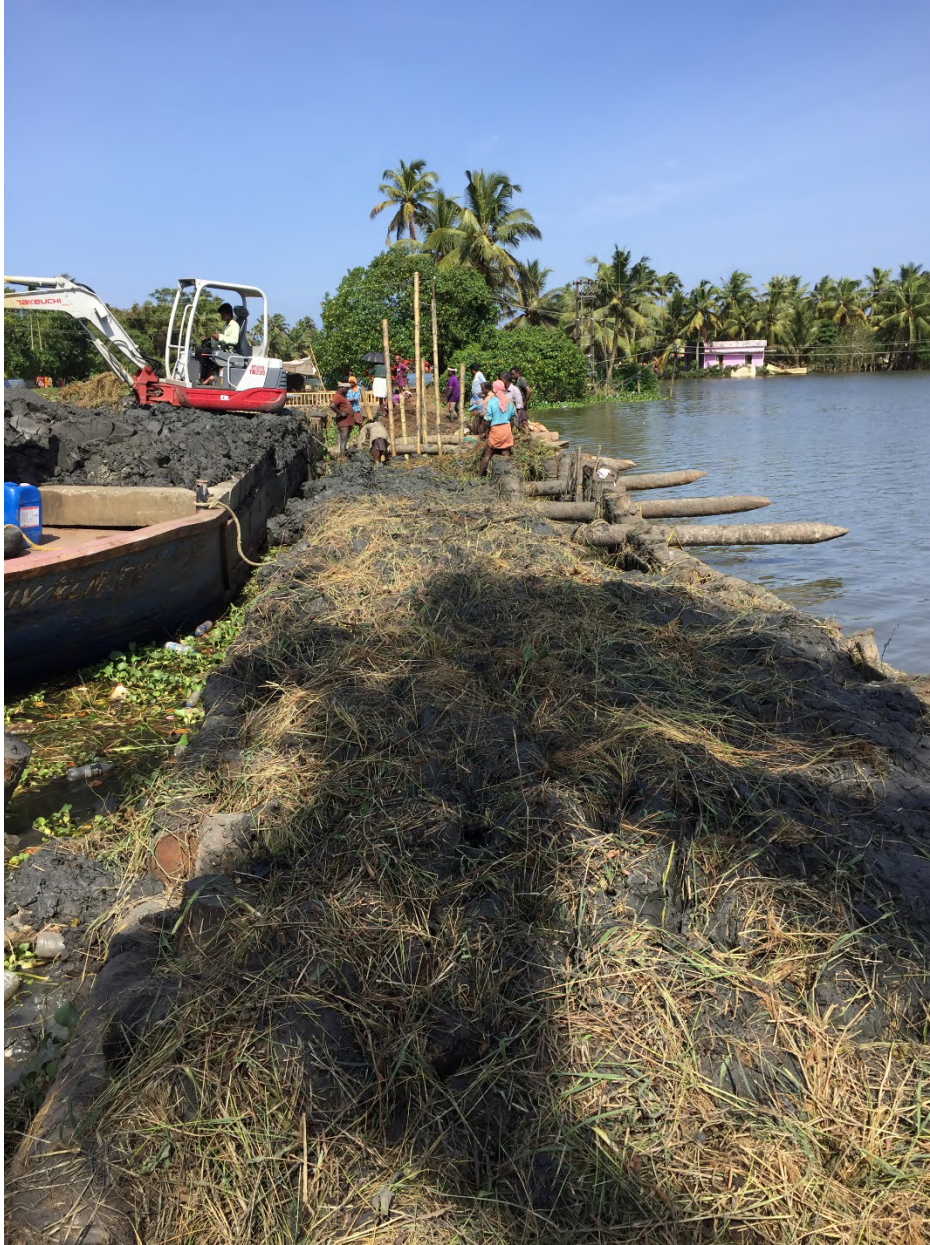
*Figure 5.5: A major bund failure of roughly 50m long near Kainakari @ 9.5029947<sup>0</sup>N 76.3749555<sup>0</sup>E. The left side of the bund in the photograph is the lake and the right side of the bund is the flooded fields.*

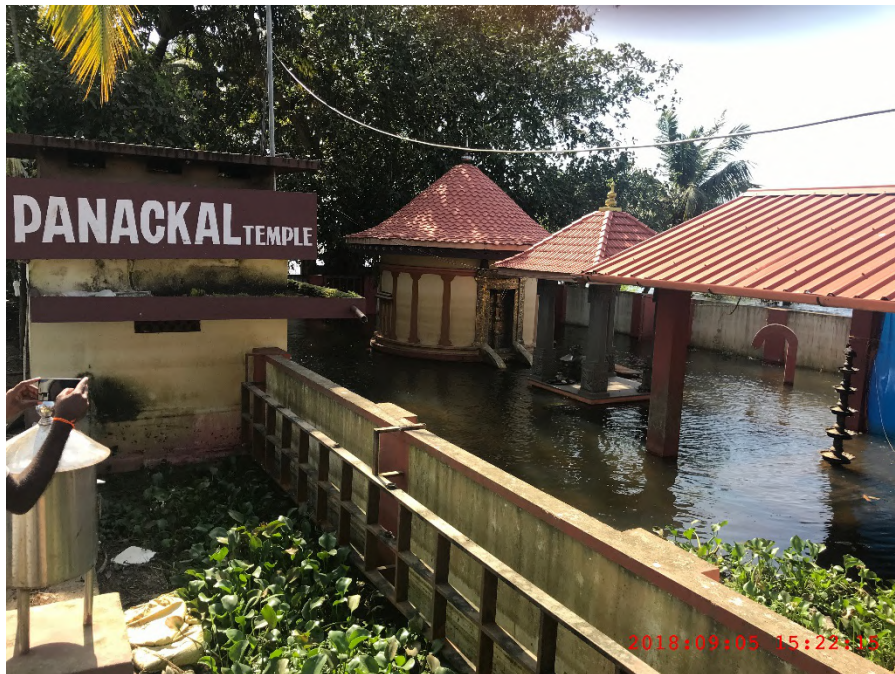
Figure 5.6: Flooded temple complex from the bund failure @ 9.5033596°N 76.3771085°E

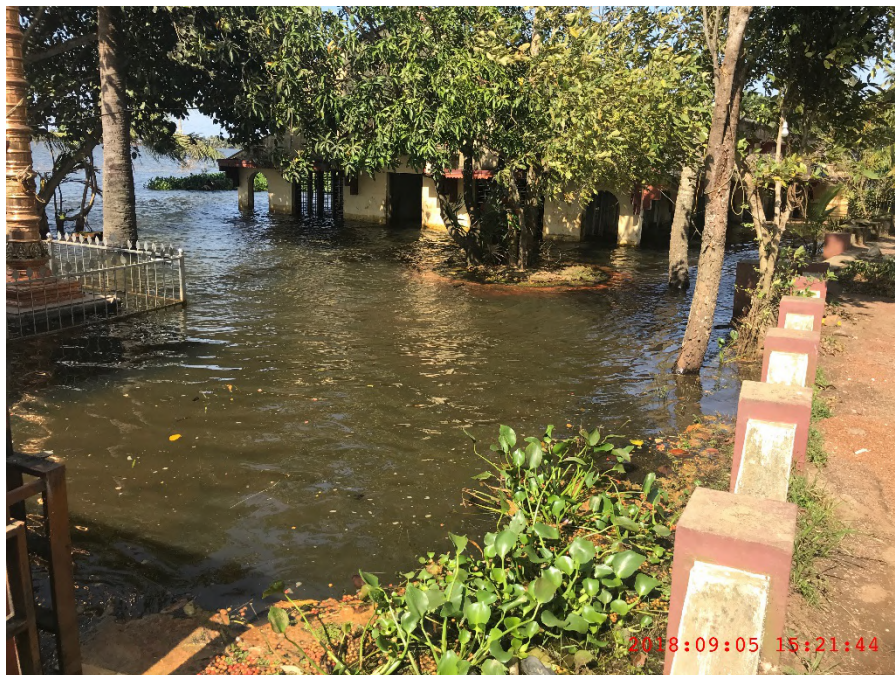
Figure 5.7: Flooded community hall from the bund failure @ 9.5033444°N 76.3770758°E

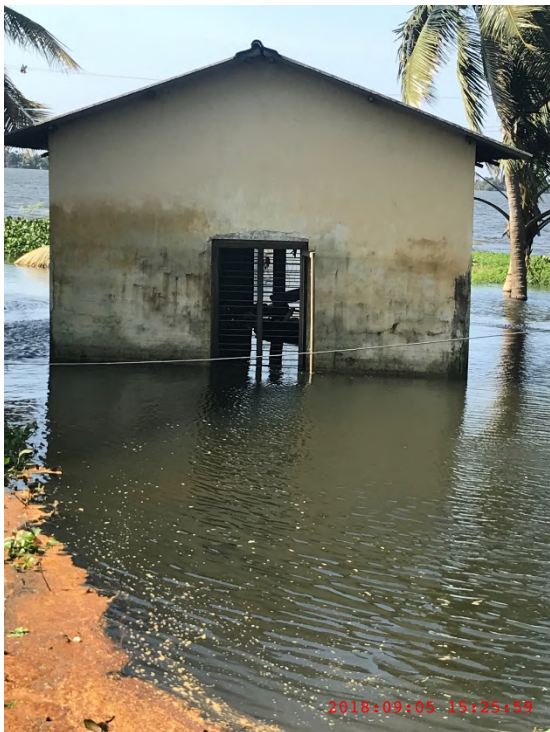
Figure 5.9: Flooded home due to bund failure @ 9.5032691°N 76.3776221°E

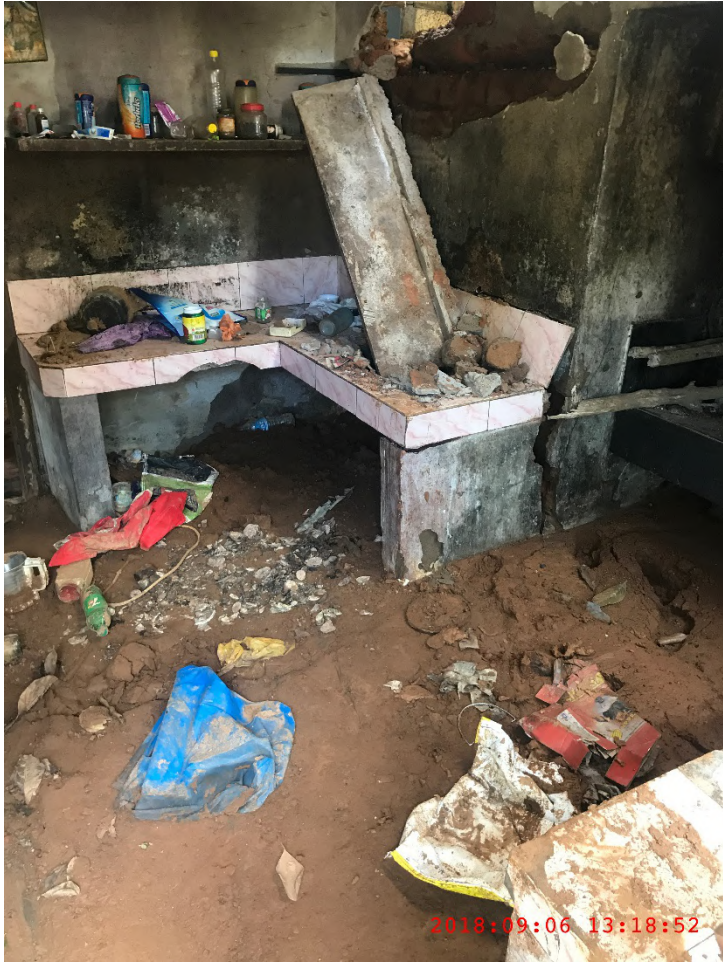
*Figure A-7: Interior of a house destroyed in landslide and debris flow @ 9.7966953° N 77.0678775° E*

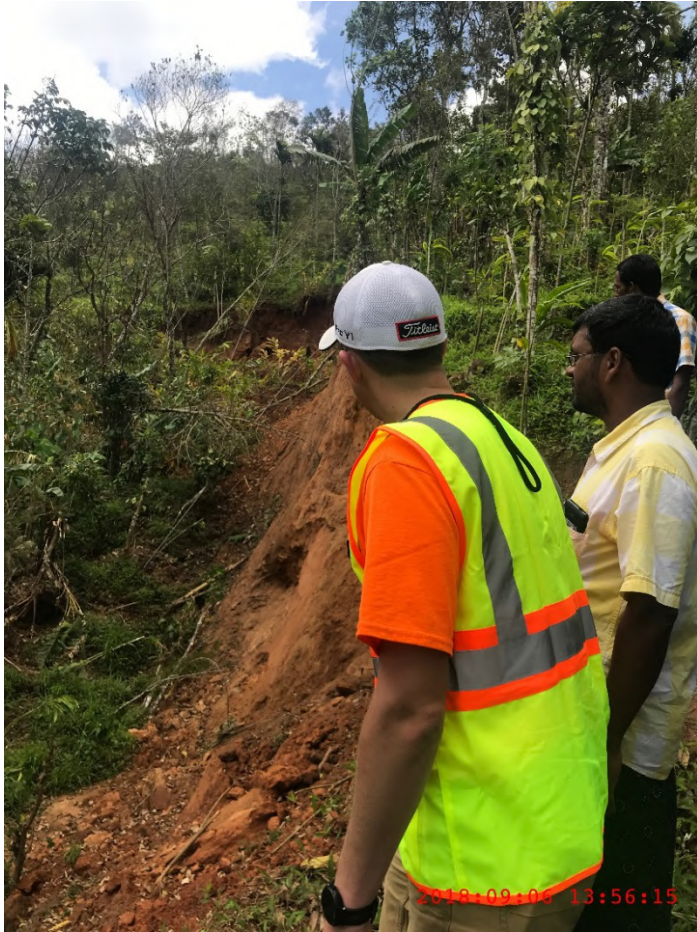
Figure A-9: Landslide scarp @  $9.7966110^{\circ}$  N  $77.0685257^{\circ}$  E

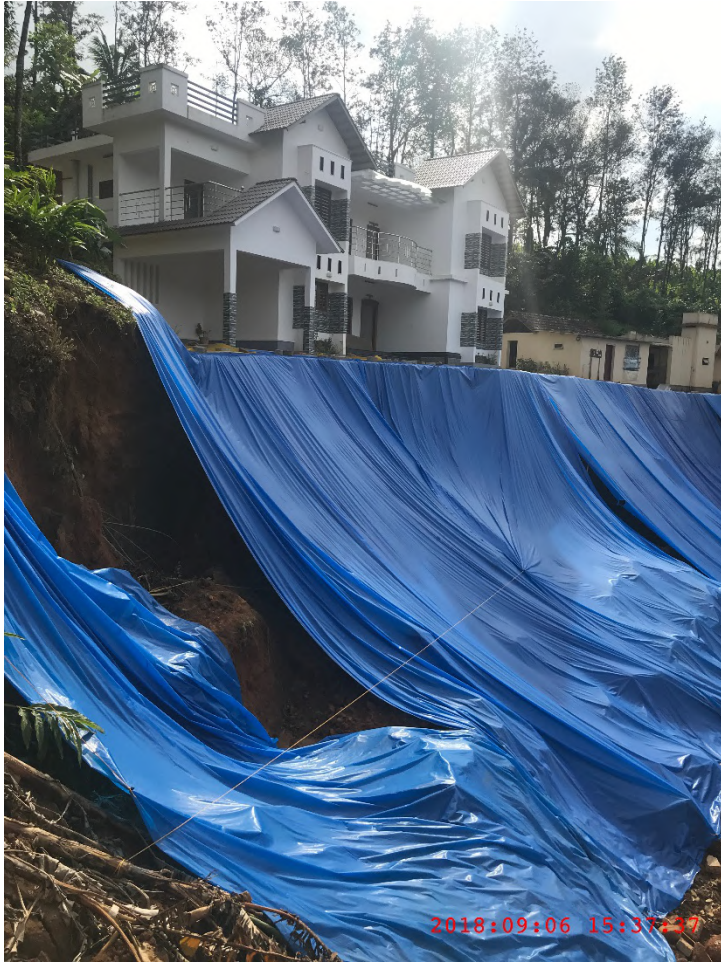
*Figure A-11: Large landslide in front of the newly built house @ 9.7925061° N 77.0680952° E*
