# GEOTECHNICAL IMPACTS OF AUGUST 2018 FLOODS OF KERALA, INDIA

Event: August 2018

**Geotechnical Extreme Events Reconnaissance**  
*Turning Disaster into Knowledge*  
**Sponsored by the National Science Foundation**  
**GEER Association Report NO - 058**

**Date: 10-17-2018**

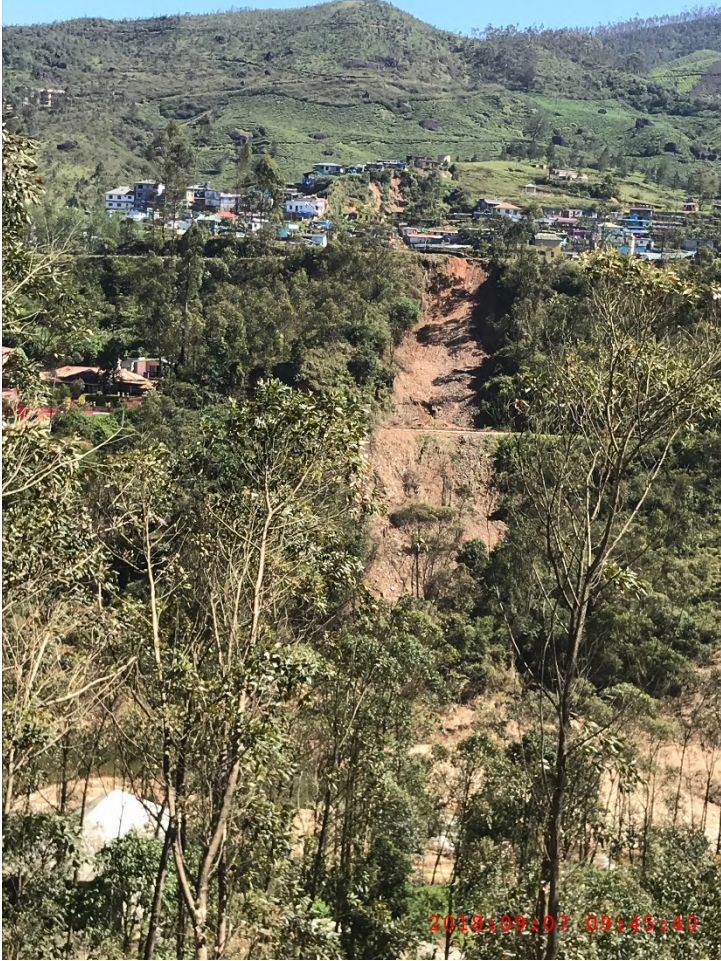
*Figure A-15: Debris flow failure @ 10.0830840° N 77.0711627° E*

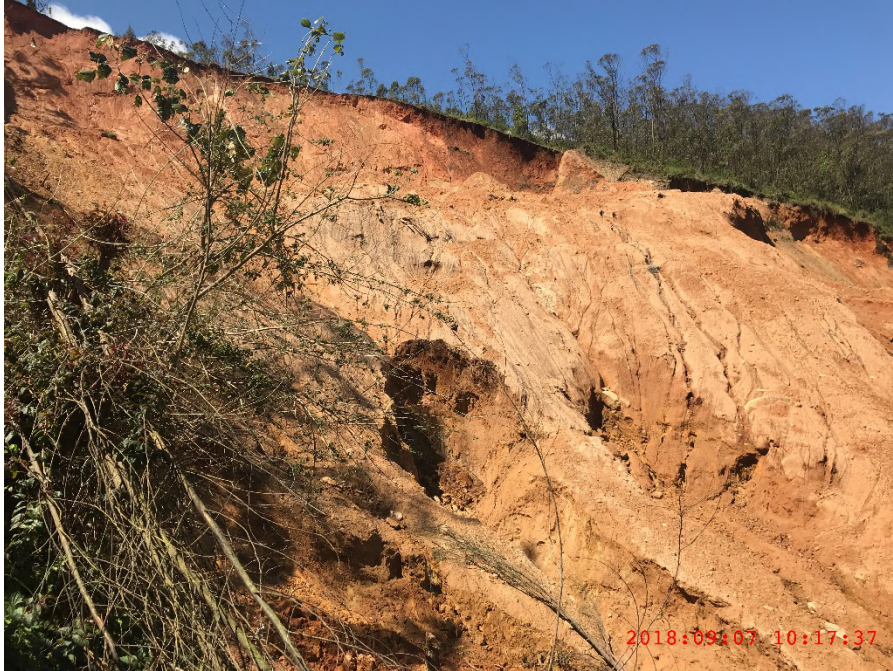
*Figure A-16: Munnar college landslide showing piping channels @ 10.0822483° N 77.0734512° E*

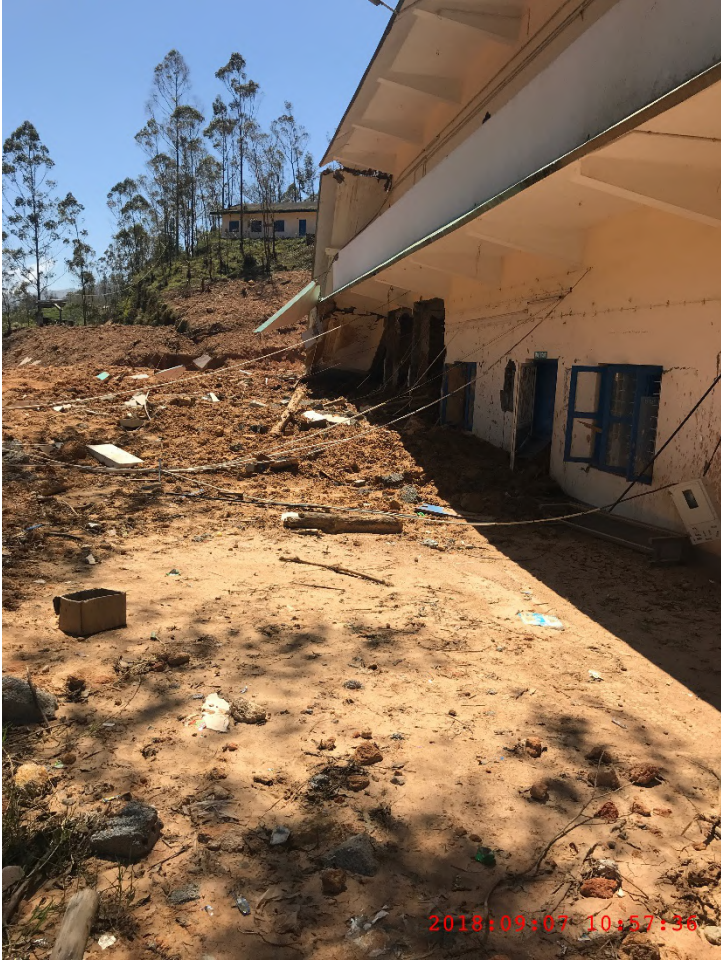
*Figure A-18: Destroyed Munnar College building @ 10.0826962° N 77.0726538° E*

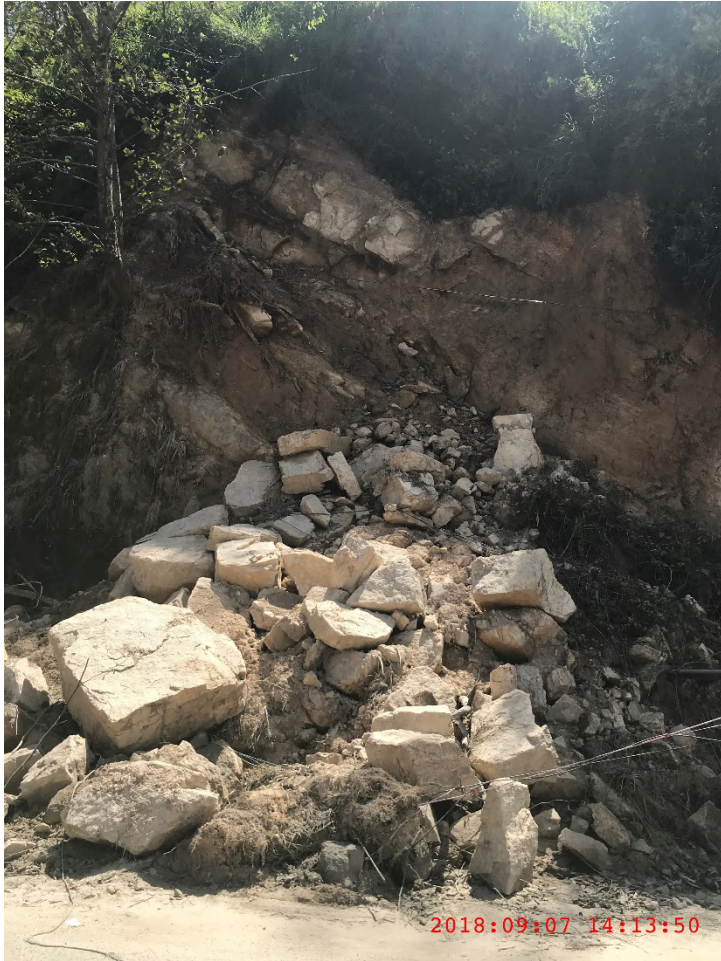
*Figure A-19: Rock fall @ 10.0835676° N 77.0615970° E*

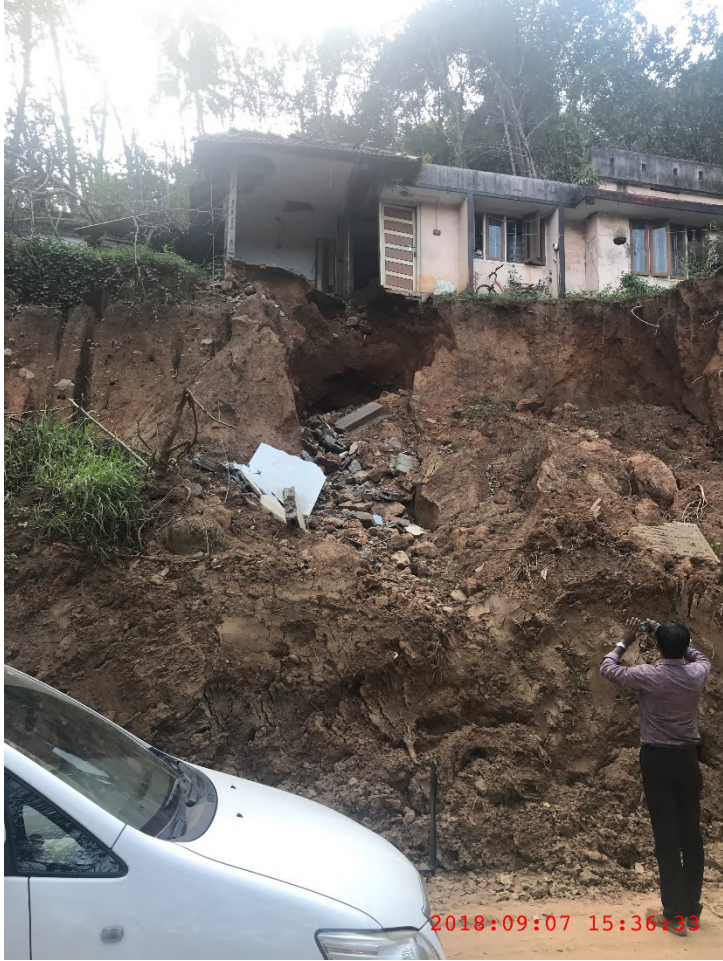
*Figure A-24: Another view of the pipping channel @  $9.9756741^{\circ}$  N  $77.0216901^{\circ}$  E*

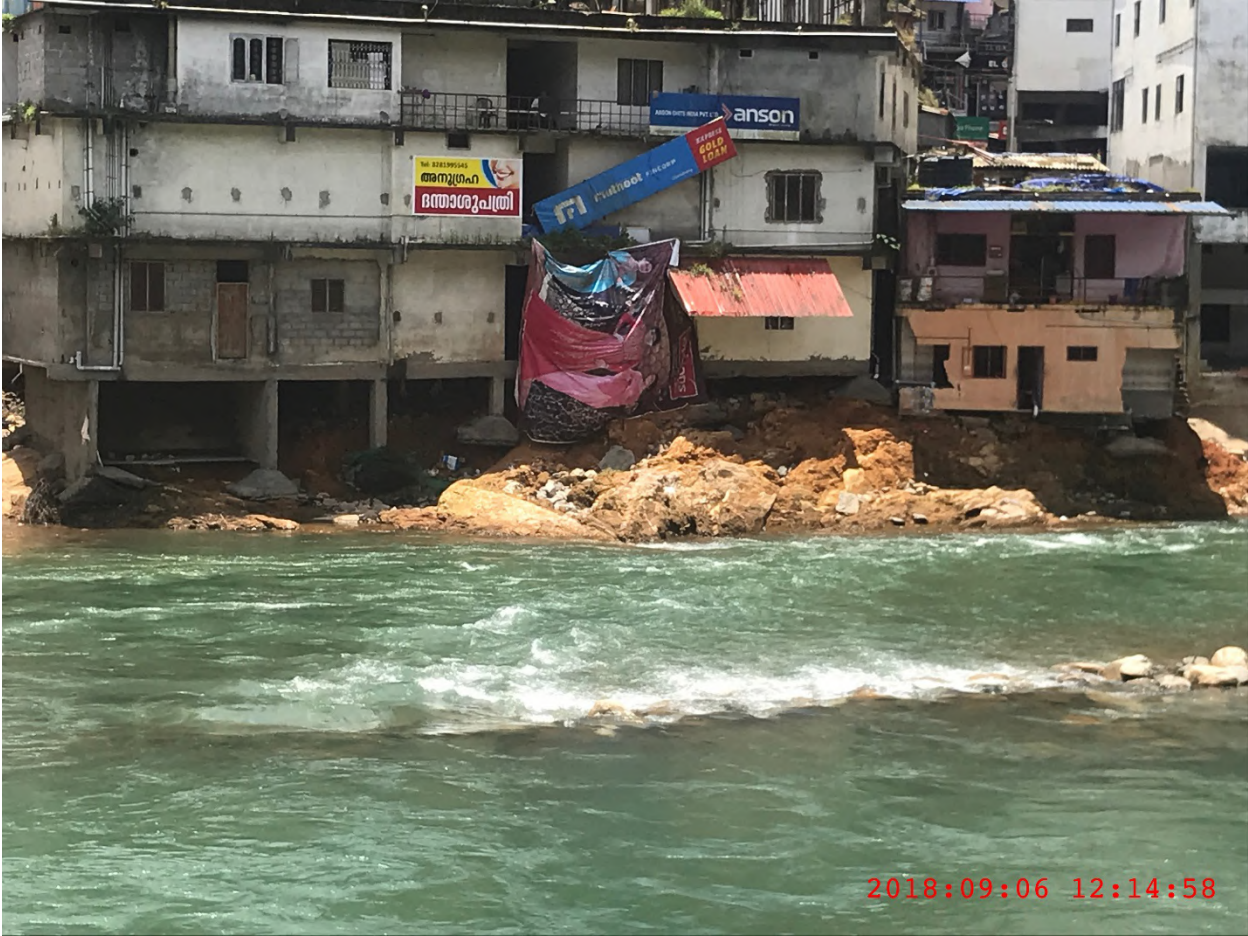
Figure B-1: River erosion @ 9.8575718° N 76.9636035° E

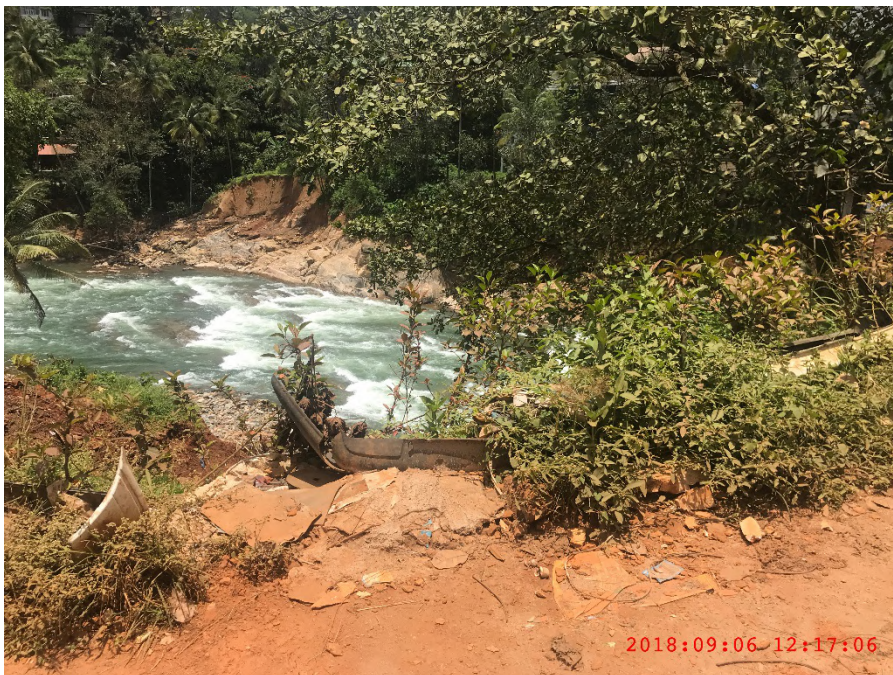
Figure B-3: River erosion @  $9.8585518^{\circ}$  N  $76.9639427^{\circ}$  E

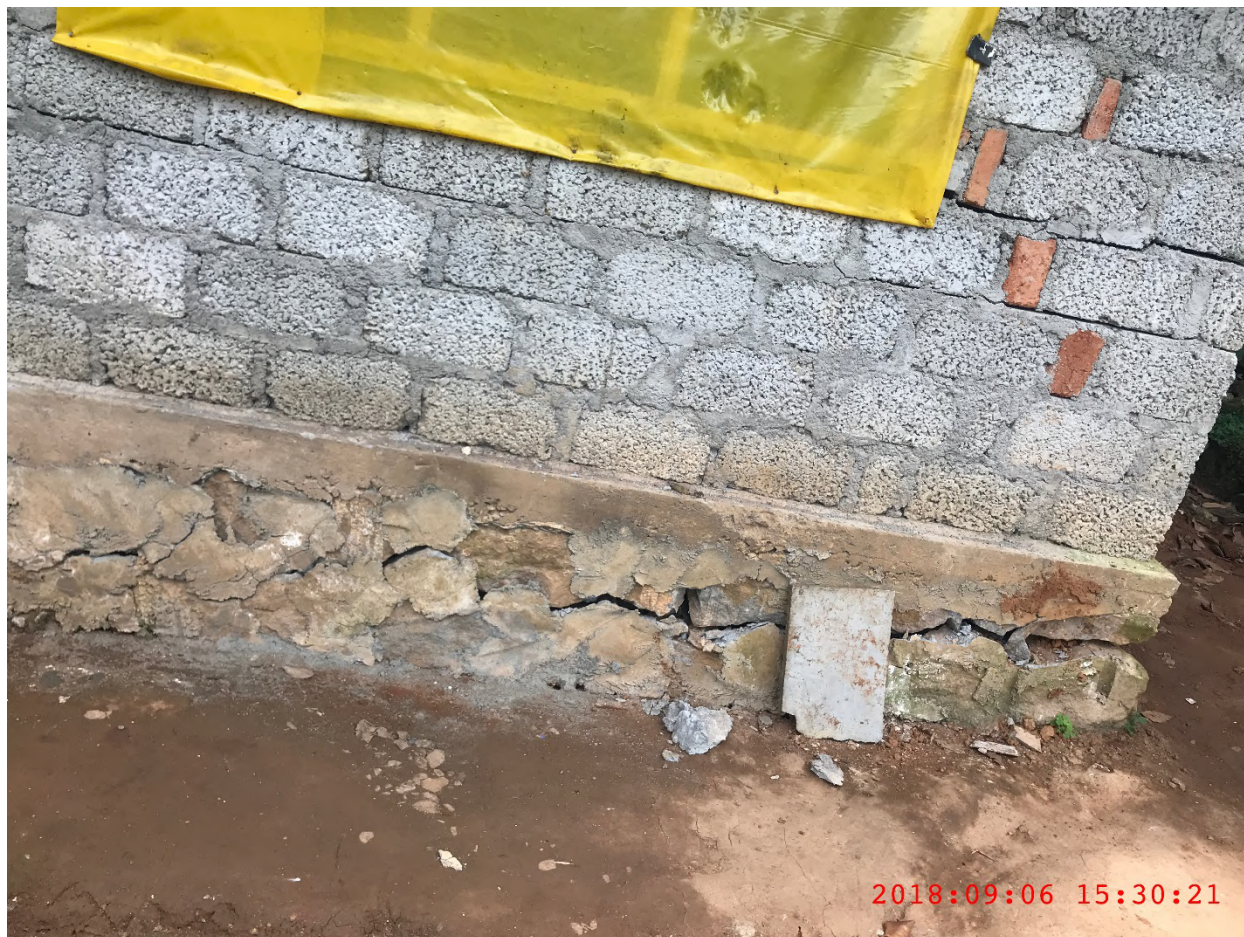
*Figure C-1: Foundation of the house cracked due to ground displacement @ 9.7918757° N 77.0687403° E*

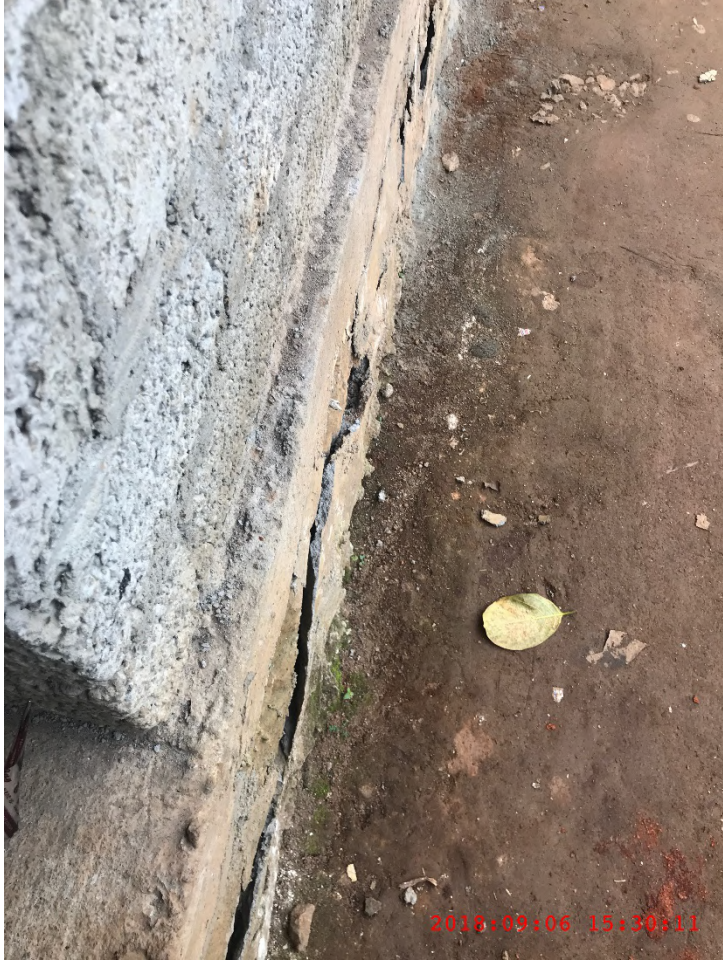
*Figure C-2: Another view of the foundation crack @ 9.7918656° N 77.0687362° E*

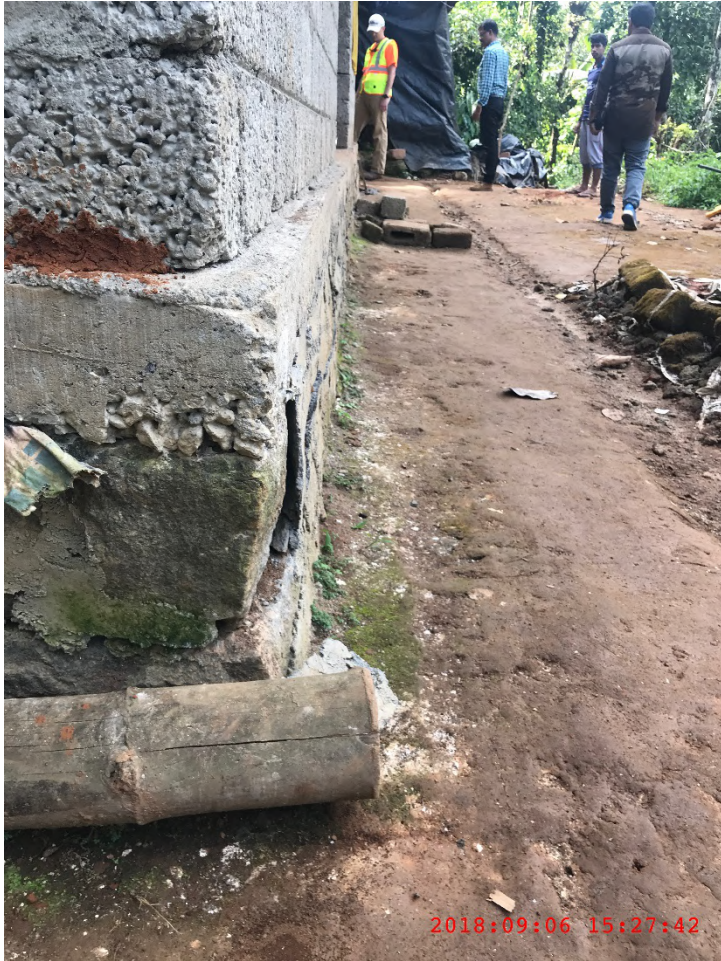
*Figure C-3: Another view of the foundation crack @  $9.7918219^{\circ}$  N  $77.0688023^{\circ}$  E*

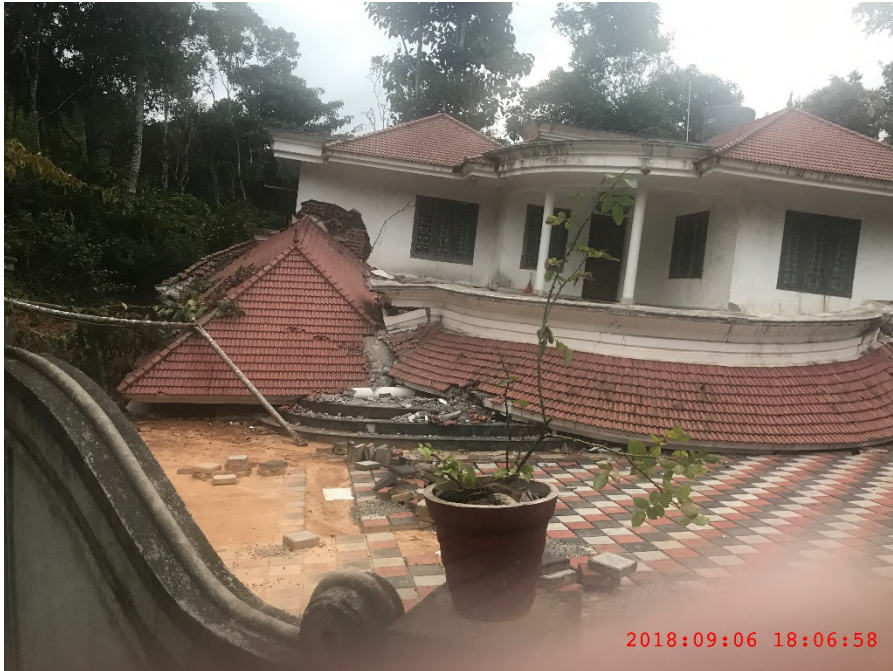
*Figure C-4: Building destroyed due to ground movement. An entire floor has been subsided @ 9.8746102° N 77.1193815° E*
