A FIELD INVESTIGATION REPORT ON THE WELL COLLAPSES IN KOTTAYAM DISTRICT IN KERALA

Investigated by: Dr. Vijith H, Sr. GIS Specialist (Scientific Officer)

Hazard, Vulnerability and Risk Assessment (HVRA) Cell
Department of Revenue and Disaster Management, Govt. of Kerala
2nd Floor, Institute of Land and Disaster Management
PTP Nagar, Thiruvananthapuram 695038
Tel/Fax: 0471-2364424. Email: hvrcell.gok@gmail.com

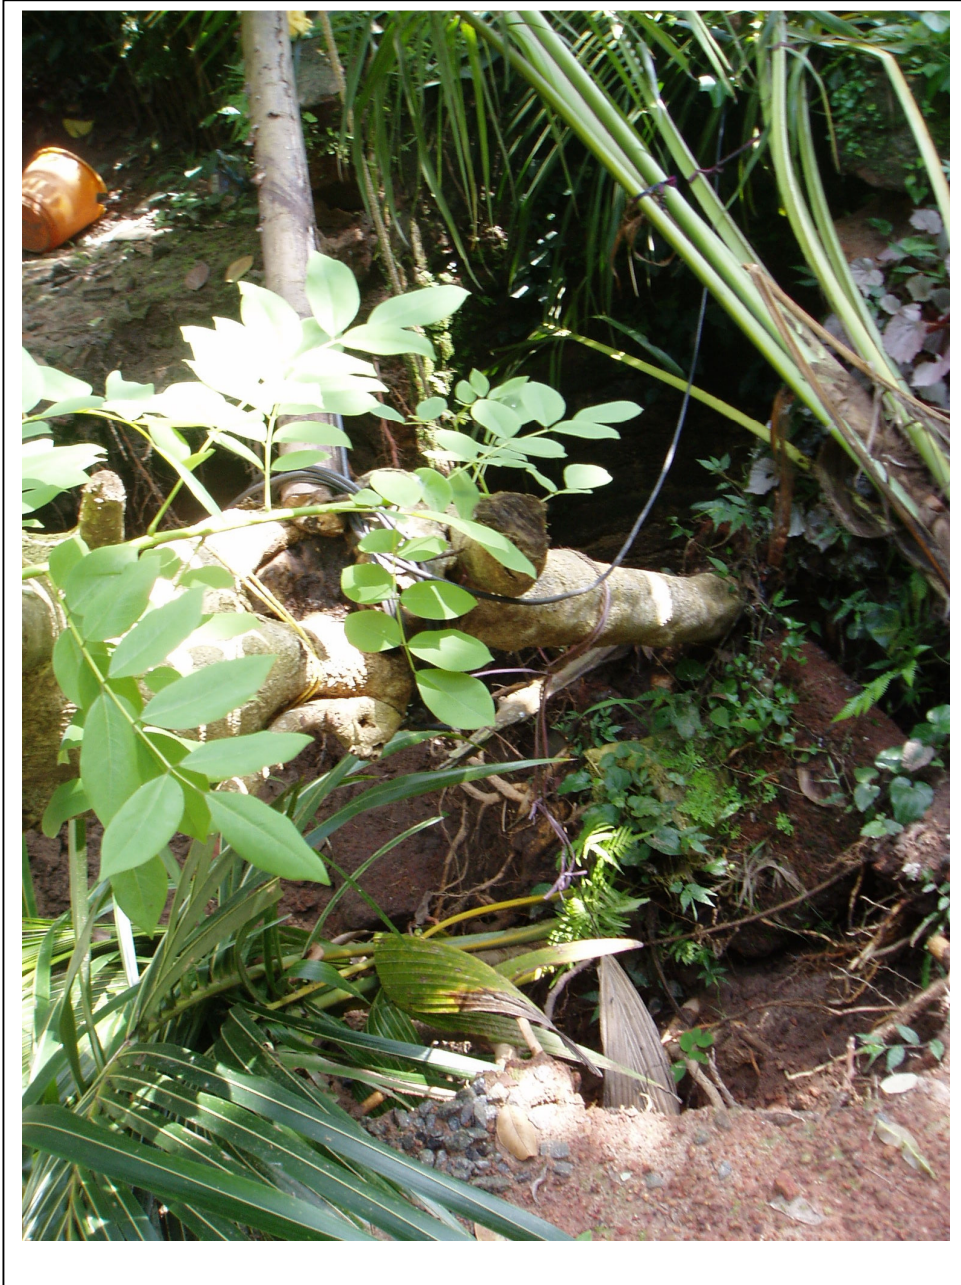
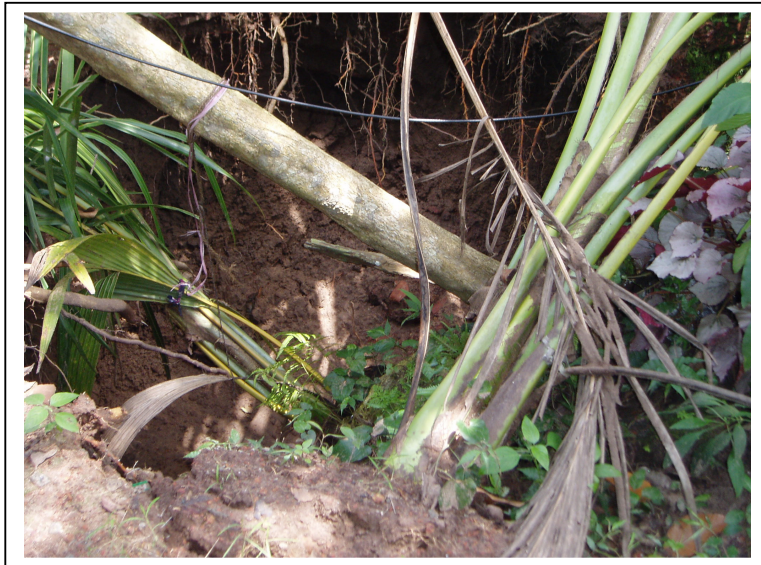
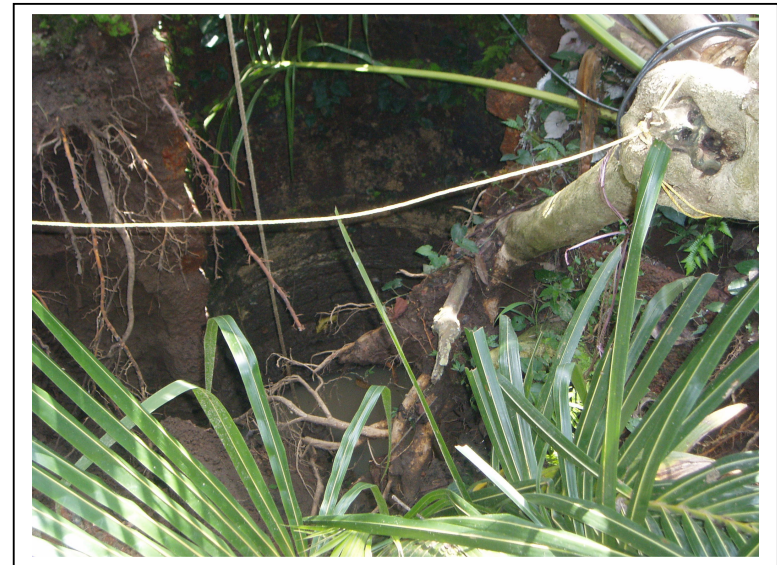
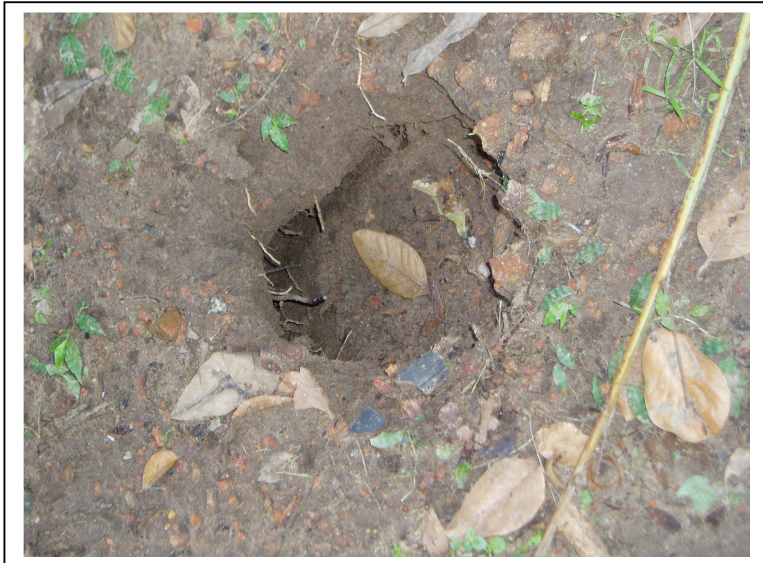
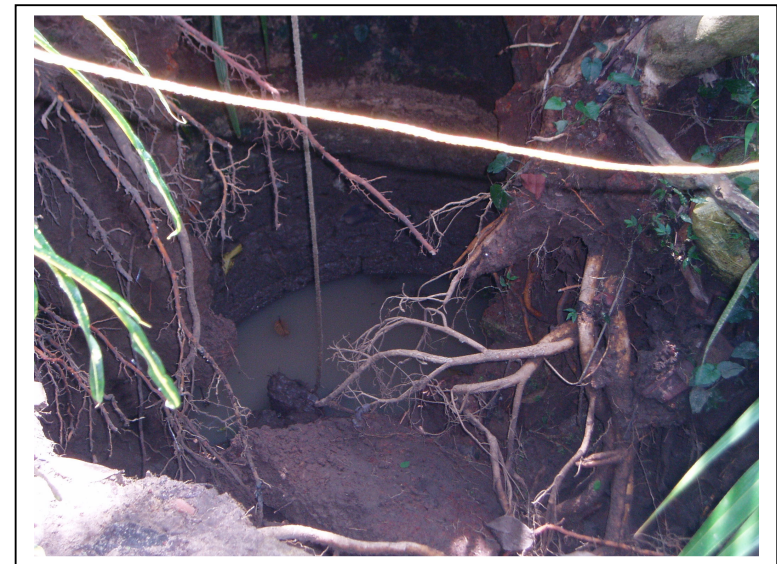
LOCATION 1

The first well was (N 9^o 26' 11. 4" and E 76^o 32' 30.2"; 34 m above MSL) in the plot of Mr. Kunjukunju K. Maruvathu, Kuthukallunkal, Panachikavu P.O., Perunna (Chenganacherry municipality, Chenganacherry village, Chenganacherry taluk, Kottayam District). The plot was slightly elevated from the road. The area comes in Upper Kuttanad and geologically is sedimentary in nature. The collapsed well has a diameter of ~1.2 m, with a depth of 50 feet. The well was dug 100 years ago, had laterite lining and was perennial even during extreme drought conditions. About one month before the event

happened, the water in the well started showing an orange colour with effervescence effect and a bad odour (rotten egg's). During the period small changes in water level was also observed.

On 15th August, around 08.00 am, a small sound similar to boiling water was heard from the well and change of colour, effervescence and slight crystallisation on the top of water were observed. On the same day around 10.00 am, water in the well up-welled with effervescence, following which with a big sound, one side wall of the well collapsed. At the same time a new hole with same depth of the collapsed well developed adjacent to the well and the walls of this sink hole collapsed within a few minutes. The colour of the water turned starch like and had the water felt thick; white suspended sediments were also found in the water.

The basement of a 200 years old house inclined towards the western side (opposite to the direction of the well) and a new crack developed near to the kitchen area.

In order to make a general assumption about the process, information regarding the wells in the neighbouring houses were also collected. None of the wells in the neighbouring houses reported any unusual phenomena. But neighbours heard a large sound like something falling from the top. The detailed investigation and field observation carried out in the plot indicate that, more number of small hollows present in the land. This phenomenon was come to notice, while the owner was taken a small pit for growing the vegetables. The pit he has taken was gone down without showing the bottom of the same. These kinds of more number of small holes were noticed around the collapsed well. From the field observation and feedback data collection, it was assumed that the well collapse and associated hole development was due to the activity of soil piping and the was accelerated by the ground shaking contributed by the earthquake on 22nd July, 2012.

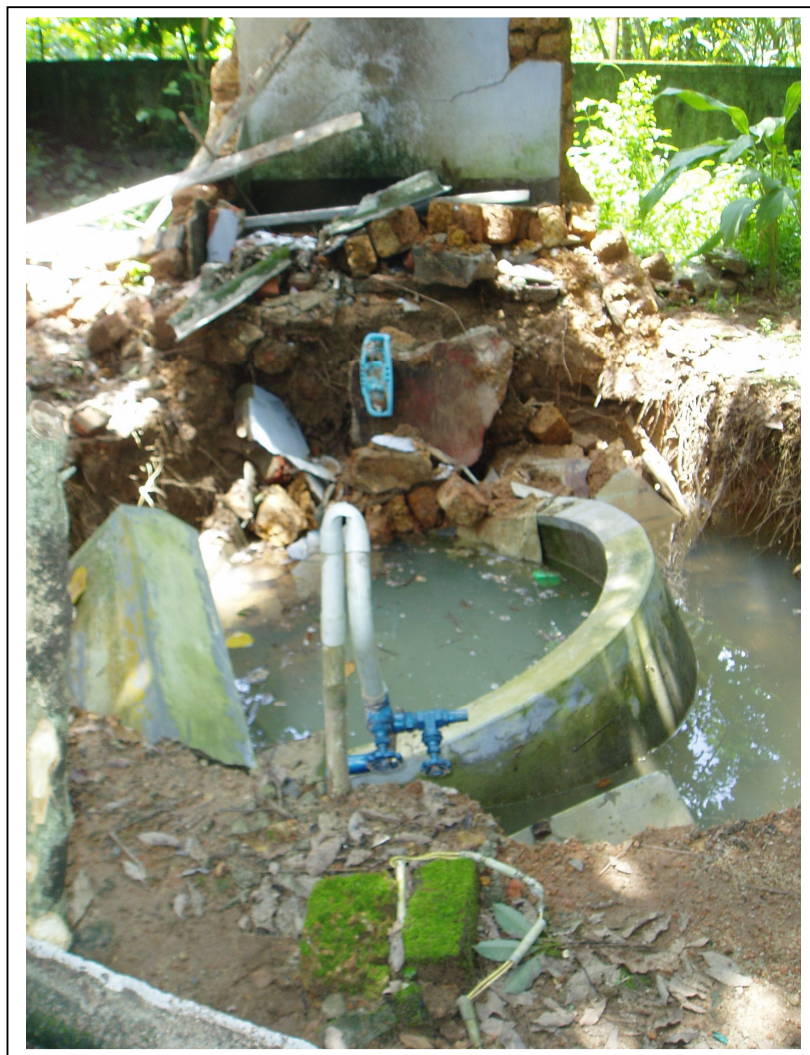
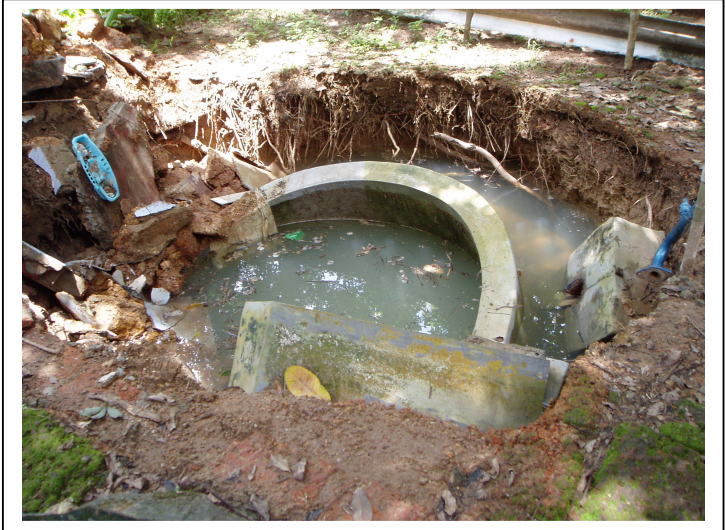
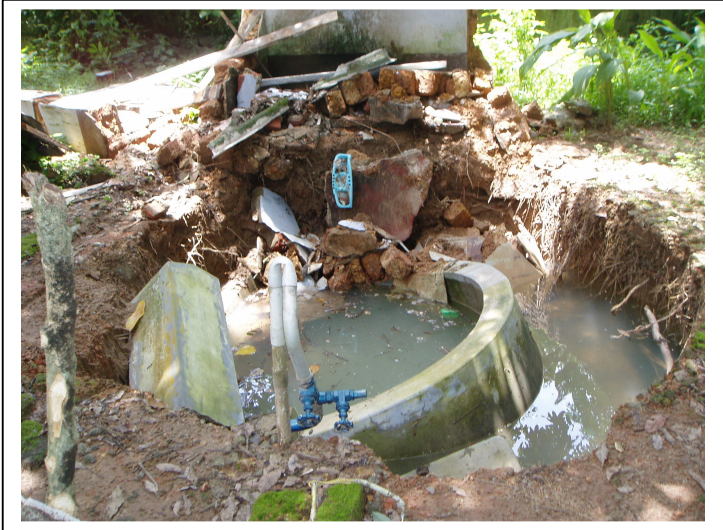
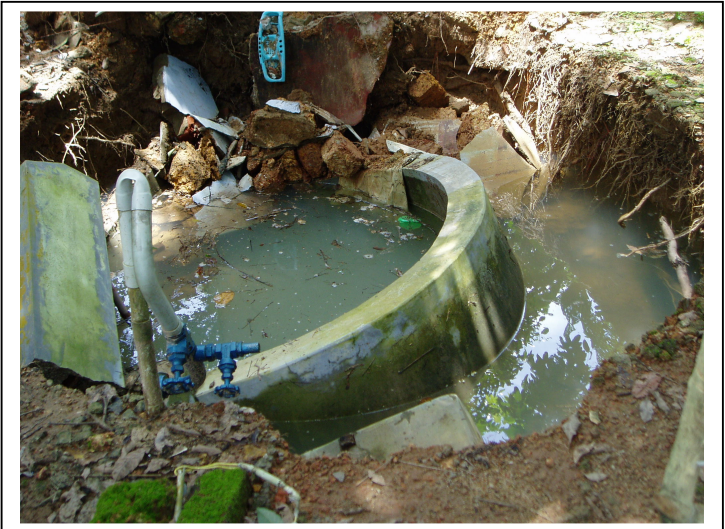
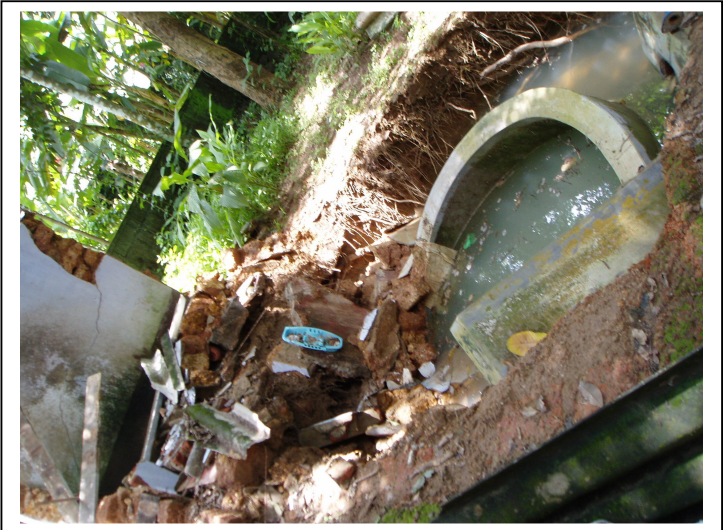
LOCATION 2

The second well was located in the northern side of Kottayam district, (N 90° 40' 33.8" and E 76° 30' 36.4" with an elevation of 24 m above MSL) in the plot of Mr. E.G. Gopakumar, Gokulam, Neendoor (Neendoor Panchayath, Onamthuruthu village, Kottayam taluk, Kottayam District). The house is located on the flank of small mound, with paddy field on other side. The collapsed well was of a diameter of 2 m with a depth of 25feets. The well was constructed on 30 years back and lined with Laterite bricks.

15th August, 2010, morning 08.30 am, slight inclination was observed in both pillars of the well, following the upliftment of side floors. At the same time, one wall of the bathroom adjacent to the well also detached from the main basement and other wall. Suddenly with a big sound, the detached portion of bathroom, pillars and rings of the well went down to the watered portion of the well. At the same moment, the surrounding land portion also collapsed into the well. An inventory of wells in the neighbouring houses were also carried out for enquire about the changes of water level and other related issues in the wells and no such incidents were reported from any where.

To understand the force and factor behind the well collapse, history of the well and construction procedures were also enquired during the

investigation. The well was constructed in the flood plain area, in which the bottom rest on sandy clay layer. The lining of the well was done with locally available laterite brick and two pillars were also constructed in the top. Few years back, some of the laterite bricks, which are used for the lining, were fallen down and no maintenance were done for the same. This has enhanced the movement of side filling material into the well bottom, which become made a huge void in the well wall. Due to heavy rain and associated infiltration of rainwater, this void acted as a conduit for easy down movement of the materials. This caused the loss of support and cohesion of the side wall material, which lead to the collapse of the well. This finding was supported by the field photographs, which shows the direct central down movement of the overburden, which contains the remaining lining material and pillars of the well.
