Report on 9 year continuous Lightning strike damage in the house of Sri. Shivadasan Nair,
Aneesh Bhavan, Near Kaithakootu Reethu Palli, Puthoor, Kollam District

Ref: Government Ltr. No. 153/K2/2017/DMD dated 17-01-2018

Investigation Series 2018
23-03-2018

Anupama N
Hazard Analyst

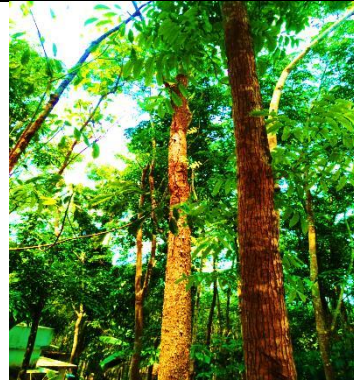
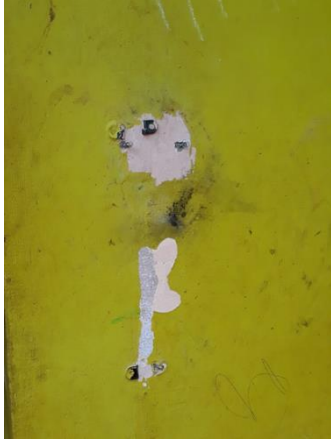
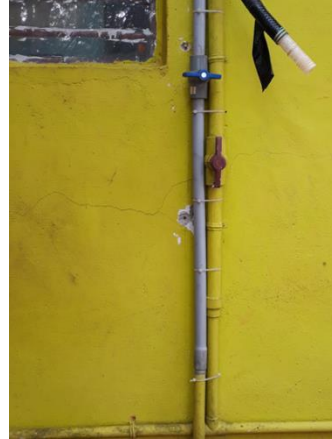
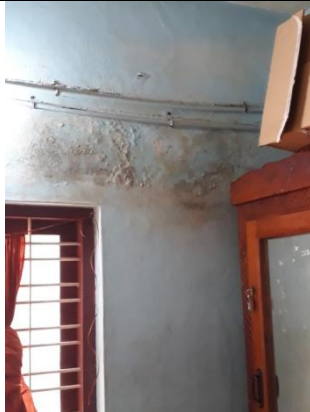
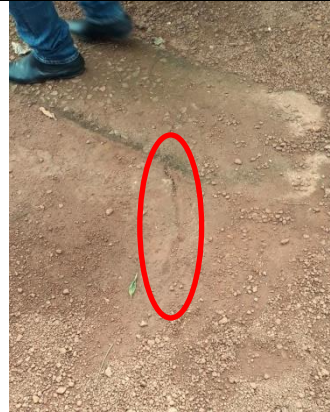
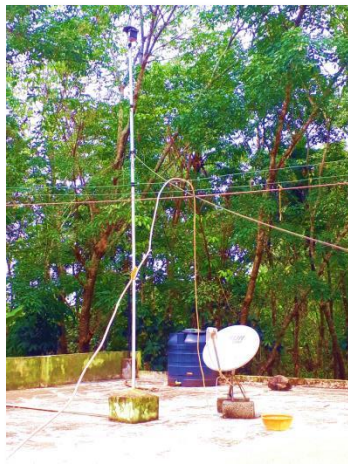
Various marks of damage due to lightning strikes

- The proximity of the house to the large number of tall trees (Rubber trees and other tall trees seen around the house) is an important reason for the lightning strikes. From the field evidences, it is suspected that lightning conducted through the tree, travelled through the ground and propagated into the electrical circuit of the house.

- Evidences also lead to believe that side-flashing events may be a cause of these continuous damages, specifically affecting the house.
- Proximity to electric posts and the undulating topography of the house may also be contributing to the exposure of the house to frequent lightning.

- The house has to establish a comprehensive structural earthing
- In order to avoid the flash current from reaching the house through ground, a ring conductor needs to be established
- Lightning grade surge protectors shall be installed to prevent damage to electrical and electronic gadgets
