**Landslide Susceptibility Assessment and Preparedness Strategies,
Thiruvambaadi Grama Panchayath,
Kozhikode District, Kerala.
(DM/328/2016/SDMA dated 6-10-2016)**

**Submitted by
Dr. S Sreekumar
2019**

Associate professor (Retd.) and Principal Investigator
PG & Research Department of Geology and Environmental Science,
Christ college (Autonomous), Irinjalakuda, Calicut University

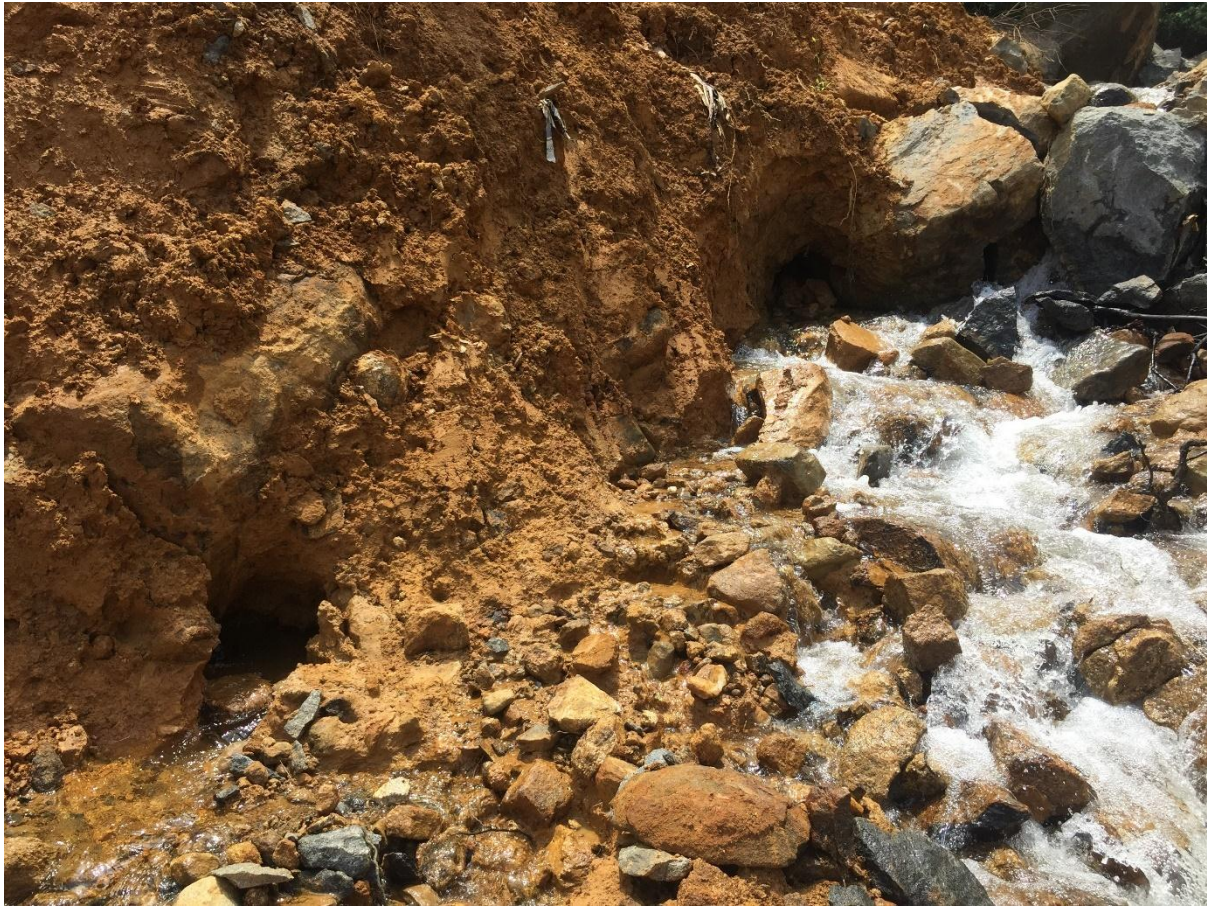
Debris slide is reported in Maripuzha is located at longitude and latitude N 11° 26'56.16" & E 076° 06' 4.2". The height of the scar is 10 m and width 52 m. The main type of vegetation is arecanut, pepper and coconut. The event occurred on 14th August 2018. The thickness of the overburden is 2- 3 m. The top red coloured and high clay content. It is initiated by continuous heavy rainfall. The Debrisflow which occurred in Vellarimala in the previous days have contributed to activate the debris slide at Maripuzha. The Vellarimala debris flow scar is situated on the SE side of the Maripuzha Debris slide. Both the failures are associated with perennial streams of first order. Evidences of sub surface tunnel erosion (Soil piping) could be observed at the scar face (Plate 1). Large amount of water was discharging through the two tunnels formed at the toe of the slip face. among these two tunnels at the bottom of the slip face have discharged large amount of water. The slide debris destroyed the road and Agricultural properties. Perched boulders can be seen on scar faces this can be a threat in future if prolonged rainfall exist. Charnockite is the main rock type of the area. Highly weathered Charnockite and laterites observed. General hill slope of the area is 25°.

Plate 1: Sub surface tunnel erosion (Soil piping)

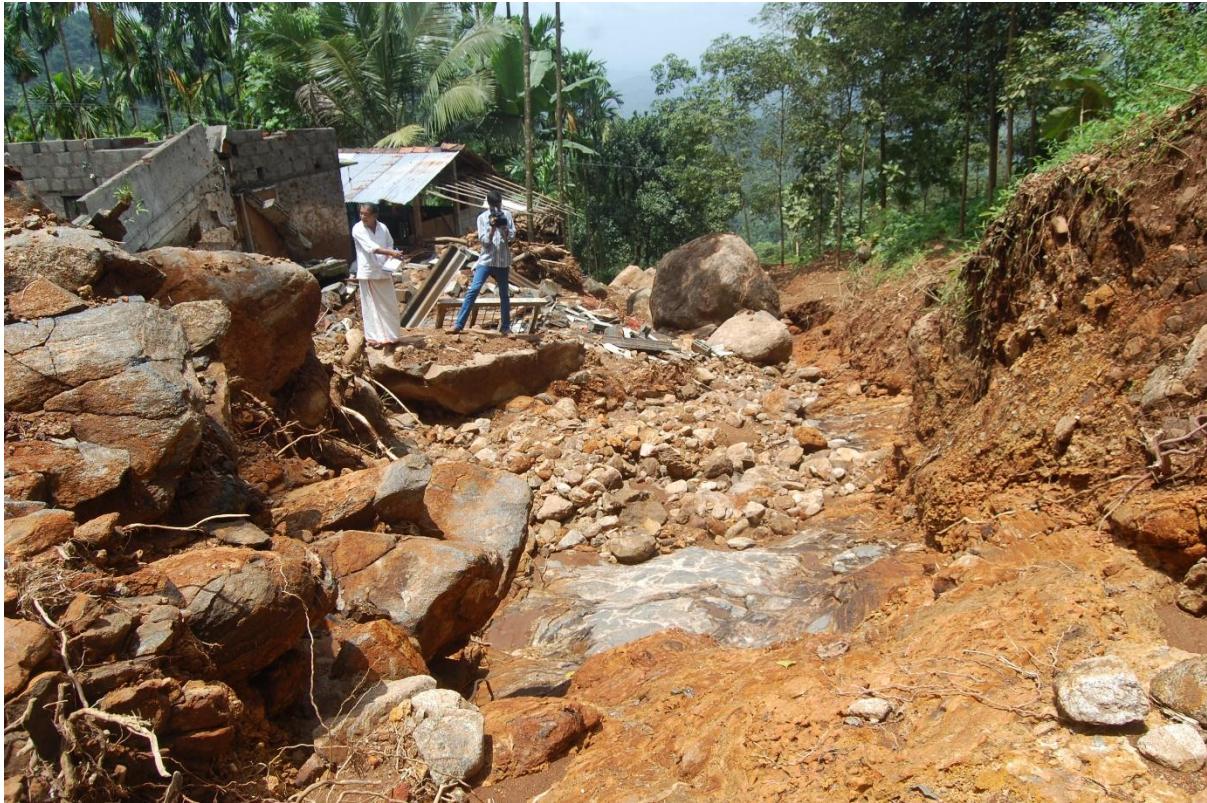
Tharippapoyil is situated in Thiruvambadi Grama Pachayath. Debris flow occurred in 7th August 2012 (Plate 5). Friction angle determined as 22⁰ with cohesion 3.5kN/m². Total silt clay percentage is 35.8. Non-plastic soil with liquid limit 39. General slope is 28° N 210. The prominent joints observed are 30° N 110, 35° N 270, 40° N 180, 44° N 160 and 10° N 20. The intersection of joint planes J2 and J4 fall with in the crescent shaped area, which is the potential slide surface. The chances of wedge failure are high in the locality (Fig. 5.1). Continuous rainfall for 2 or 3 days and it exceeds 120 mm chances of failure exist in the area. The factor of safety of the area can be lowered down by the infiltrating water and can cause further slope failures. Progressive failures may be initiated by water seeping into joints and cracks, raising pore water pressure and thus weakening joints (Bishop, 1967). Factor of safety less than in 1 in both dry and wet conditions.

Plate 5. Plate House collapsed due to the impact of debris flow at Tharippapoyil

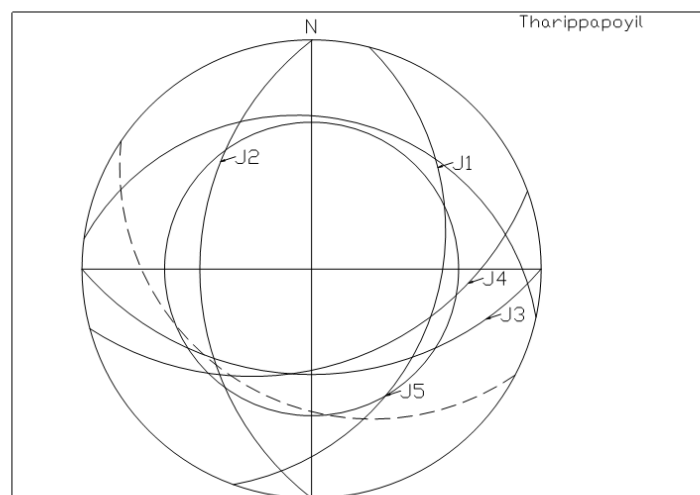
Fig. 5.1. β diagram of joint planes. Complete circle represents the friction angle. Dotted arc represents hill slope and continuous arc represents joint plane.

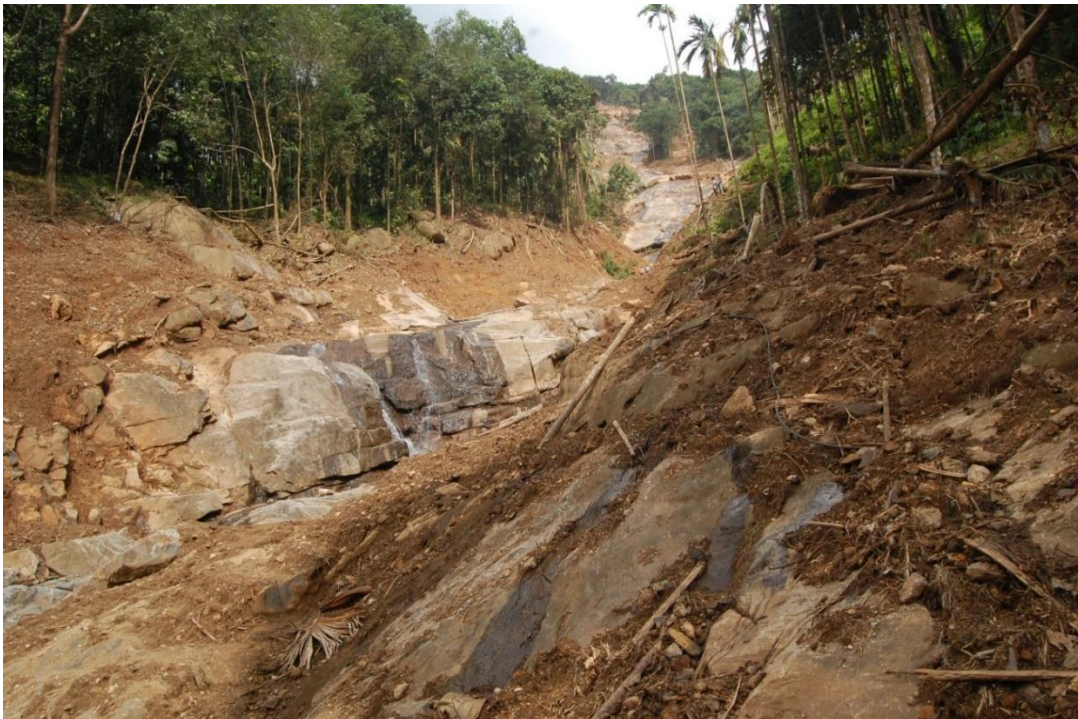
It falls within the Thiruvambadi Grama Panchayath. As a result of debris flow on 7th August 2012, settlements were collapsed, agricultural farm spread over one acre was devastated (Plate 6). The slope is characterized by rubber, arecanut and coconut. The length of the flow is 400 m and general slope is 21° N 180. The host rock is charnockite. The thickness of overburden 3 to 3.5 m. Weathering has produced thick layer of overburden. A thin Lateritic layer is encountered in the weathered zone. The thickness of the top soil from 1 to 2 m. Relative relief is very high. Forest vegetation occupy at the top portion of the scar. The detailed geological map is presented in Fig. 5.2. The total length of the scar was 1.2 km. on the top portion width was 150 m and middle 90m and bottom portion width reduced to 30 m. Total height of the scar is 240m. rocks are outcropping along the boundary of the scar. Arecanut and rubber plantations present both sides of the scar. Five houses were completely damaged. Large rock boulders are seen in scar face. The total volume of debris moved through the scar is estimated as 10540 m³. Geo technical an analysis shows that the friction angle determined as 21.04⁰ and cohesion 3.2kN/m². Total silt clay percentage is 28.10. Soil is non- plastic with liquid limit 39. Three joint planes are observed are 28° N 180, 32° N 185 and 60° N 175. The joint plane J2 parallel to the hill slope identified as potential surface for plane failure (Fig 5.3). Factor of safety less than 1 in both dry and wet conditions.

Plate 6. The debris flow controlled by joint planes

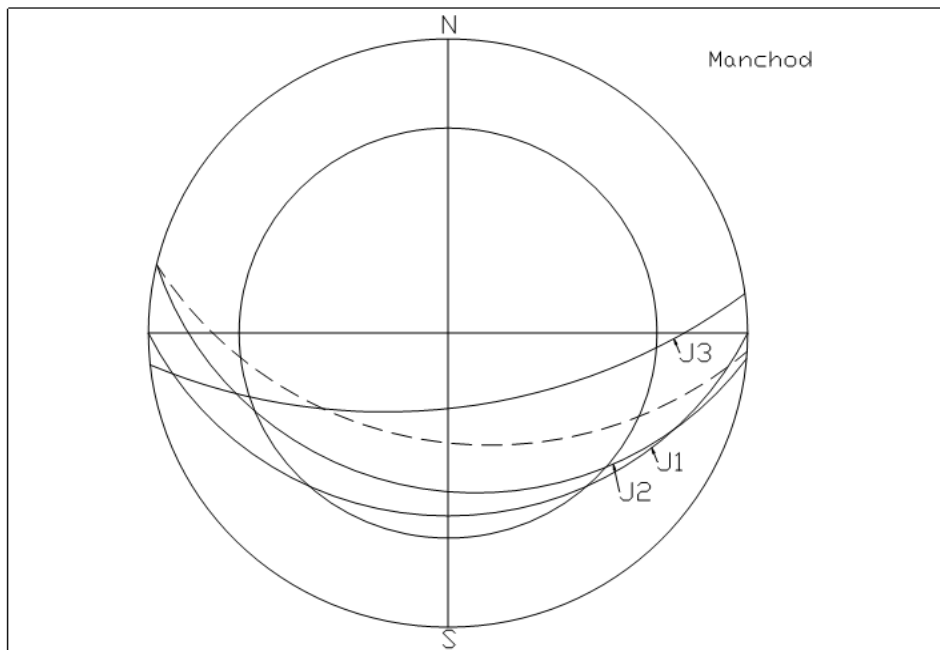
Fig.5.3. β diagram of joint planes. Complete circle represents the friction angle. Dotted arc represents hill slope and continuous arc represents joint plane.

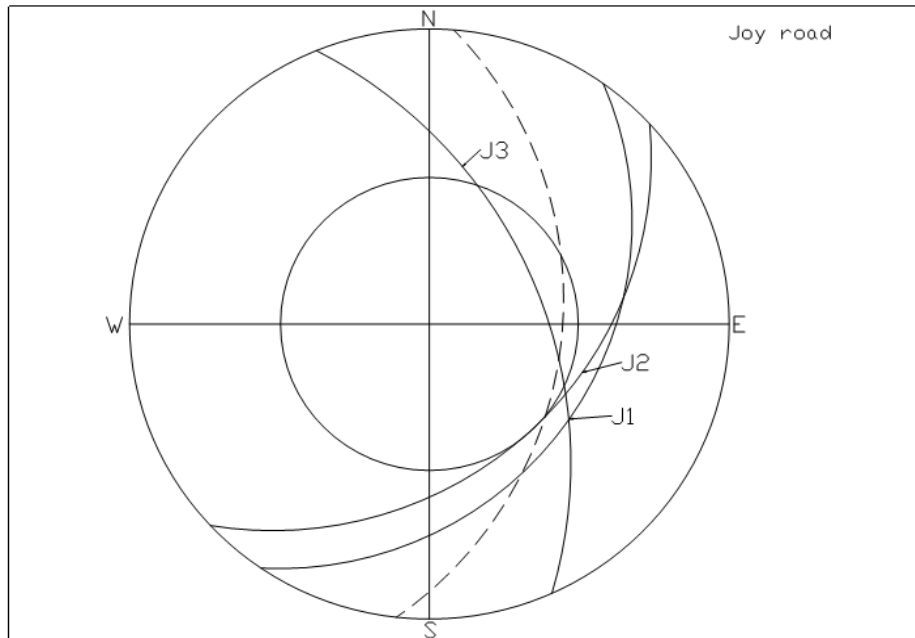
It is situated above the Manchuvad where the slide initiated. General slope is 40° N 95. The thickness of the overburden is 4.5 m. Debris flow is associated with a perennial stream. Natural factors like slope, overburden thickness are the chief causative factors for the debris flow. Flow of the natural drainage is controlled by joints of the rock and slope of the terrain. It is considered as a rainfall triggered landslide. Naturally it can be considered as a profile falling under Highly hazardous zone. Charnockite and hornblende gne5.6 iss are the major rock types. Relative relief is very high. Friction angle determined as 28^0 with cohesion 7 kN/m². Total silt clay percentage is 28. Soil is non plastic soil with liquid limit 36. Four joint planes are observed (35° N 120, 40° N 130, 50° N 70 and N 200). The joint plane J2 parallel to the hill slope is identified as surface for plane failure. The intersection of joint planes J2 and J4 falls just outside the crescent shaped area, which is the potential surface along which wedge failure can take place during wet condition (Fig 5.4). Factor of safety less

than in 1 in both dry and wet conditions. However, the slope is found safe in dry condition because of irregular nature of joints and presence of vegetation.

Fig.5.4. β diagram of joint planes. Complete circle represents the friction angle. Dotted arc represents hill slope and continuous arc represents joint plane.

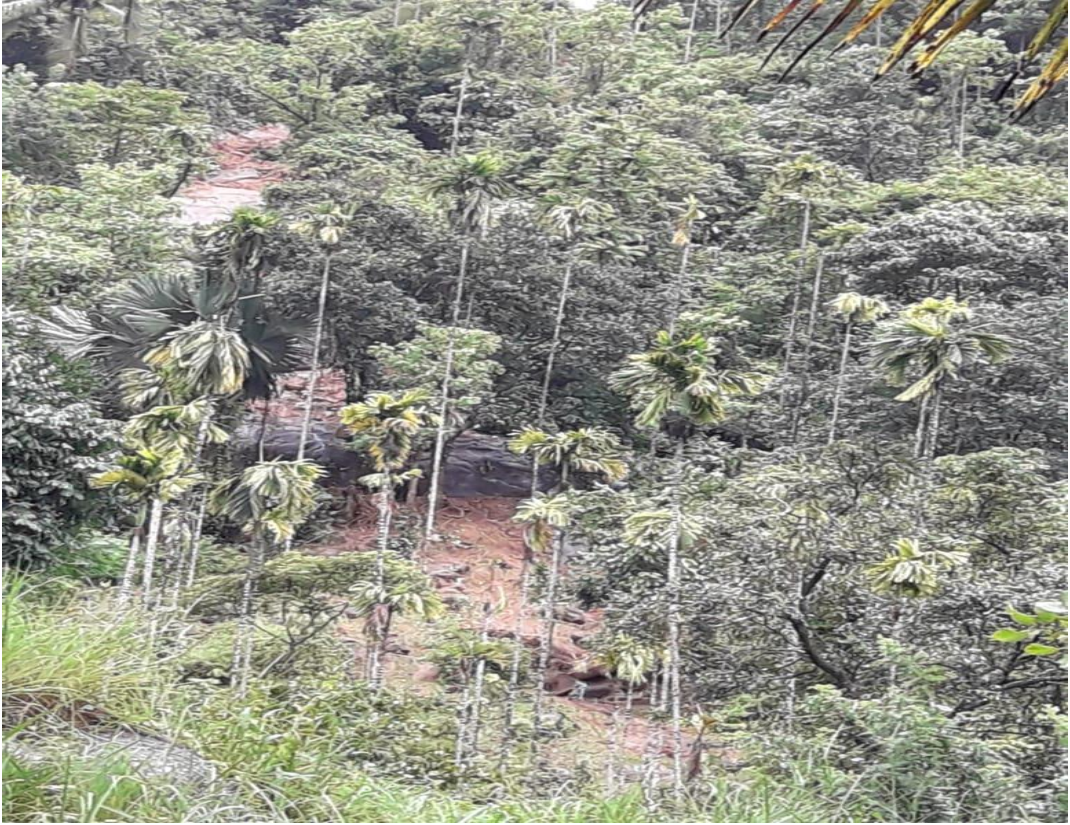
It is located on N 11° 25' 51.63" E 076° 05' 6.63". General hill slope of the area is 40. The debris flow occurred in private land which was cultivated by cocco, jathi and arecanut. The debris run off distance of debris is 500 meters (Plate 7). Loss of 300 arecanut trees were reported. the road was damaged due to the debris flow. The width of the scar varied, 5 m at the top, 18m at the middle part and toe portion 30 m. Isolated rock espousers are observed in scar face. The detailed geological map was prepared for the location (Fig. 5.5). Charnockite is the basic rock type of the area. Lateratisation at different degrees are observed. The soil is light brown with clay content slightly plastic when wet. Highly weathered charnockite was observed on scar face. Large rock boulders are also seen resting on the scar face. The total volume of debris flowed through the scar is calculated as 6340 m³.

Plate 7. Debrisflow at Karimb

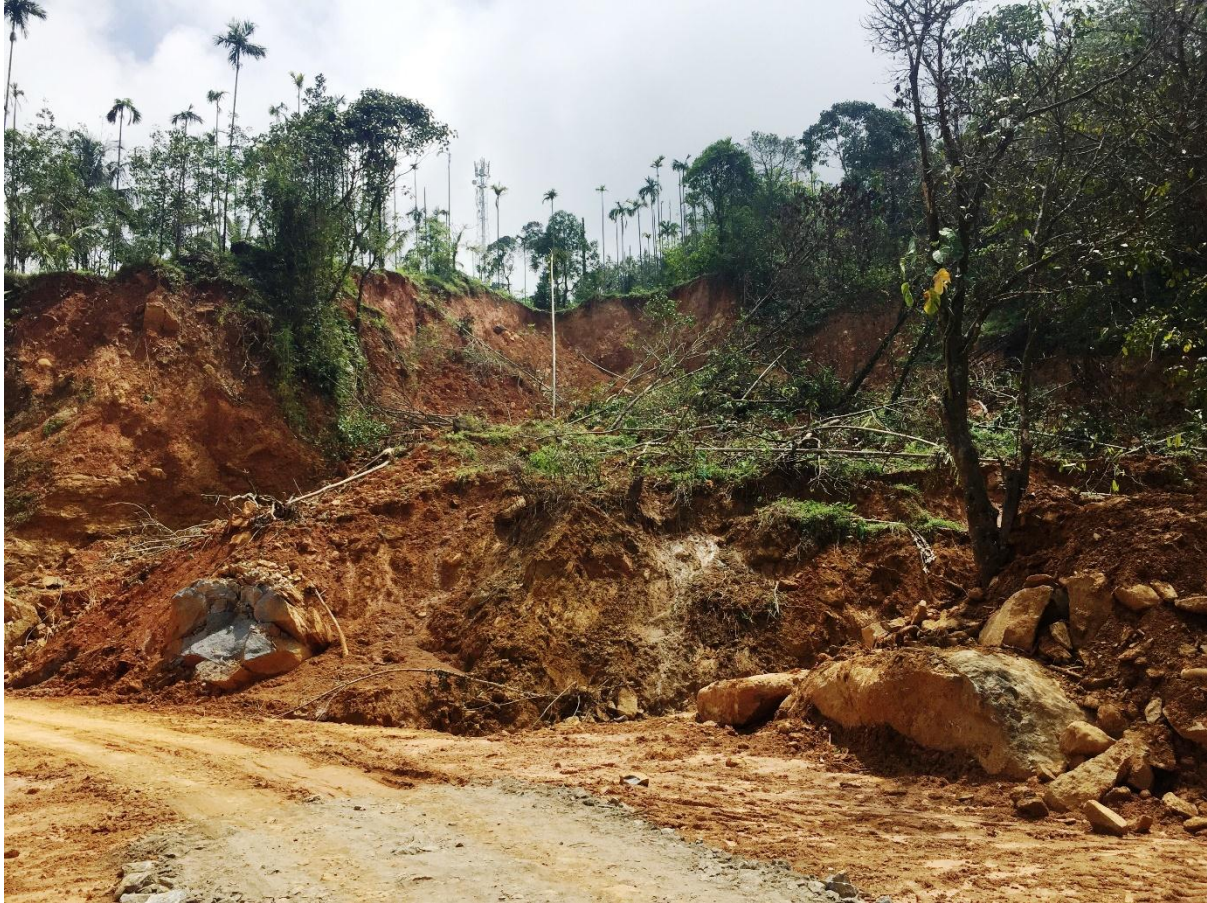
subsidence have occurred in Vellarimala and Maripuzha respectively (Plate 8). Several houses and buildings were damaged as a result of the slumping events. Loss of cultivated land including arecanut plantations was noted in Ward 2.

Plate 8. Debris slide at Maripuzha

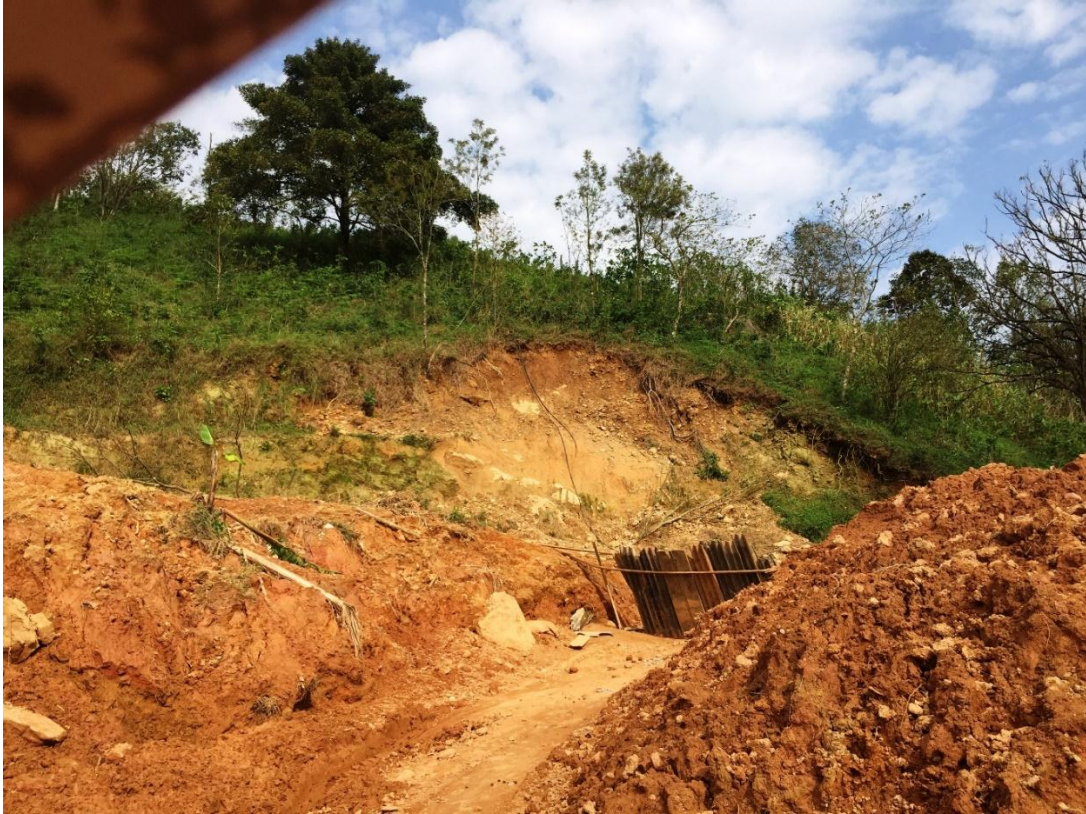
In 2018, multiple debris flows and slumps occurred in Koodaranji panchayath especially in Nayadampoyil (Plate 9), Valaamthod, Kurishumala, Kalpeeni and Mullampori areas. Some houses and farm lands were completely destroyed in Ward 4 & 1. A large crack had developed in Ward 4 and 10. In Koombara (Kurishumala) area 1 house was completely and another was partially destroyed (Plate 10). Many houses developed cracks and suffered structural damages in Ward 1, 4, 9 and 10. Soil pipping was observed in Ward 10 of this panchayath. In Kalpeeni area, the total death toll of human casualties amounts up to 2 and a total of 13 houses were destroyed. Excessive rainfall and land use changes to monocrop plantations could have acted as major factors inducing landslides.

Plate 9: Slump at Nayadampoyil

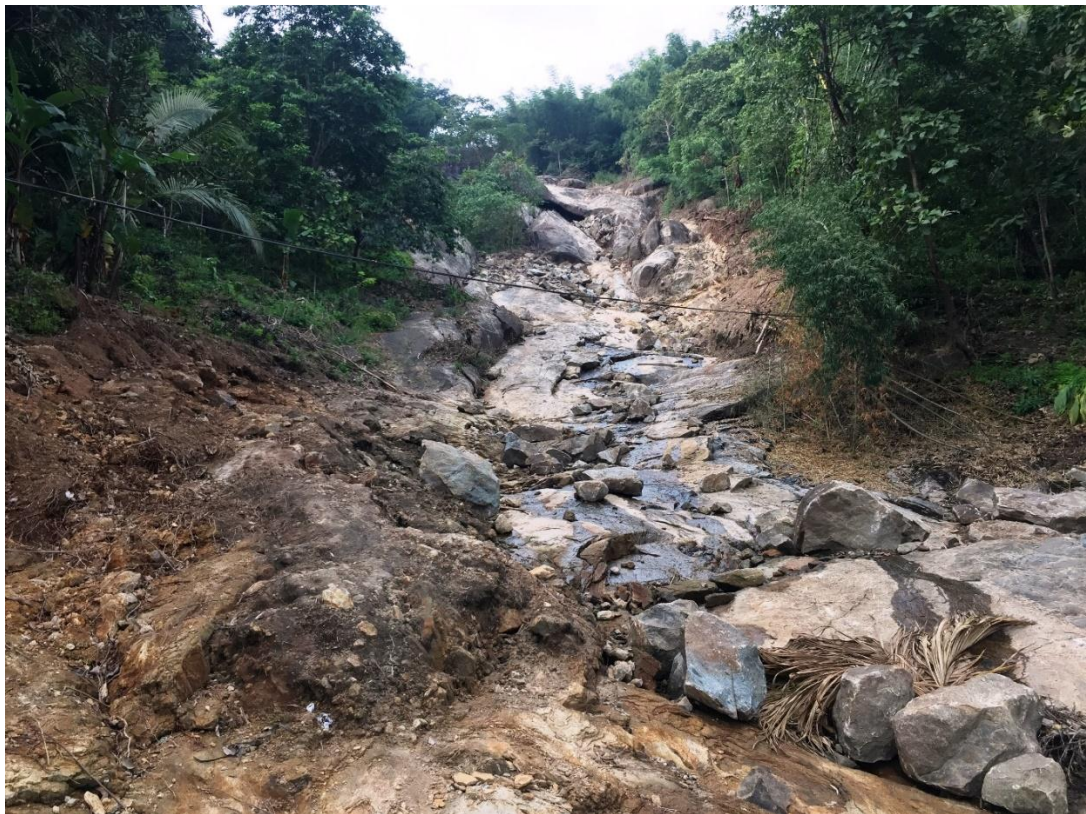
Plate 10: Debrisflow at Kurishumala

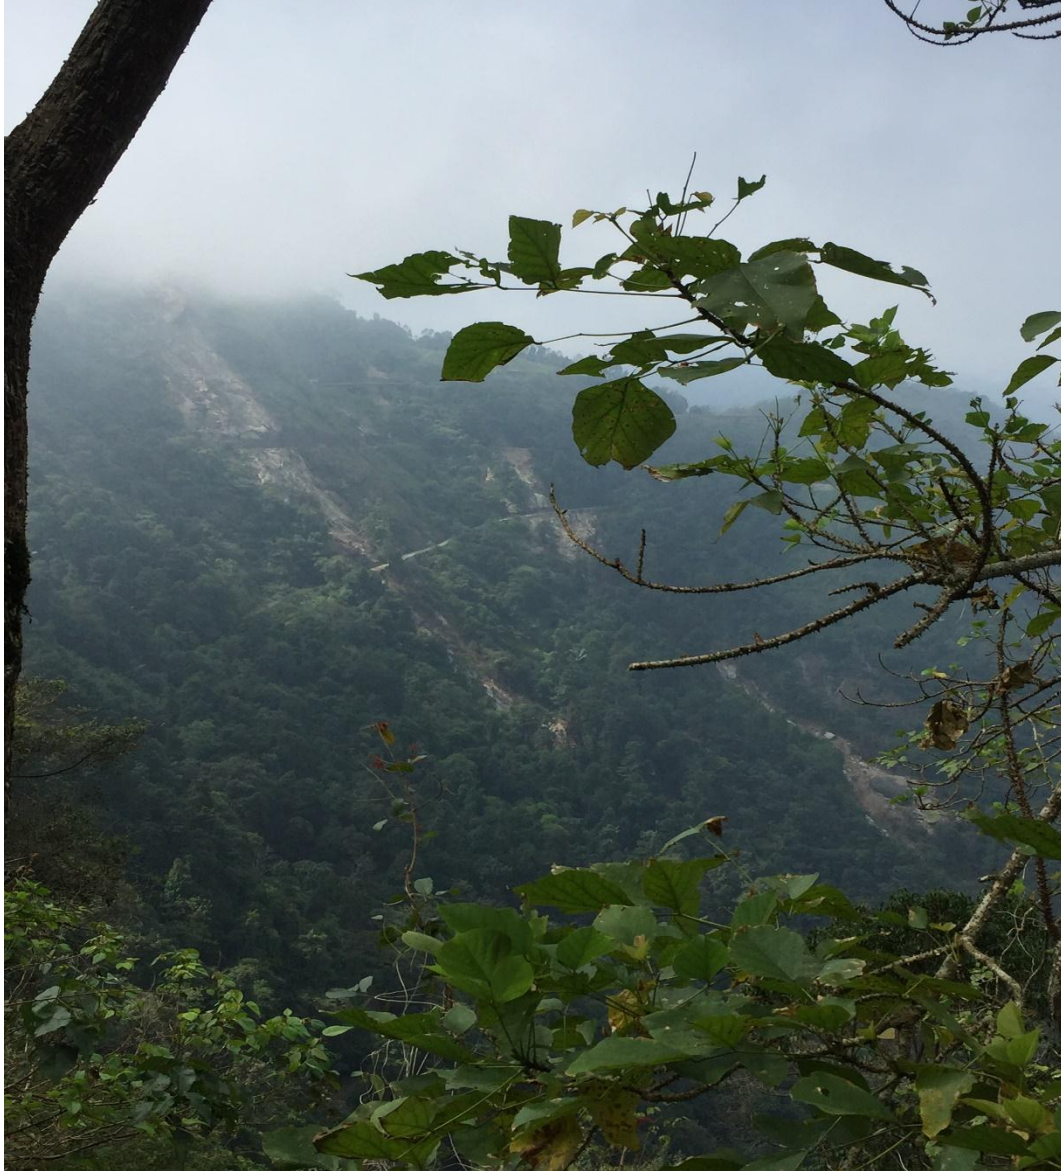
slump and debris flow and rockfall events occurred in different parts of Kurachundu panchayath. The worst effected areas are Kakkayam dam site, Ilpillayi mala and Kallanodu areas. Three houses were totally destroyed by landslide near Peruvennamuzhi reservoir and access roads to the dam site was completely destroyed as a result of the landslide (Plate 11).

Plate 11: A view of series of slope failures in near Kakkayam Dam site.

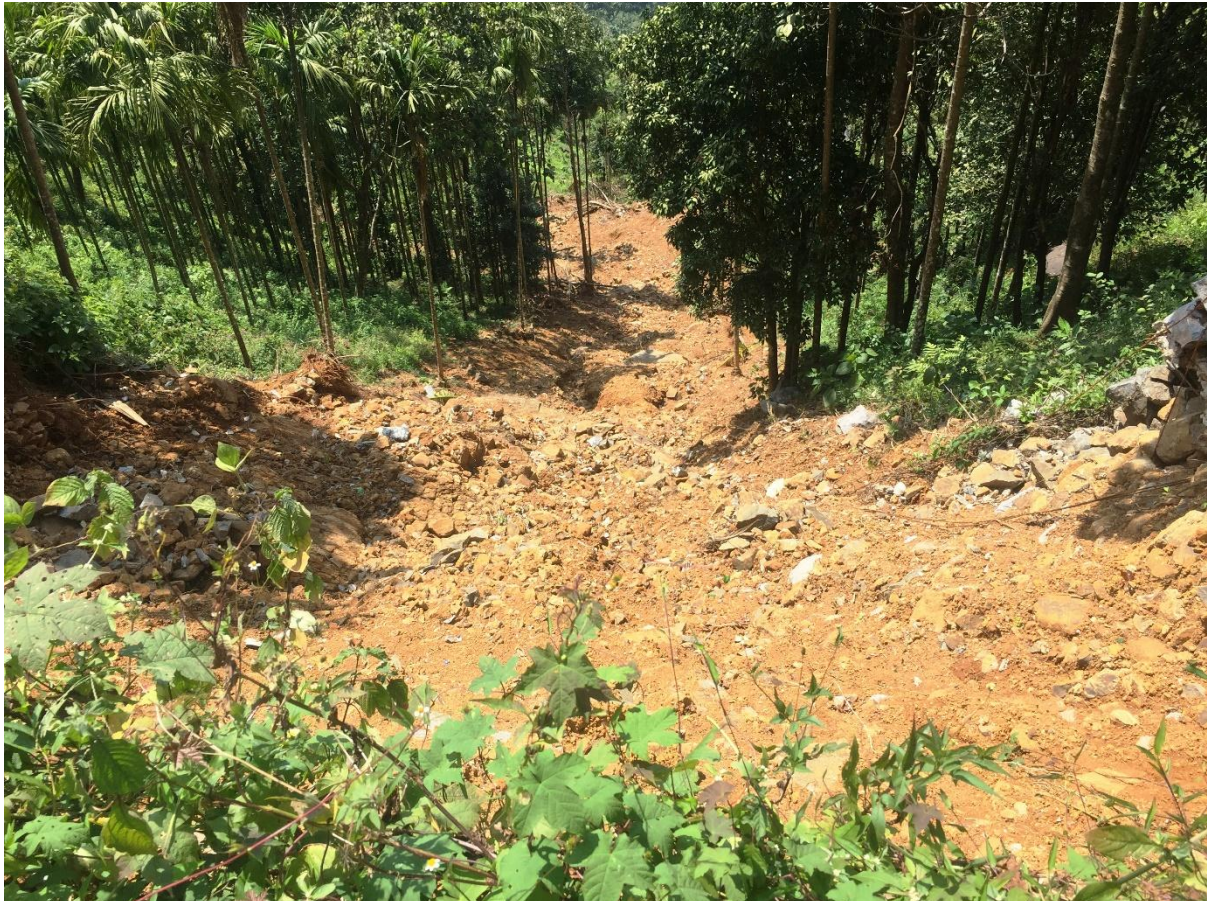
Damages have occurred in the Kuttiyadi hairpin due to the slump in 2018. Roads and side walls damaged extensively have been destroyed as well (Plate 12). Heavy rains and land use change from existing wild vegetated to cultivated farm lands may be sited as the reason for such slump events.

Plate 12: The scar of the failure starting towards valley from the road edge.

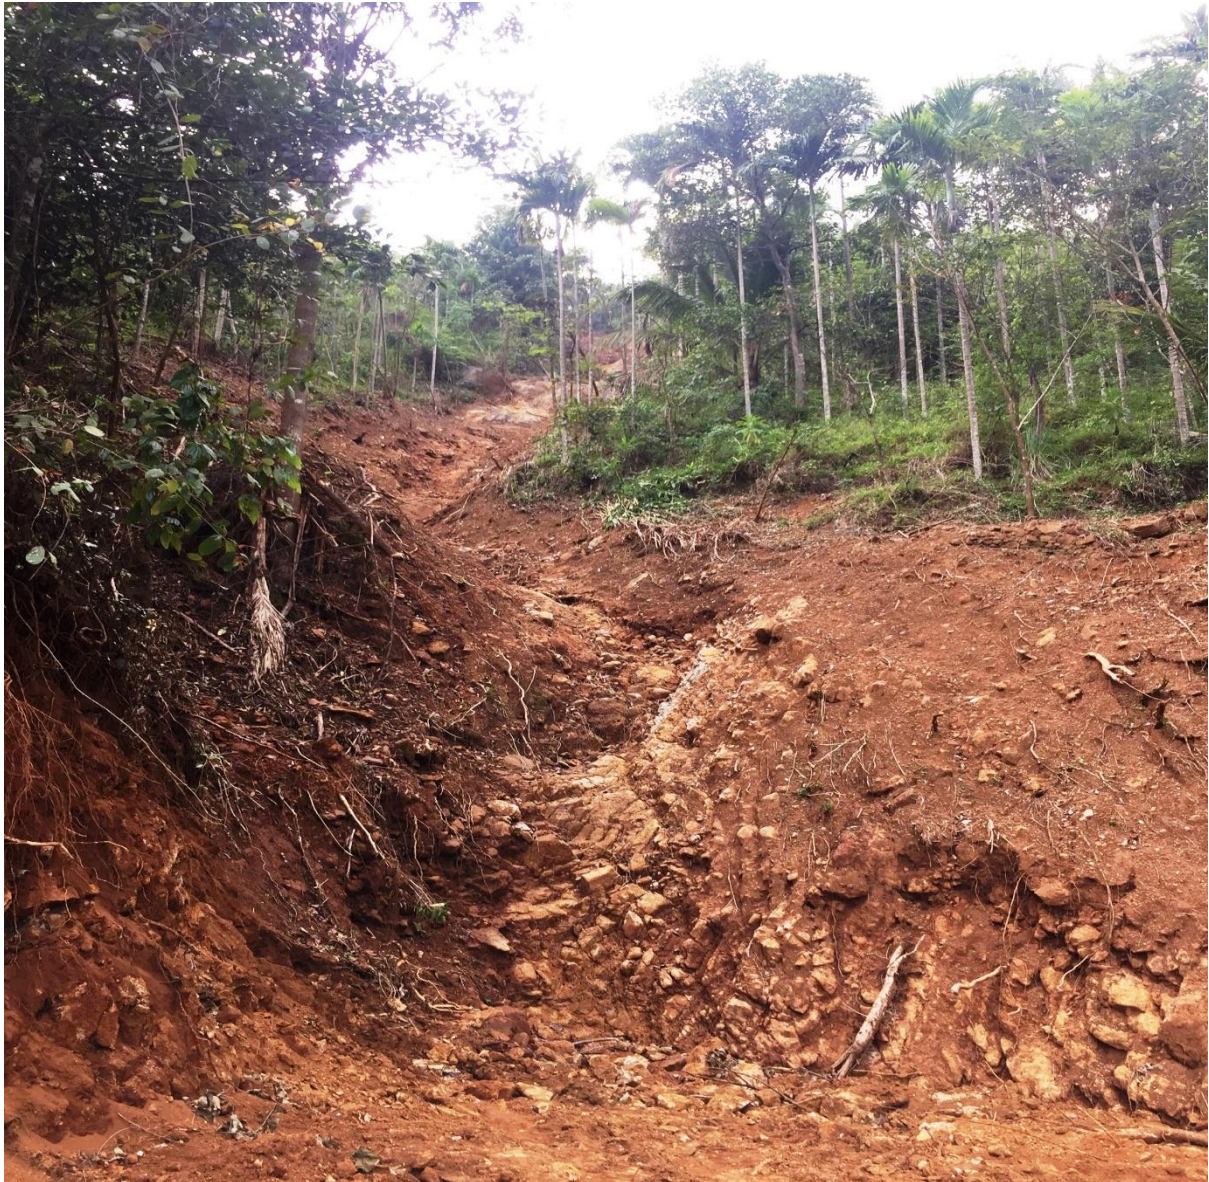
In Vaanimel panchayath, slumps and debris flow occurred in Pannyeri, Koothadikunnu, Valiyapaanam and Aalummoola areas in 2018 (Plate 13). In Pannyeri area cultivated areas including plantations of arec nut, coffee, banana and coconut trees were uprooted and dumped into the stream below and a check dam was destroyed as well. Excessive rainfall and change of natural vegetation to farm lands have created instability to the region. Road cut cliffs had failed and destroyed the village roads and agricultural land along the valleys, particularly in Ward 10.

Plate 13: Debris flow at hill slope Valiyapaanam.

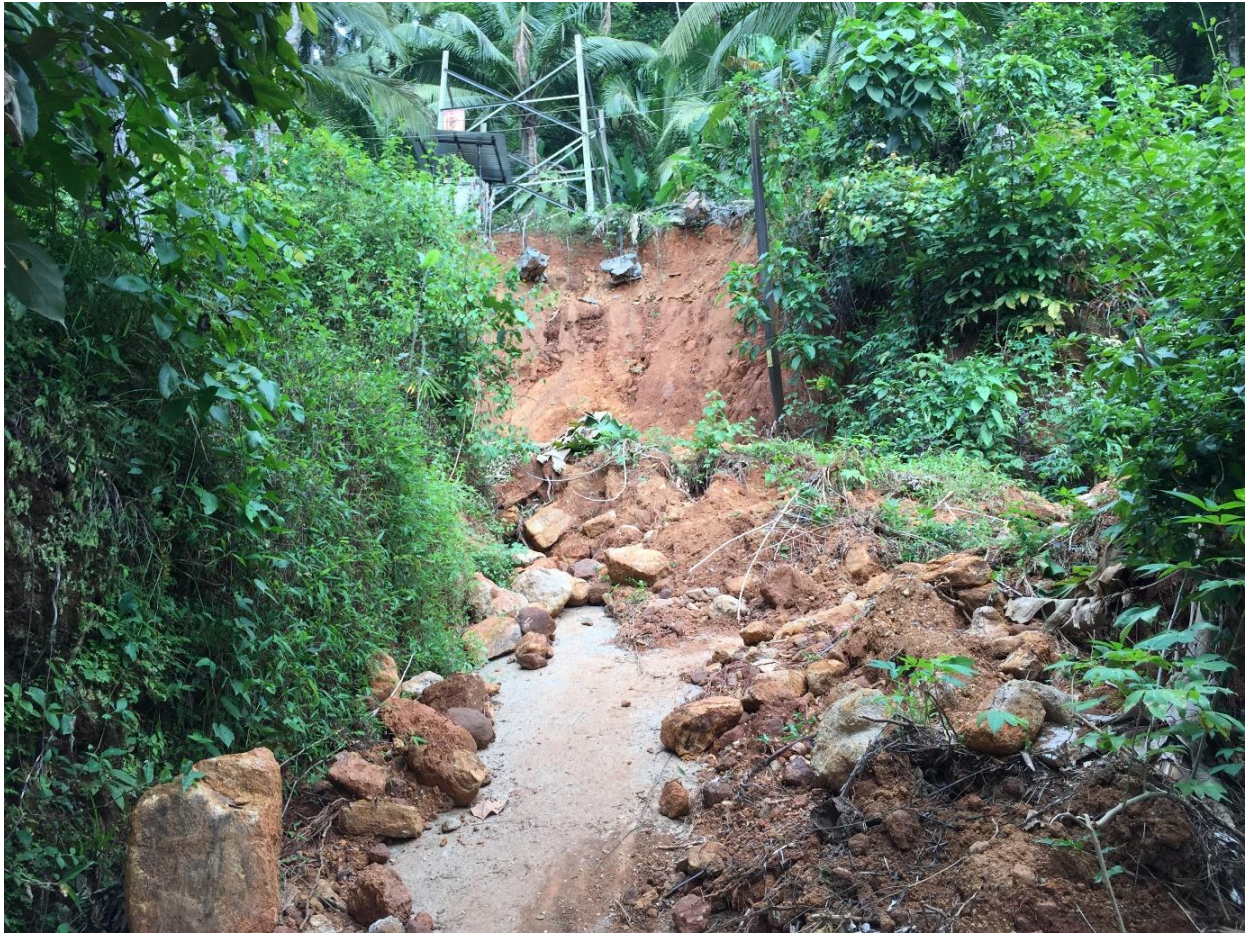
In Kodenchery panchayath a debris flow and slump event occurred in Vendekkamboyil and Kodenchery (Bus stand) area. Two houses were destroyed and nearly an acre of agricultural land was destroyed and a crack was developed in the ground in Ward 3. Water can infiltrate these cracks and develop pore pressure if heavy rainfall take place. This area is prone to further failure in future. In Ward 10 near to Kodenchery bus stand, a house was partially damaged due to slumping. Excessive rainfall is supposed to be a triggering factor for such events in these areas. In Koduvalli, slump occurred in Chembattamel. Evidences of soil piping is observed in the area (Plate 14).

Plate 14: Slump due to soil piping in Chembattamel

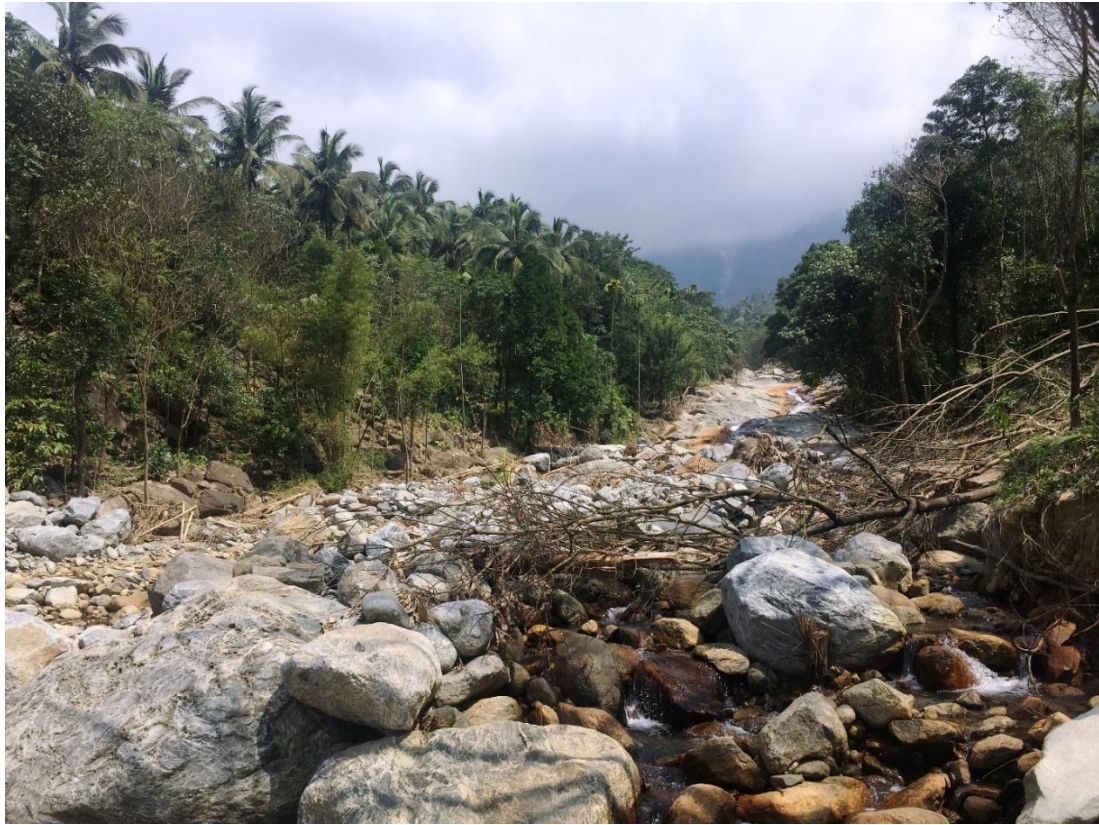
Puthupadi panchayath experienced number of disastrous slope failures. Multiple slumps occurred along Thamarassery churam and Eduthuvechakallu. A major debris flow event occurred in Mattikunnu (Ward 2) with a death toll of 1. A bridge was fully damaged and 3 were partially destroyed. 20 houses were partially damaged near Mattikunnu bridge (Plate 15). Excessive rainfall and change in agricultural practices are considered as the major reason for landslide events.

Plate 15: Accumulation of debris at Mattikunnu.
