# **Studies on “The Soil Piping in the Highlands and Foothills of Kerala to avoid the disaster”**

**Final Report**

**National Disaster Management Authority**

**National Centre for Earth Science Studies**

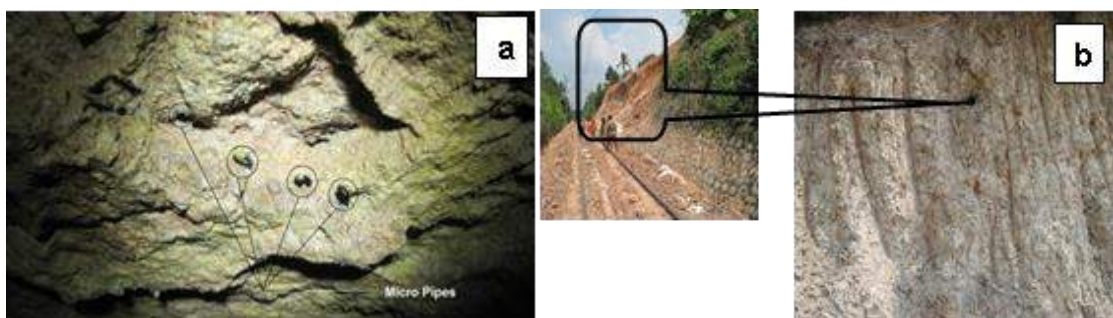
Micro pipes or juvenile pipe (figure 3.8a) are the initial stage of piping. The diameter of pipe is <5cm. Clayey and lateritic soils are favorable for the formation of juvenile pipes. Juvenile pipes often found in the laterite cutting made for railways and roads. These pipes often saturate the laterite cutting Mulanthuruthy (figure 3.8b). The failure of the railway cutting occurred during 2012 near Mulanthuruthy near Ernakulam is a typical failure affected by such juvenile pipes. The juvenile pipes when present in large numbers in an area indicates the susceptible nature of the soil to soil piping.

Figure 3.8: Micro (Juvenile) pipes.

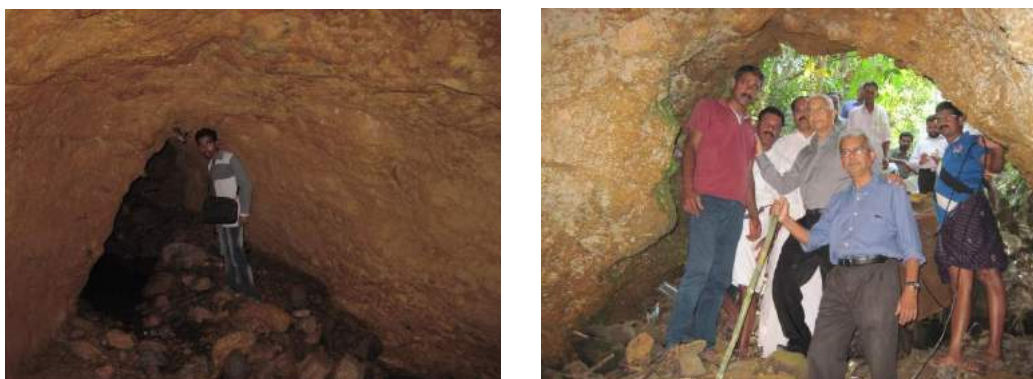
Mature pipe (Figure 3.10) is the third stage of development of pipe. The diameter of pipe ranges from 30cm to 5m. It may have an outlet; it acts as an underground drainage. This is the common pipes seen in the Western Ghats. The land subsidence is often caused by the growth of these pipes. This often branches in to smaller pipes giving an appearance of dendritic pattern. The size of the tunnel reduces towards the outlet attaining an overall shape of a funnel. The outlet of these pipes is often located in the lower side slopes or the valley. Here the water comes out as a fountain rather than a spring. These type of pipes are common in the affected localities. In Kerala Kottathalachimala (Kannur) , Iritty, Tattékanni (Idukki ) are typical examples.

**Figure 3.10:** Typical pipes (Mature pipe)

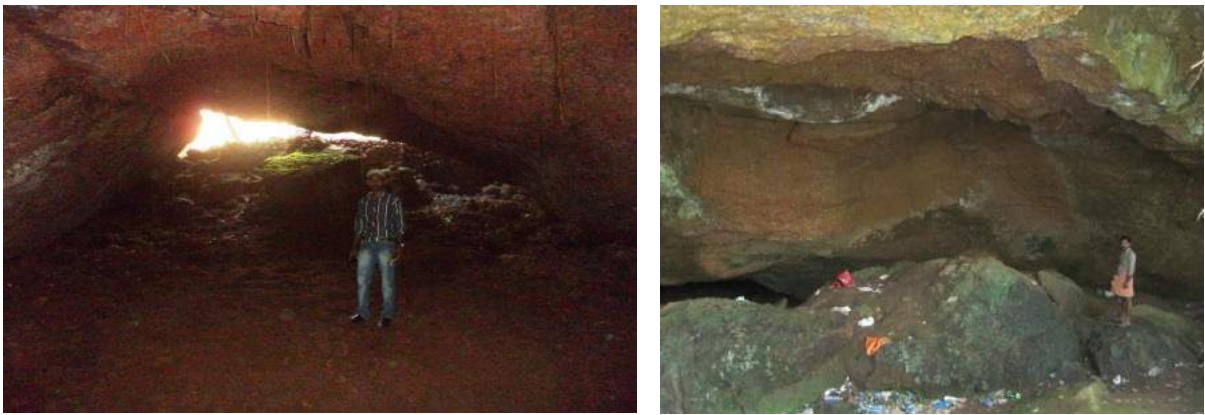
It is next stage of pipe after development of a typical pipe. The diameter of huge pipe (Figure 3.11) is  $>5\text{m}$ . It will also have an outlet. It acts as an underground drainage, it has no definite shape. These pipes often associate with their lower versions such as typical / mature pipes. These pipes are almost stable, the water erosion is very less and the walls of pipes are so hard Huge pipes are located in the Kasaragod (Kuttikol / Nellyadukkam) and Kannur (Umrampoyil) districts

Figure 3.11: Oversized pipes (huge pipes)

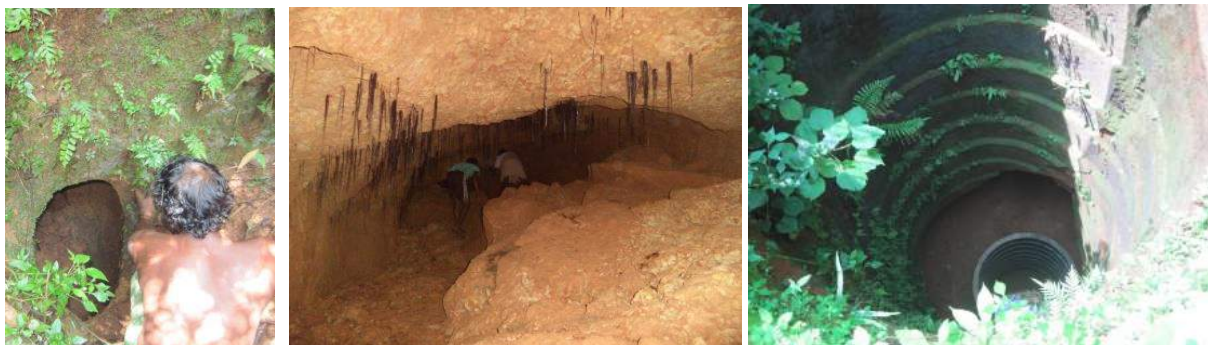
The other locations are Kuttikol panchayath at Kasaragod taluk; Muttonkadavu at Karindalam village (Figure 2.15, Loc. E12°20'54.1"and N75°23'16.3"), the pipe occurs in lateritic terrain at gently sloping area;the size of pipe is around 30m diameter therefore it included to the oversized / huge pipe in the piping classification.

**Figure3.15:** Piping in Kuttikol, Kasaragod district

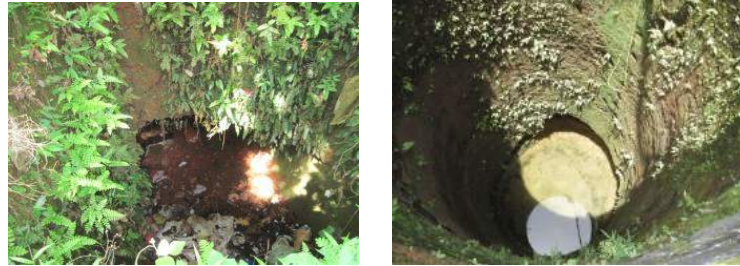
The another Piping occurs in the Erinjilakodu in Kolichal village (Figure 2.16, Loc.  $12^{\circ}27'11.3''$  and  $N75^{\circ}17'35.7''$ ) is of mature piping category, and also the terrain is lateritic.

*Figure 3.16: Piping and affected well in Erinjilakodu, Kolichal village*

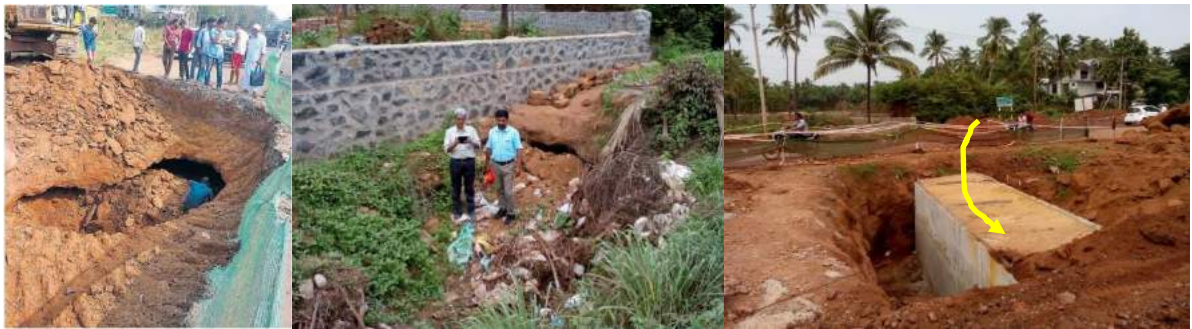
The piping occurs in Pallikara (subsidence in Kanhangad - Kasaragod State Highway, (Figure 2.17) is in lowland area and also in lateritic terrain, in this pipe comes under typical pipes category in Kasaragod district

*Figure 3.17: Soilpiping incidence occurred in state highway Pallikara, Kasaragod district*

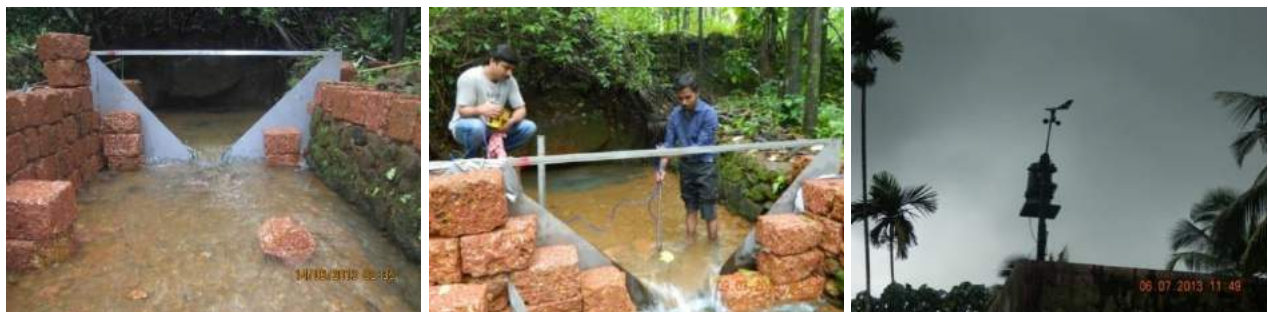
The V-notch Constructed of started was completed (figure 3.19) and data collection has been started (table 3.2). The Automatic weather station was also installed (Figure 3.19b and table 2). Arrangements were made locally for daily observation and to collection of data. The V-notch weirs were installed in open channels, coming from the piping outlet, to determine discharge (flowrate). The basic principle is that discharge is directly related to the water depth above the crotch (bottom) of the V; this height is called head (h). The V-notch design causes small changes in discharge to have a large change in depth allowing more accurate head measurement than with a rectangular weir.

*a. Discharge flow measuring from V-notch wire      b. Rainfall- Automatic weather station*

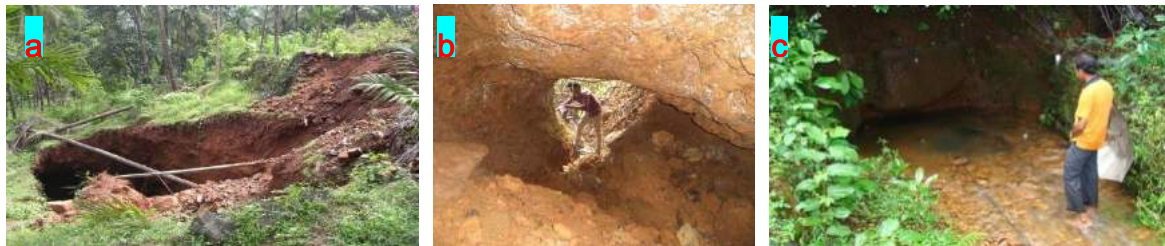
The study conducted in the locality revealed that there are two such depressions due to subsidence in the eastern hill slope and the three more incidences occurred in the western slope and the locality indicating that the area is prone to such incidences.

*a. Piping Inlet, b. Middle opening of pipe, c. Piping Outlet*

**Figure3.20:** Subsidence associated with Piping in Chattivayal

The field survey conducted in the locality revealed that there are two such depressions in Eastern Slope of the Kottathalachimala due to subsidence in this locality indicating that the area is prone to such incidences (Figure3.20a, b and b). This indicates that there are underground pipes present in this locality, many of them falls in the small to typical category pipes. Quick draining of water through these depressions proves the presence of the pipes. There are a number of dug wells in the area. But none of them sustain water even during high rainfall times such as monsoons. The locals have complained that water level never gains after certain level even during rains. This indicates that there is considerable loss or leakage is occurring in the wells.

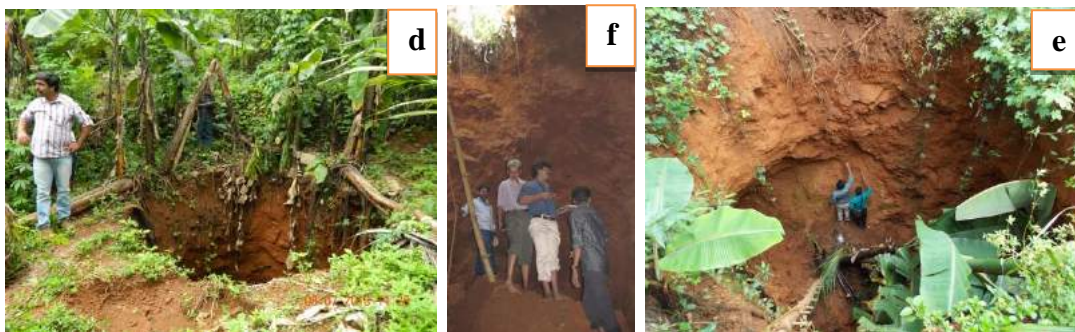
**Figure 3.24:** Unstable Soilpipes in Kottathalachimala, Kannur

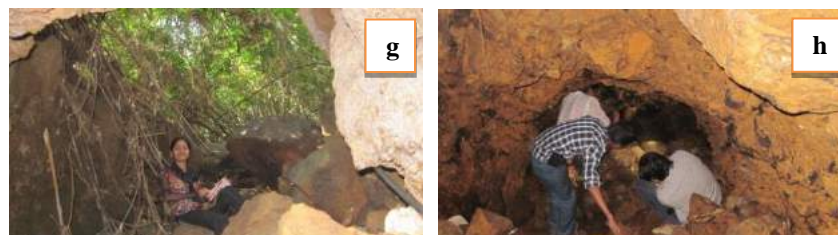
**Figure: 3.25** Soilpipes in weathered rock in Kottathalachimala, Kannur

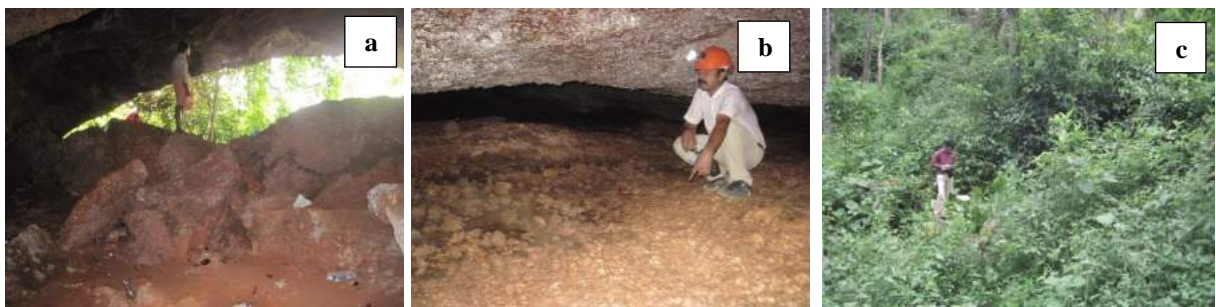
**Figure 3.27:** Inlet and out let of the Pipe in Ummrampoil, Kannur

The newly reported incidents in Kannur are [Padiyottuchal(Figure 3.26, Loc. N12°14'59.2" and E75°20'33.7"), Ummrampoil(Figure 2.27, Loc. N12°14'23.7" and E75°19'33.6"), Vayakkara (Figure 3.28, Loc. N12°14'58.0" and E75°19'50.7") and Malankadavu in Palavayal village (Loc: N12°18'5.6" and E75°23'48.5") in Peringom village are in Kannur district and soil samples were collected. From the field observation the tunnels are old and the area is dominated by the laterites. Field investigations revealed that the entire locality is affected by soil piping. Piping process has affected the Saprolite clay of the laterite.

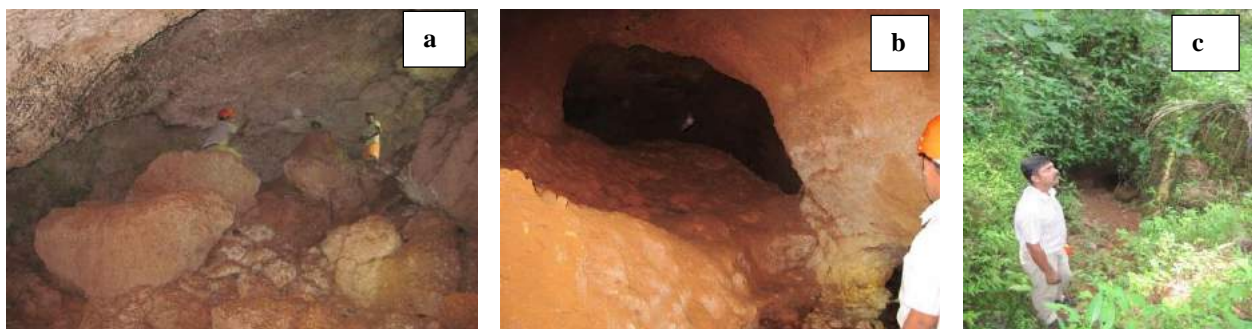
**Figure 3.28:** Oversized Piping in Lateritic terrain by erosion of clay layer in Vayakkara, Kannur

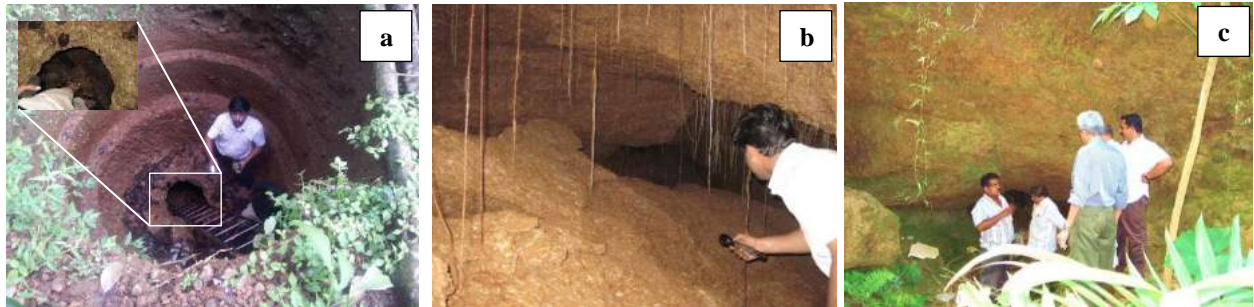
has occurred inside a well (GPS location is N12°02'09.4"E75°45'07.2"). The affected locality is in the foot hills and surrounded by hilly area. Piping has affected the saprolite portion of the laterite. Piping outlet is located at 120m north of this area. The soil is 1.5m thick and overlying the well-developed laterite. The slope of the terrain as well as the tunnel orientation is towards North West direction. The underground tunnels formed are found to be affecting the affecting the ground water storage of the wells in this area.

*Figure: 3.29 Soilpiping affected well at Niranganpara, Kannur*

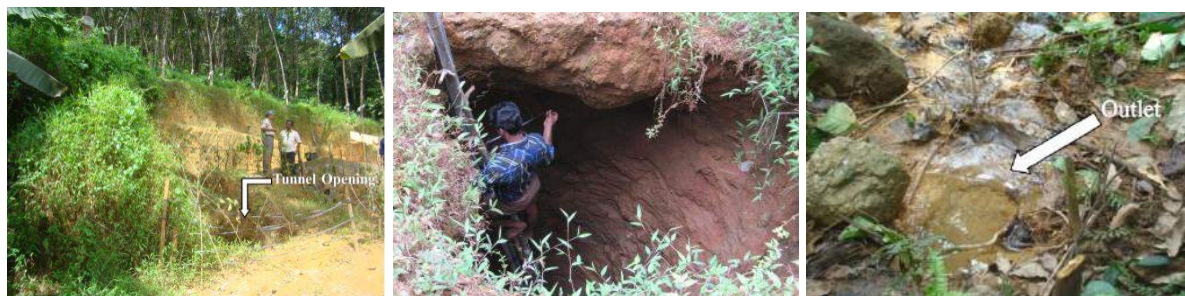
The Piping affected locality is Peringassery in the Udumbanoor and Kanjikuzhi village in the Thodupuzha taluk of the Idukki district. Peringassery is located on the Paramada - Udumbanoor road. The expose cavity of the subsidence has a diameter of about 2.5m. (Younger pipes) It is about 12 meters deep. The cavity is believed to be interconnected by underground pipe like features. The soil type is mainly lateritic on the top and clayey in the bottom. The landuse is mainly mixed crops with rubber. A spring is seen emerging about 200m north of the collapsed section. This could be an outlet of the pipe. This pipe is ferrying water beneath the main Paramada - Udumbanoor road. The figure 3.33 shows a schematic section of the piping affected locality that indicating pipes cut across the road.

*Figure:3.32 Soilpiping in Peringassery, Idukki district*

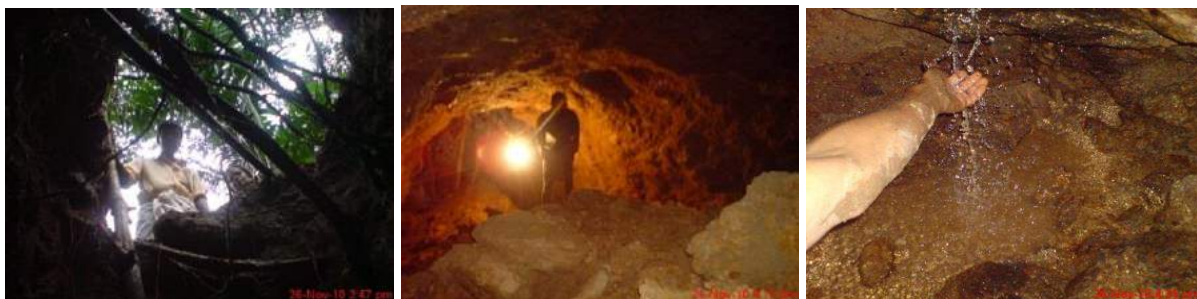
Another land subsidence has occurred at Thattekanni on the Neriyaankalam- Idukki road (Figure 3.34). The subsidence vent has a diameter of 1m. It is about 6-7 meter deep. The cavity is interconnected by typical pipes which are little more than 5m in combination with younger pipes. The soil column is unconformably lying over the hard crystalline rock. Piping is located in this area having lateritic soil. Since groundwater follows the topography, the steeply sloping terrain produces high hydraulic gradient in the region. Piping can affect materials ranging from clay- size particles to gravels, but is most common in fine grained soil such as fine- grained soils such as fine sand silt and coarse clay.

**Figure:3.34** Soilpiping in Thattekanni, Idukki District

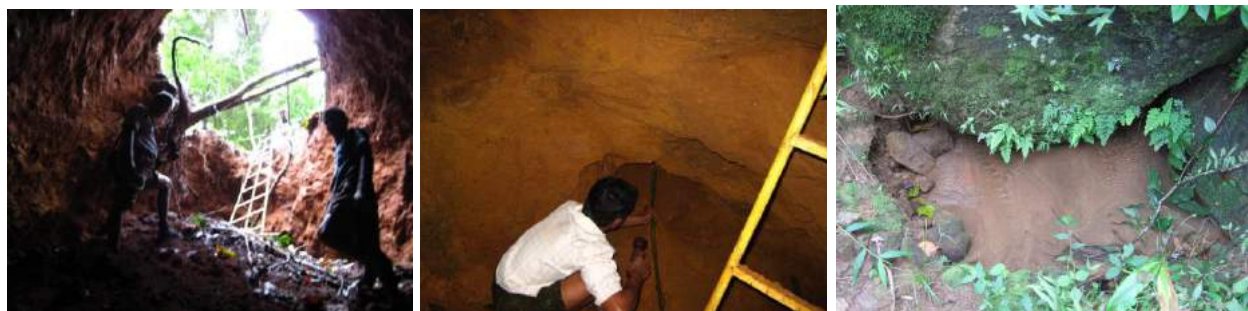
Another prominent subsidence (N 09° 50’ 31.3” E 77° 03’ 34.7”) has occurred in the same Udayagiri locality on 14.8.2010 at 5.30pm (Figure 3.36). The subsidence crater has a diameter of 3meter and depth of 7meters to the top of the debris of the roof which is accumulated on the floor. The material of the roof is fine red clay and overlying the weathered basement. Piping has taken place at this contact. Piping has taken all the weathered coarse material and it was found deposited in the valley head located downslope in the NW direction. (N 09° 50’ 33.6” E 77° 03’ 34.0”) and (N 09° 50’ 33.3” E 77° 03’ 37.1”). It is suspected that there are a number of outlets. The tunnels are of mature type in combination with small and micro pipes. These outlets are small in dimension and it is observed that the weather coarse sediments are found deposited in this locality. The outlet (figure 3.37c) locality is marsh with constant input of water through these pipes (figure 3.37b).

**Figure 3.37** Different types of pipe in Udayagiri area

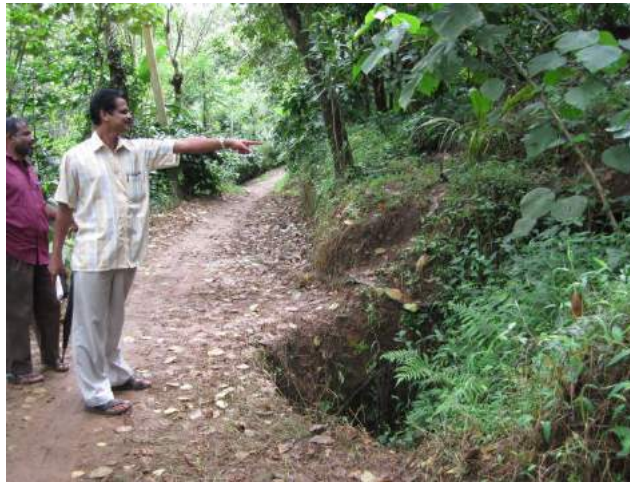
about 2m and the depth is about 2m. The inlet pipe and outlet pipes are blocked due to debris from the collapsed material.

**Figure 3.38:** One of the old subsidence crater observed in Udayagiri

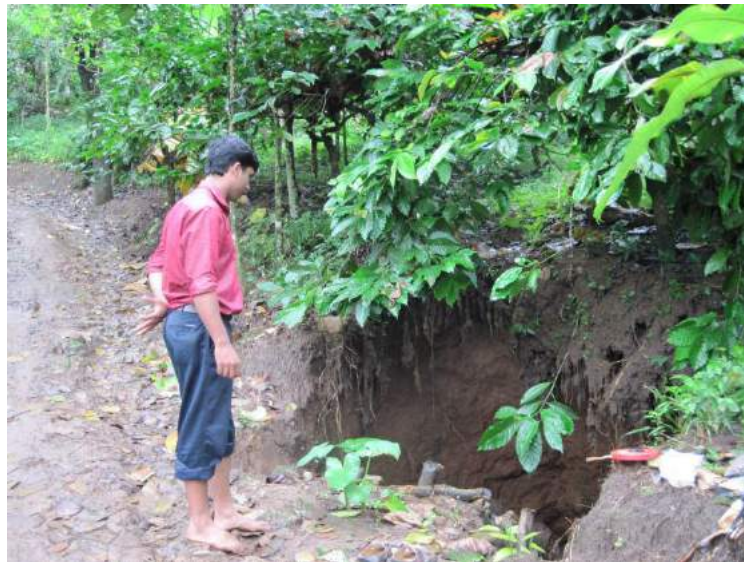
Another subsidence (N 09° 50' 30.8" E 77° 03' 36.7") also occurred along the banks of the path during the same period (figure 3.39). This crater has a depth of about 2.65 m and has a diameter of about 3.25 m. Both these subsidence craters are situated on side slopes of the 1072 hill which is conical in shape. The slope where these incidences had occurred is sloping towards W-NW. There are subsurface pipes present which are like to run in NNE-SSW direction. However more investigations are required to determine the exact direction of pipe pathways.

**Figure 3.39:** A subsidence crater formed along the path way

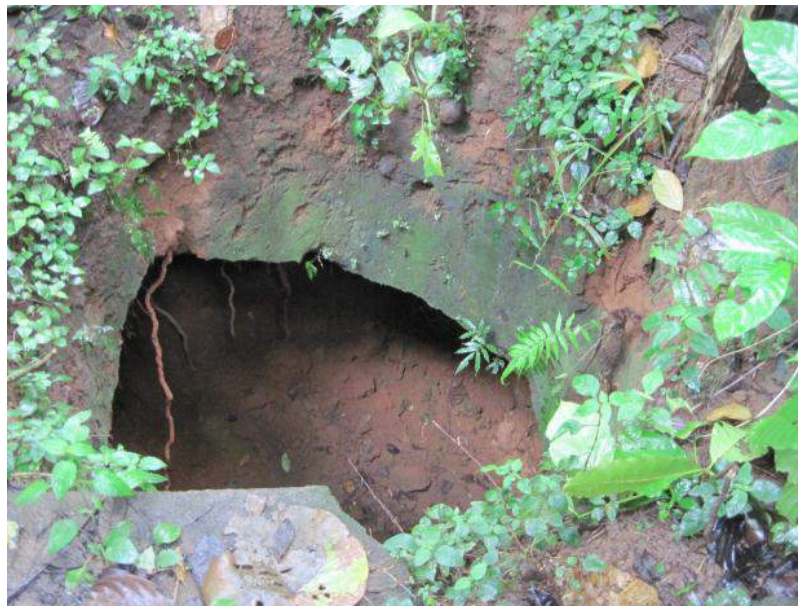
One such well (figure 3.40) is located (N 09<sup>o</sup> 50' 31.7" E 77<sup>o</sup> 03' 35.7") near Mrs. Jolly's residence (N 09<sup>o</sup> 50' 31.3" E 77<sup>o</sup> 03' 35.8"). This well was collapsed in 2002 and in unusable in the present condition. The depth of the well at present is 9meters up to the top of the filled material.

*Figure 3.40: opening of a subsurface tunnel within the well*

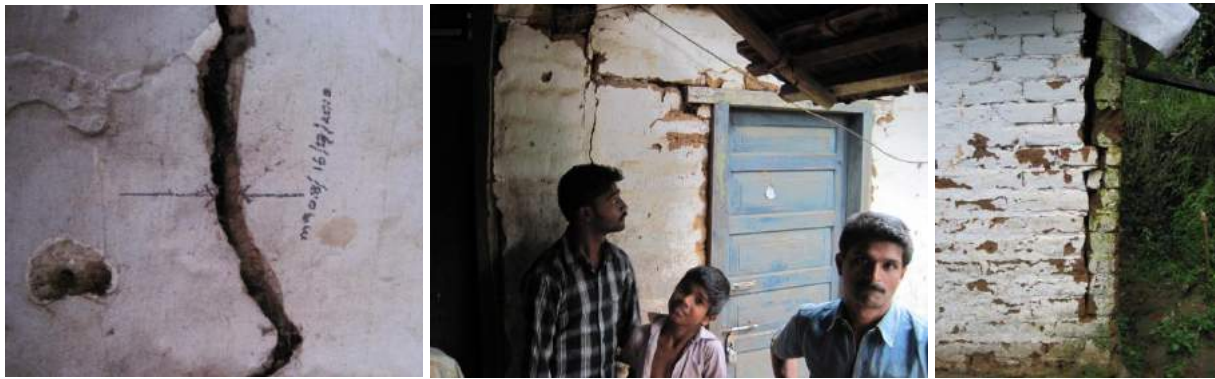
The pipe is oriented in NE- SW direction. Mrs Jolly Moolayil (Kamakshi Panchayat No IV/25) house is situated about 8m from this collapsed well. The inhabitants of the house complained to this team of noise of water flow and rumbling sounds associated with that from the basement, especially during rainy seasons. This indicates that there are chances of pipe formation beneath this house. Eventhough the formation of subsoil pipe formation is a slow process but once it reaches closer to the ground subsidence may occur suddenly. There are indications of settling seen as indicated by a number of cracks (Figure 3.41) on the wall of Mrs Jolly's house. During high rains and when the discharge through the pipes is high the chances of erosion is rather high. So this area should be subjected to detailed investigations. It is recommended that the family should be relocated to a safer locality during high rains. The other houses in this locality are not showing any visible indications of instability at the time of inspection

**Figure 3.41:** Cracks on the wall (Mrs. Jolly's house)

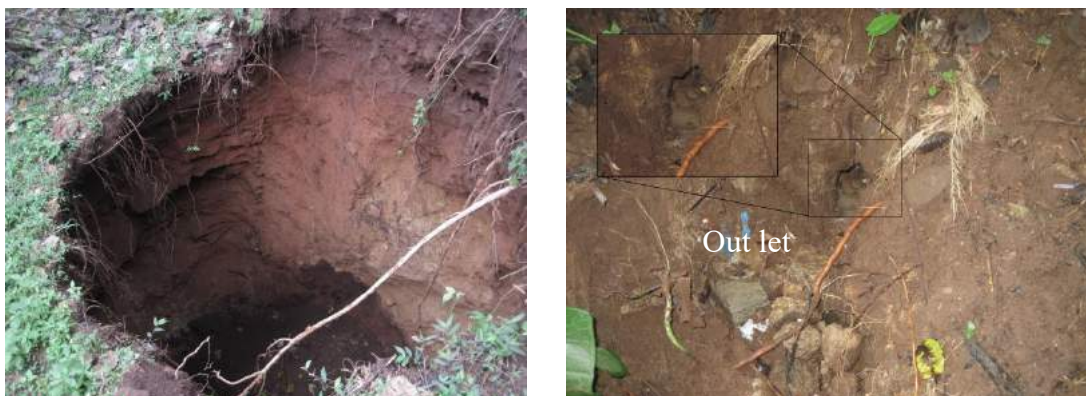
The area is situated on highland region, the landform is contain dendritic type drainage is seen in this area. The affected is located in the east facing slope of this hill. In this region the general trend of the major drainage and landforms is NW–SE. This locality falls in the sub-basin of the Periyar drainage basin. The area receives copious rainfall but a reliable rain gauging was not available for the study. Piping occurs in very fine and loose soil area. It is very close piping

**Figure 3.42:** Inlet and outlet of Piping in Nalaam mile, Idukki district

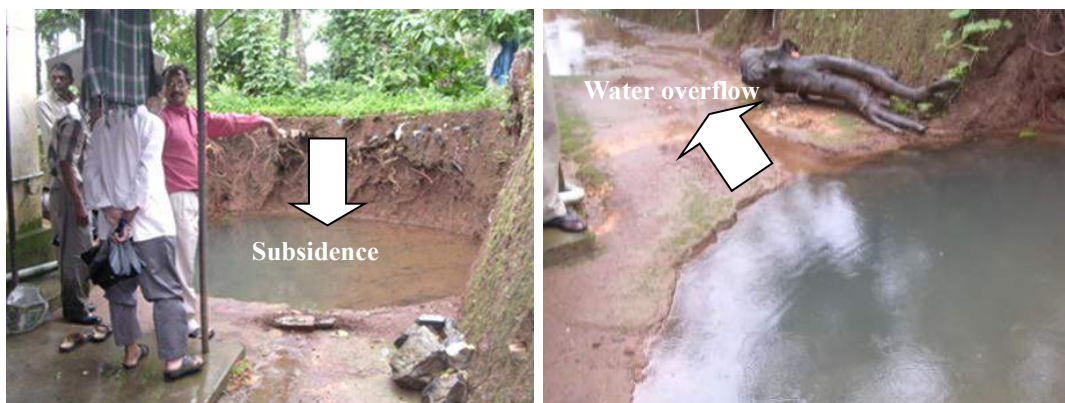
The process continued for few months and the discharge stopped leaving behind a subsidence pit connected upstream and downstream by small tunnels. The mitigation work was carried out by filling up by stones and earth. This is the practice carried out by the locals. This area will be under observation and if required chemical amelioration techniques will be adopted to prevent new erosion. In the down stream locality wall cracks have been observed in few houses located in the down slope side indicating land subsidence. Since the whole area is affected by soilpiping the SDMA is alerted for a detailed investigation of Banasurasagar dam site .

**Figure 3.45.** Subsidence at Banasurasagar, Vythiri taluk Wayanad district

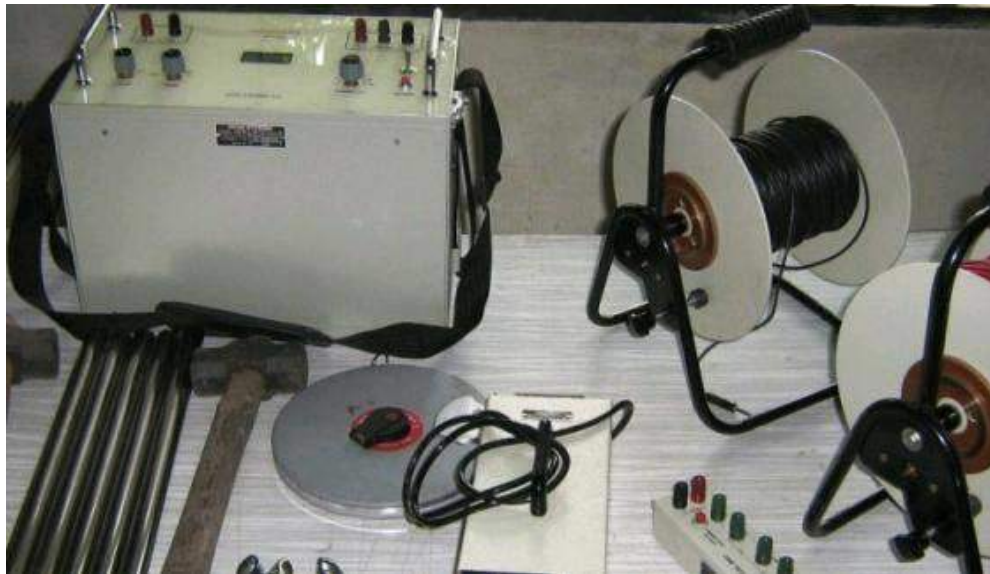
Electrical resistivity instrumentation systems (Figure4.1) basically consist of a transmitter and receiver. The transmitter supplies a low frequency (typically 0.125 to 1 cycles/second or “Hertz”) current waveform that is applied across the current electrodes. Either batteries or an external generator, depending on power requirements can supply power for the transmitter.

*Figure: 4.1 Earth resistivity meter (M/s. Anvic Systems - Resistivity meter)*

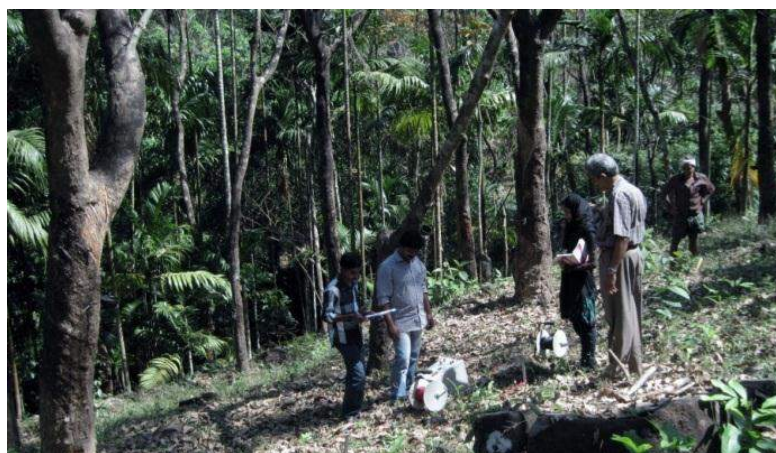
*Figure: 4.2 Electrical resistivity surveys in progress in Kottathalachimala*

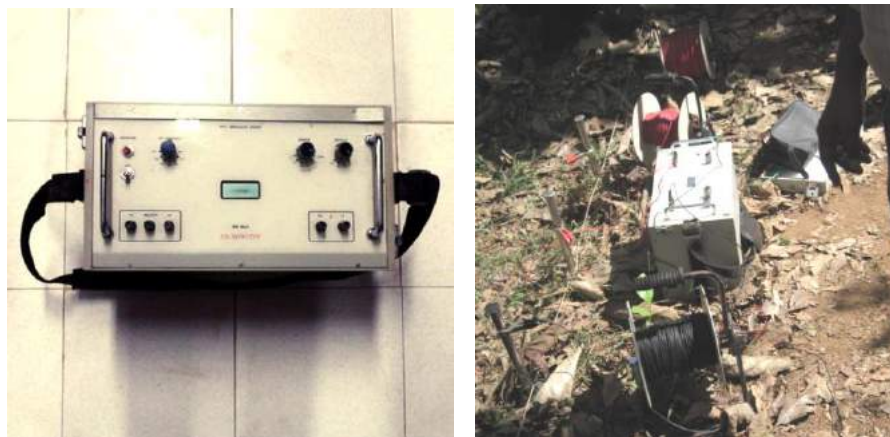
The electrical resistivity measurements have been carried out using Resistivity Meter namely Aqua meter manufactured by M/s. Anvic Systems, Pune (Figure 4.3). It has a maximum output of 300 V and 500 mA using a rechargeable battery as power source. It measures resistance with a precision of  $\pm 0.001$  ohms.

*Figure 4.3: Aquameter (M/s. Anvic Systems - Resistivity meter)*

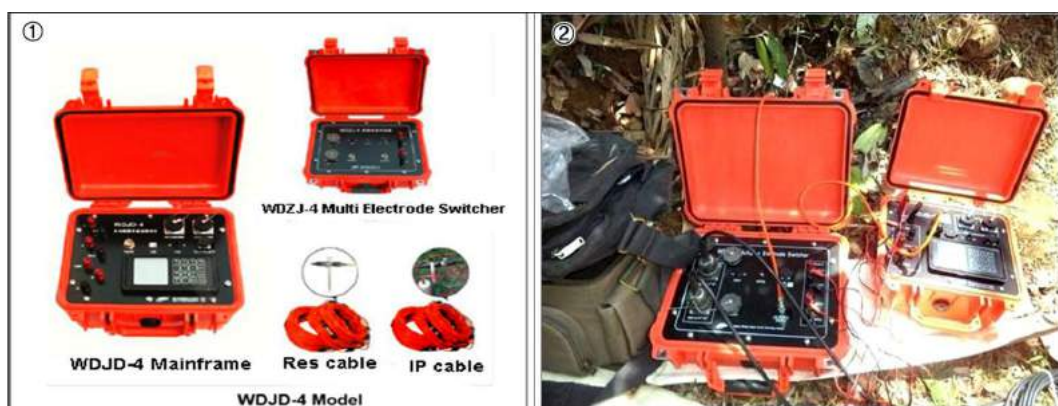
A multi-function Digital DC Resistivity/IP Meter (Figure: 4.7), is having a WJD-4 main frame, WDJ-4 switcher box (Multiplex Electrode Converter), 12V rechargeable battery as a transmitting power source developed by BTKS/WTS Limited, electrodes, multi-electrode cables etc. It features multiple functions, high accuracy, fast speed, high reliability and excellent expandability. In order to conduct multi-electrode 2D electrical resistivity survey, the instrument system will automatically select current electrodes and potential electrodes according to a specific electrode array, and gives measured results of all the data points of a cross-section. The data so gathered is processed and interpreted using RES2DINV Software.

Figure 4.7: Digital multi electrode resistivity meter (WJD-4 Multi-function Digital DC Resistivity/IP Meter)

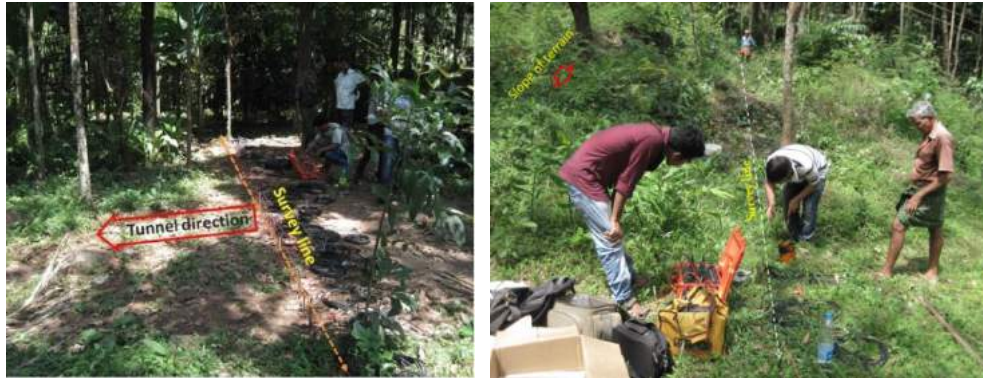
**Figure 4.19:** Electrical resistivity survey at Kottathalachimala, Kannur

Experiments using Electrical Resistivity Survey techniques continued at Kottathalachimala near Cherupuzha, Kannur district across the alignment of a known soil pipe by using the WGMD-4 Multi-function instrument. Electrical resistivity tomography has been carried out over five mutually parallel profiles using a 60 electrode-setup (Figure 4.9). A minimum of 0.25m to a maximum of 2.0m spacing has been used as electrode configuration. Use of larger electrode spacing has been constrained due to the nature of the terrain. The five survey profiles were laid in

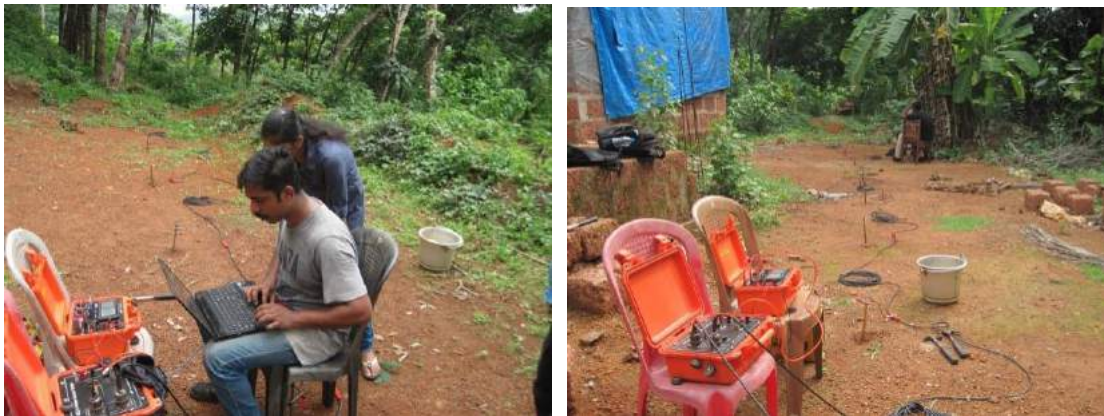
**Figure: 4.27.** Survey is conducted in soil piping area (Nelliyedukkam, Kasaragod district)

The survey tools included electrodes, connecting cables, multi resistivity meter, battery pack, laptop to deliver data gathered from the instrument in a graphic manner. Survey was done using 60 electrodes extended equally (30 each) to both sides with an interval of 2 meters.

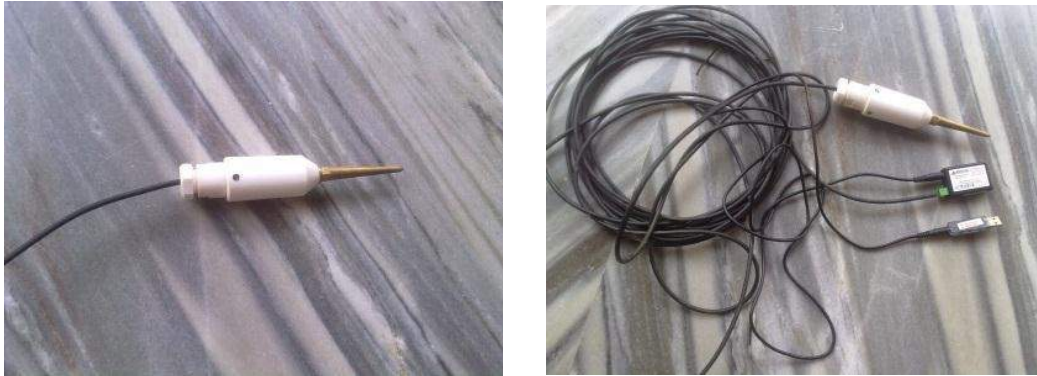
*Figure 4.35: Geophone and data logger*

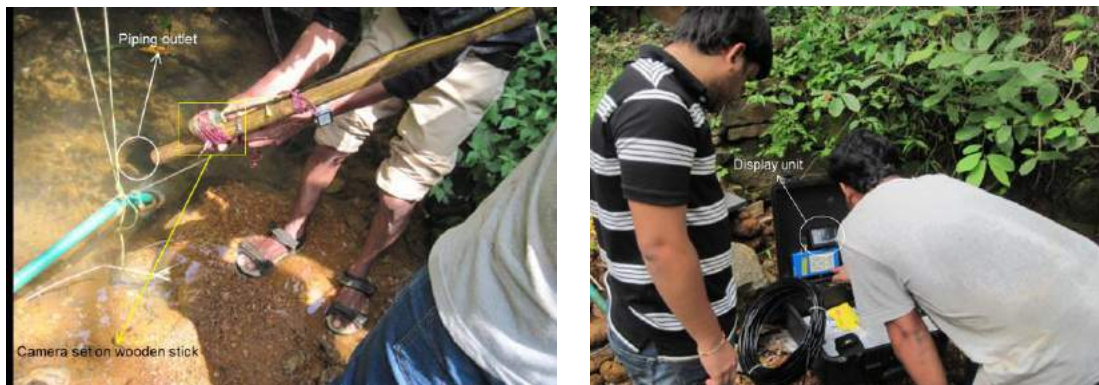
Push camera (underwater / borehole camera) was used (Figure 4.39) for visual investigation of tunnel branches at Chattivayal in Kannur district for studying sediment deposition and branching. The information from camera was recorded the video and picture mode (Figure 4.40)

**Figure4.39** Using of push camera inside the Tunnel in Chattivayal, Kannur

The studies conducted using this camera helped in the characterisation of branch tunnels and their classification. The usage camera is difficult where the tunnel is rugged with many bends. To overcome this this camera may be fitted on a robotic platform for mobility within complex tunnels.

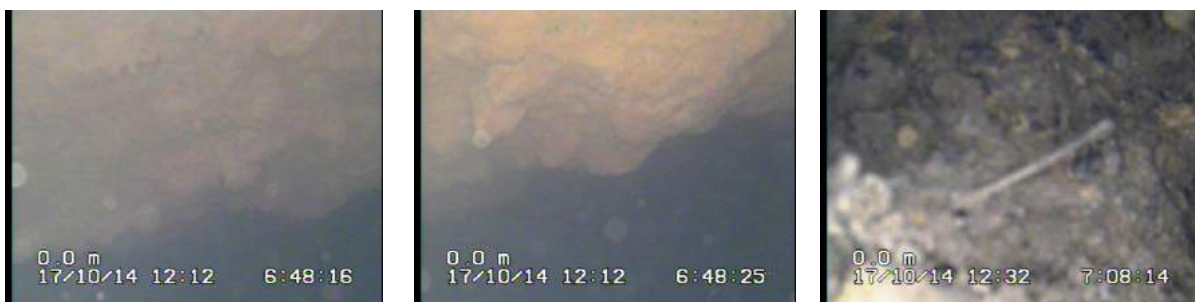
**Figure. 4.40** The images taken from inside the pipes (filled with water) by using push Camera

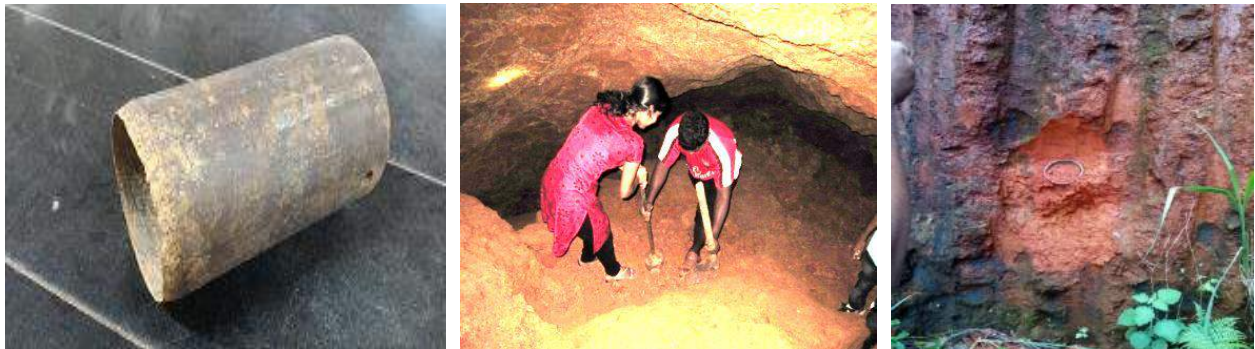
The sampler used in this study was thin walled samplers having size 10.5 cm diameter and 22 cm long. They were pushed into the soil to the complete length by light hammering and the outside soil was removed properly. The soils obtained in the samplers were covered tightly to avoid loss of moisture content. Undisturbed samples were collected from the various depths of piping and non-piping regions.

*Figure 6.1: Sample collection- various stages*

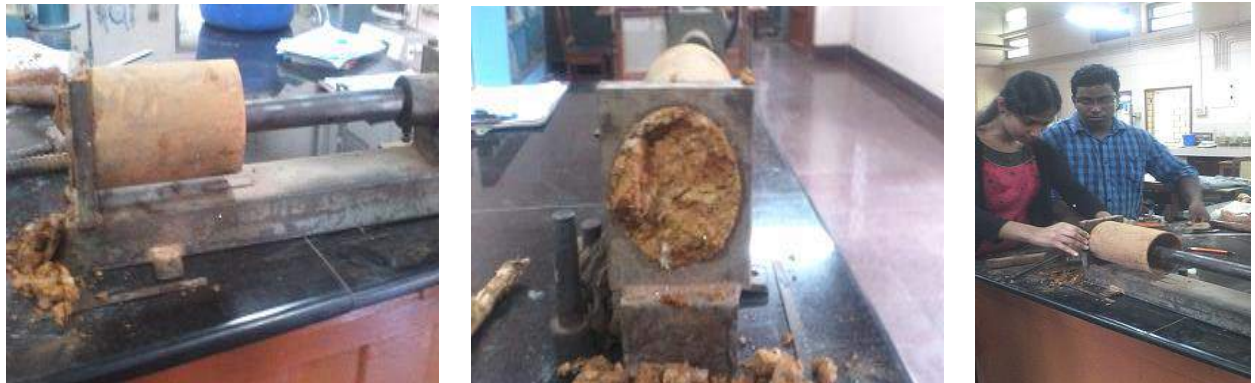
Undisturbed samples were carried to the geotechnical lab of NIT Calicut to conduct various tests. Sieve analysis, Atterberg's limits, specific gravity, permeability and direct shear tests were carried out on the samples. The sample extruded from the samples using sample extruder.

*Figure 6.2: .Sample extrusion*

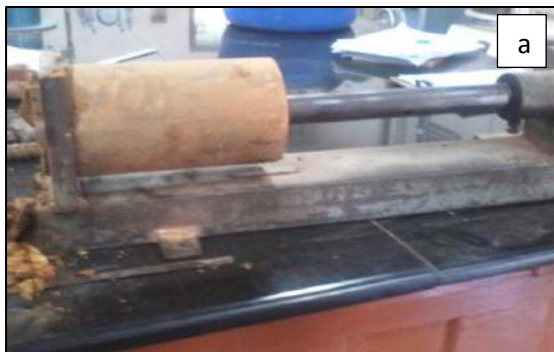
*a. Sample Extrusion*

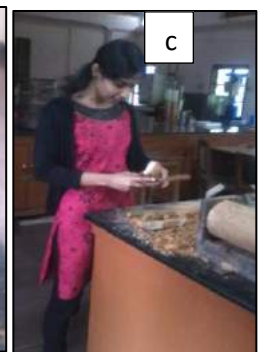
*c. Direction module Conversion*

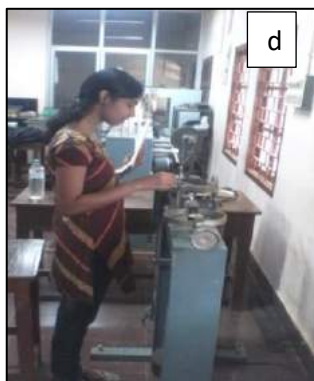
*d. Taking reading from aperture*

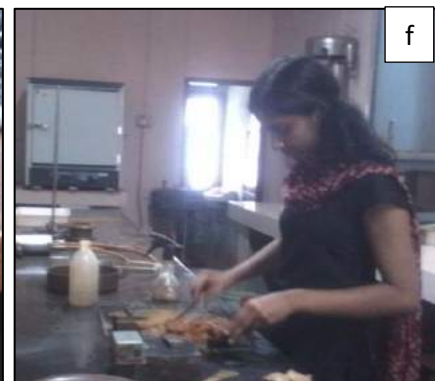
*f. Plastic limit test*

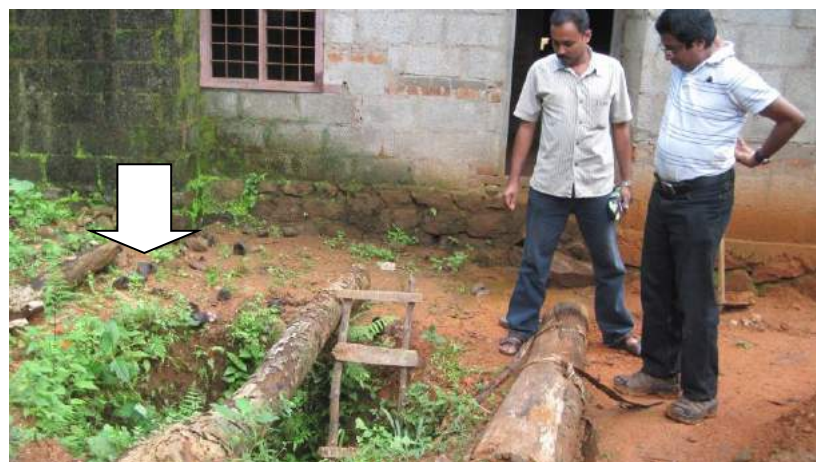
*Figure 7.1: Subsidence occurred in Ranny, Pathanamthitta*

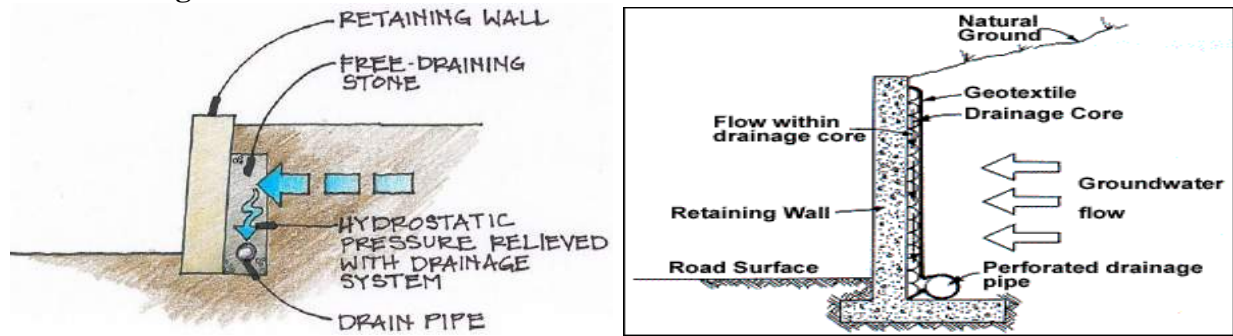
*Figure 7.6 Typical section of retaining walls suitable for stabilisation of lateritic railway cutting prone to soil piping (Panjami 2016)*

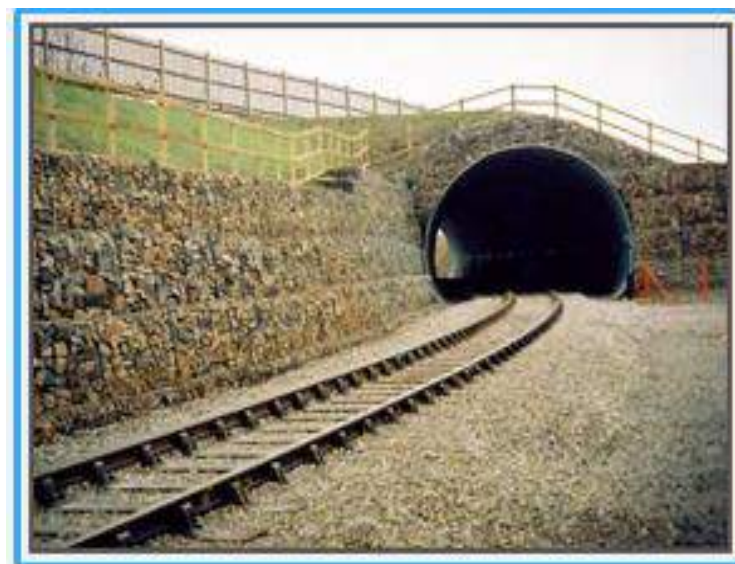
*Figure 7.7 Gabions along railway tracks (Panjami 2016)*

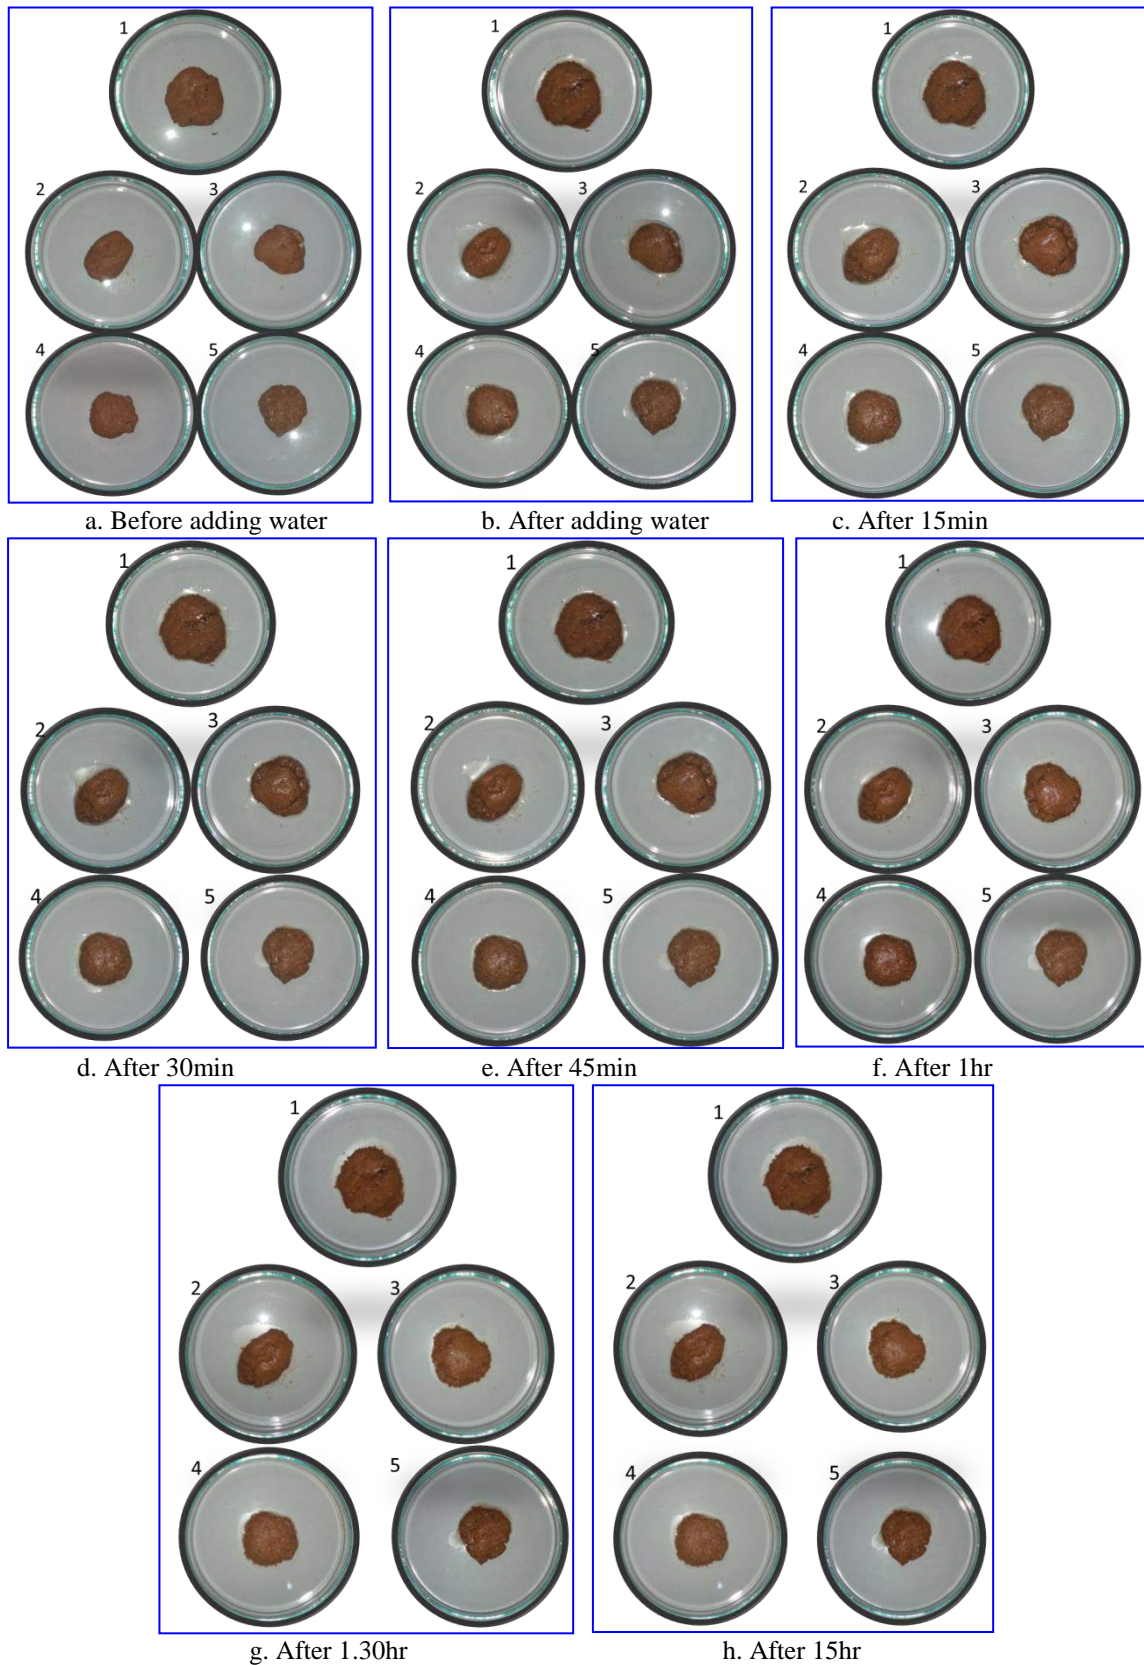
**Figure: 7.9** Dispersion test of soil sample by the addition of Gypsum  
{(1)0g of Gypsum, (2) 0.5g of Gypsum, (3).1g of Gypsum, (4)1.5g of Gypsum, (5) 2g of Gypsum}

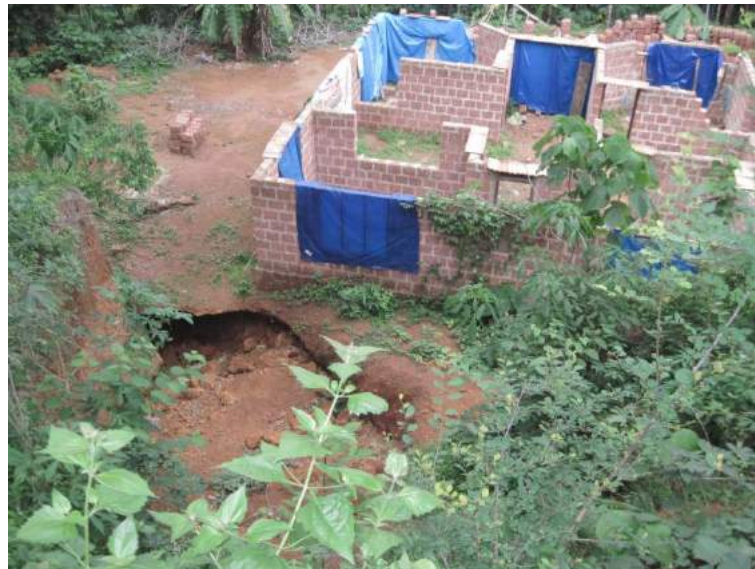
**Figure 7.10:** Collapsed pipe due to subsurface erosion
