# **Studies on “The Soil Piping in the Highlands and Foothills of Kerala to avoid the disaster”**

**Final Report**

**National Disaster Management Authority**

**National Centre for Earth Science Studies**

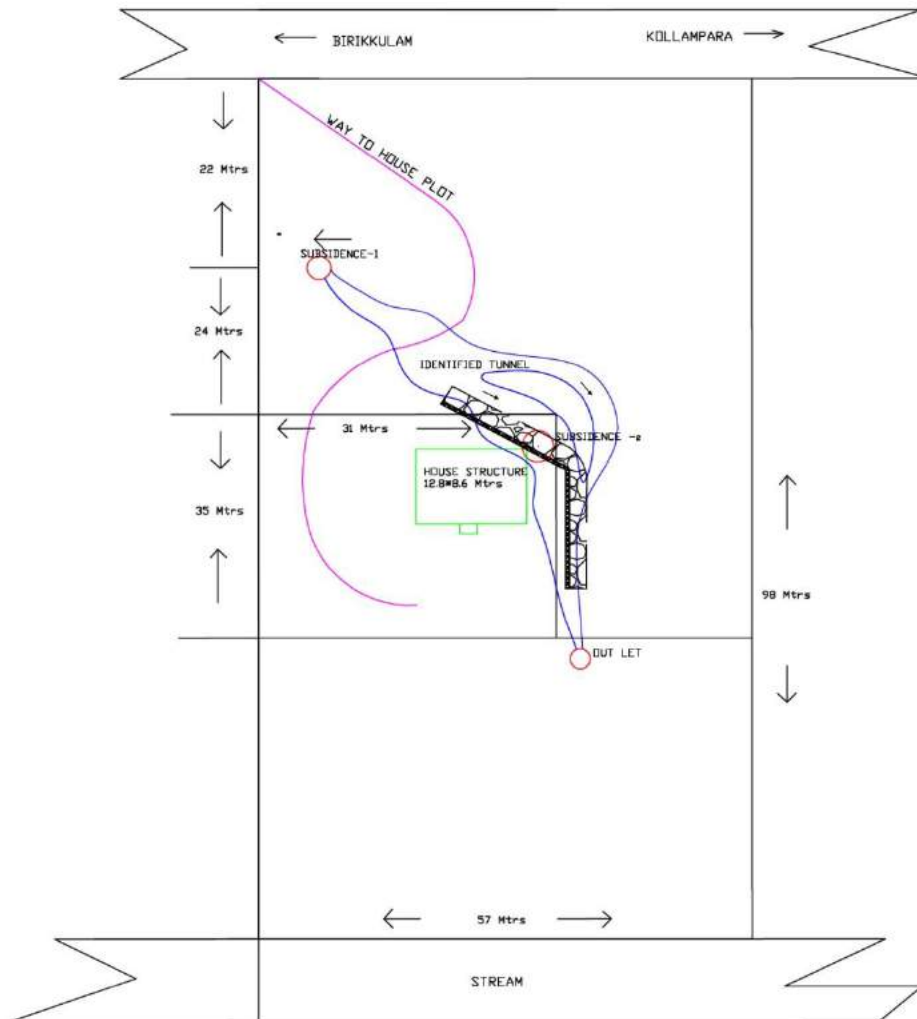
**Figure 7.14:** Water diversion plan at Nellyyadukkam

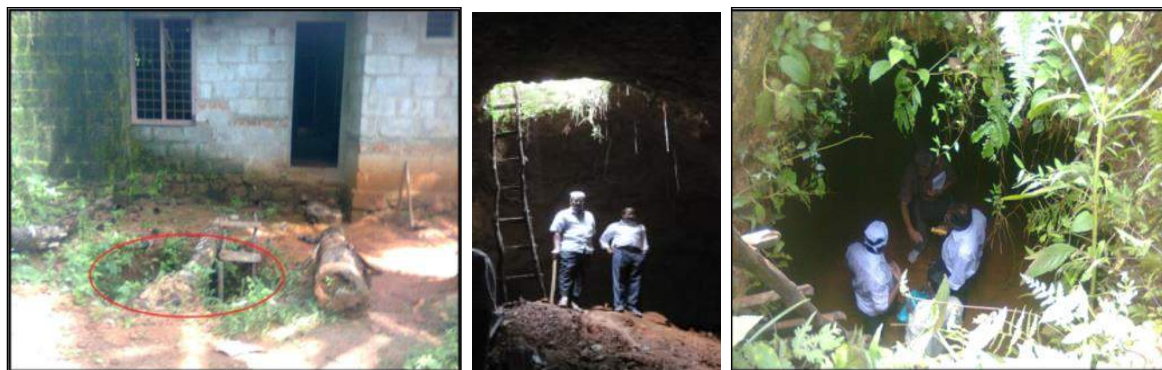
Soil piping associated with a well like subsidence (figures 7.16) near a residence was noticed on 6 April 2011 in the Kollamulla village of Pathanamthitta district. As the subsidence pit was located very near to the dwelling place the district administration has requested NCESS to inspect the land and suggest suitable interventions. The affected house is located in a +25° slope.

**Figure: 7.16** Subsidence occurred in Kollamula village, Pathanamthitta district

The house is constructed on a terraced platform cut out of the natural hill slope. The soil in general was reddish in colour and showed laterization at the bottom. The house itself is well constructed concrete structure. About 300 meters from this affected house, another soil piping incident was reported about 25 years ago. There were many such incidences were located in the nearby areas. The pipe identified was of typical in nature.

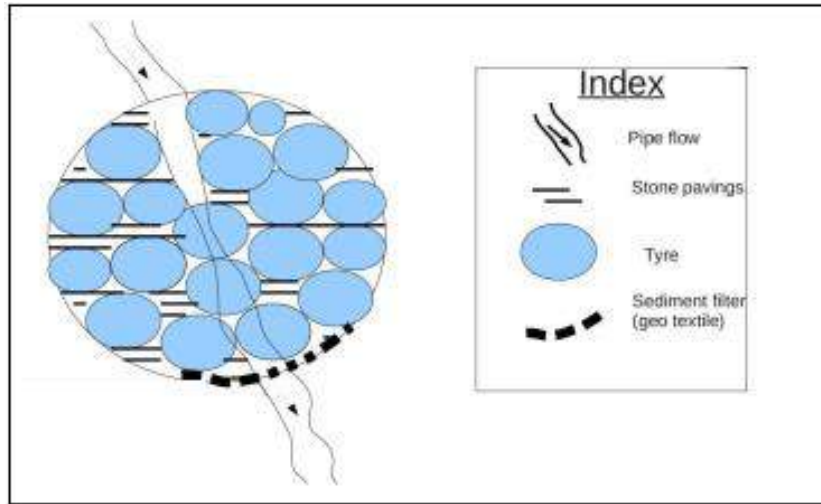
**Figure: 7.17** Design prepared for mitigation work at the collapsed site in Ranny

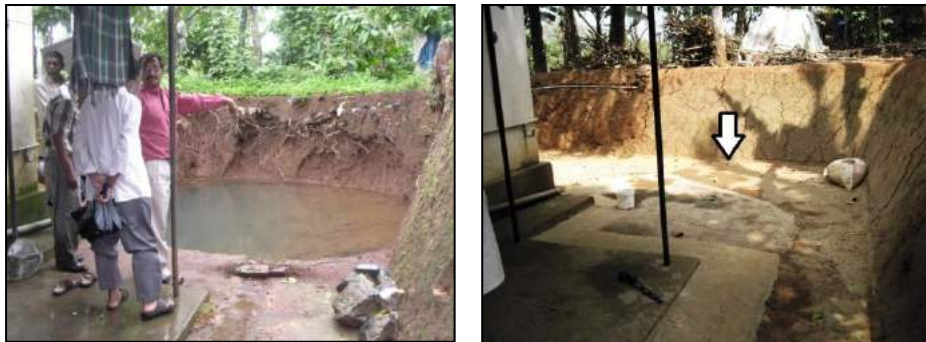
*a. Before filling subsided area 2006      b. After filling subsided area 2014*

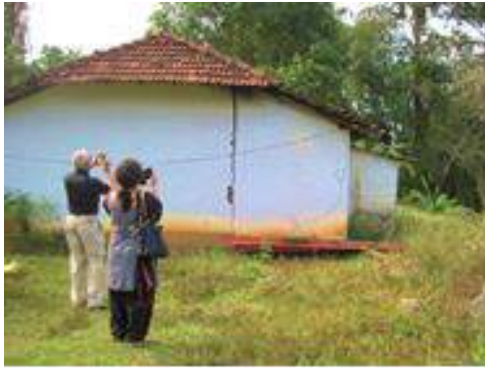
a. Cracks on the walls nearby house

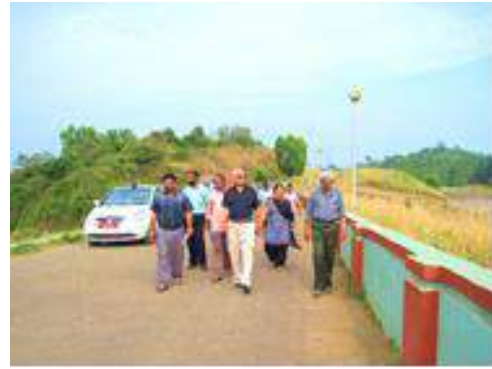
b. Near by Banasurasagar dam

**Figure: 7.20:** Detailed investigation of nearby Banasurasagar dam
