**Investigation of Kurissumoottil Granite Quarry in Survey  
Number 1/1 in Payyavoor Village, Thaliparamba Taluk, Kannur  
District**

Investigated on 25-04-2018

Investigation Series 2018  
30-4-2018

Kerala State Disaster Management Authority  
Department of Revenue and Disaster Management, Govt. of Kerala  
Observatory Hills, VikasBhavan  
Thiruvananthapuram 695033  
Tel/Fax: 0471-2331345. Email: [keralasdma@gmail.com](mailto:keralasdma@gmail.com)

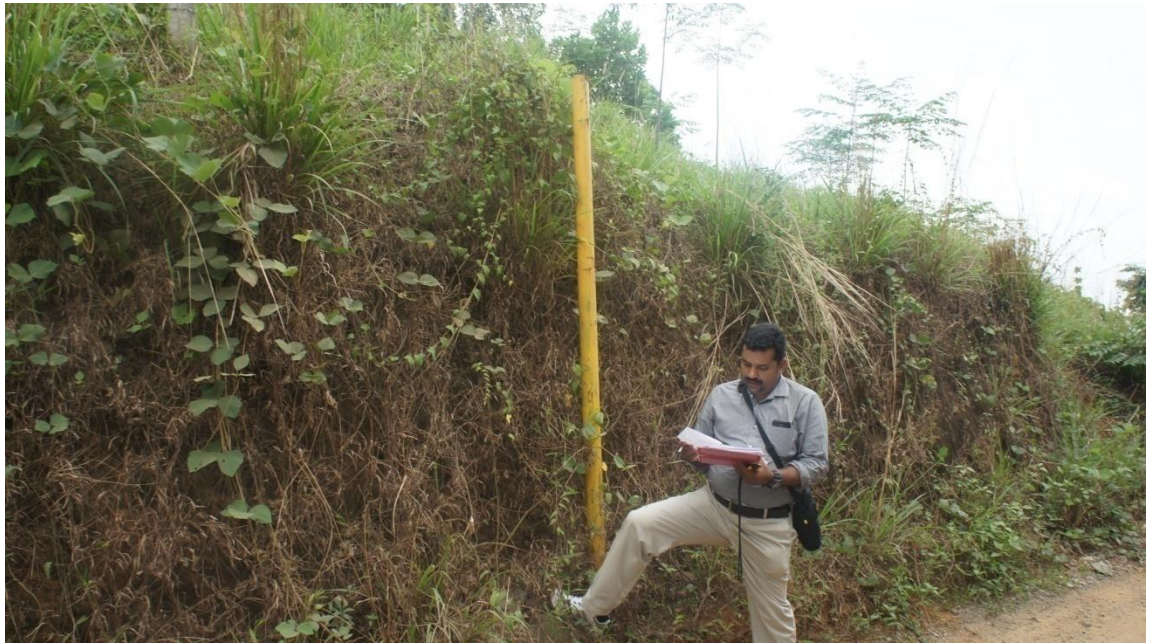
*Photo 1: GPS Survey along the iron rod*

The field inspection at the quarry was held on 25-04-2018 and the petitioner (owner of the quarry) was also present during the site visit. The quarry is located at latitude 12°5'17.4" N and longitude 75°37'18.5" E and presently it is working. The quarry boundary is defined by 10 iron rod (L1, L2, L6, L9 ,L11, L12, L15, L16 ,L21 and L23), which petitioner showed during the quarry survey. For better accuracy, we took 16 more GPS survey points along the 10 iron rods (as shown in photo 1 and 2) and details of same are given below:

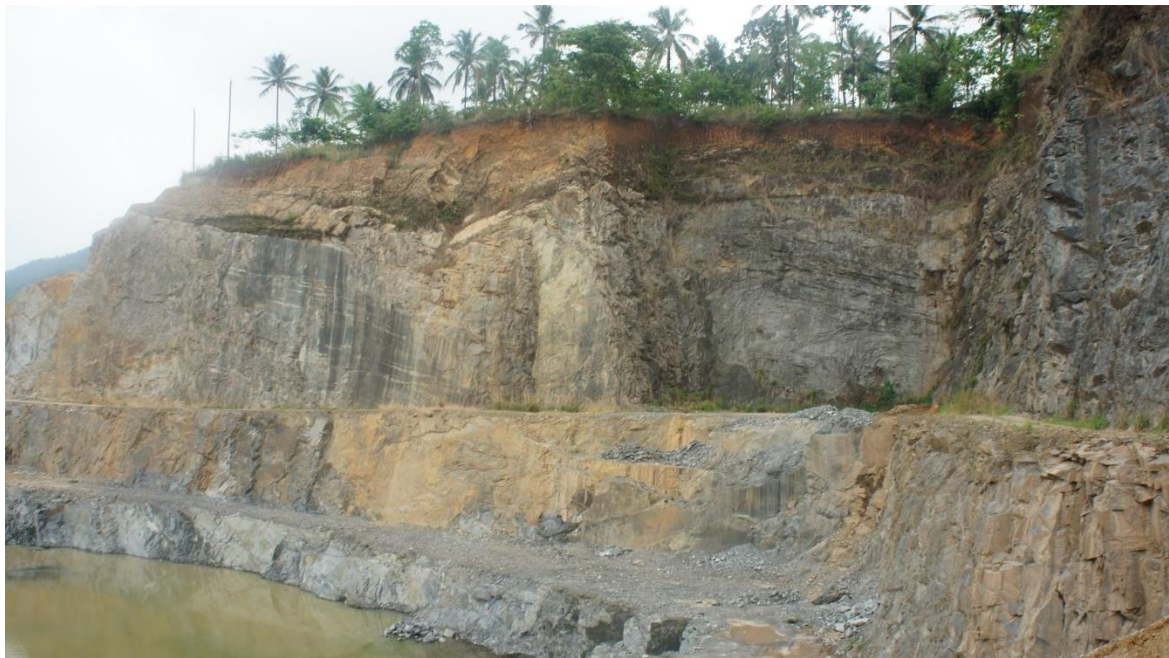
*Photo 3: Exposed overburden*

The general trend of the slope varies from  $30^{\circ}$  to  $33^{\circ}$  towards the south which is rather steep.. The thickness of overburden varies from 4 to 7 meters. The area in general is characterised by rugged topography. There is also a crushing unit at a height 480m from MSL on top right side of quarry.

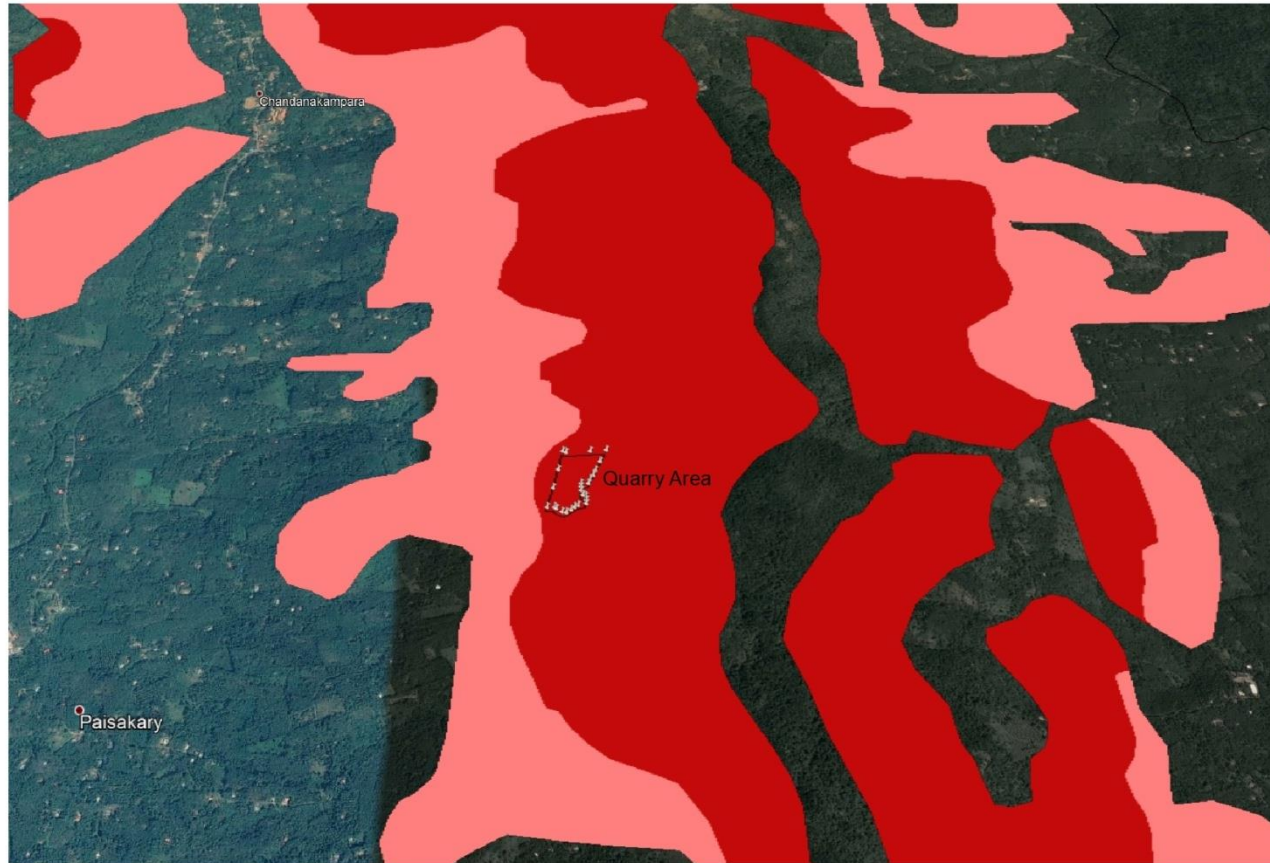
*Fig 4: Landslide Hazard Prone Areas overlaid on Google Earth.*

KURISSUMMOTTIL STONE QUARRY, SURVEY NO. 1/1, PAYYAVOOR VILLAGE  
Landslide Hazard Prone Areas Overlaid on Google Earth

- 26 GPS survey locations covering the quarry area of Kurissumootil quarry with survey 1/1 falls within High Hazard Zone (Red zone) as shown in Figure 2 & 3.
- Further these GPS survey points were plotted over google earth KML files (as shown in fig 4 ) available in the website of Kerala State Disaster Management Authority and it was obvious that the Kurissumootil quarry with survey 1/1 falls in High Hazard Zone (Red zone) same as fig 2 and 3.
- It was further verified with the Kerala State Disaster Management Plan (2015) and it concur with the above two statements.
