PROCEEDINGS OF THE SYMPOSIUM ON
**LANDSLIDES
IN KERALA 2018**
HELD AT MUNNAR ON FEB 23, 2019

PROCEEDINGS OF THE SYMPOSIUM ON
LANDSLIDES
IN KERALA 2018
HELD AT MUNNAR ON FEB 23, 2019

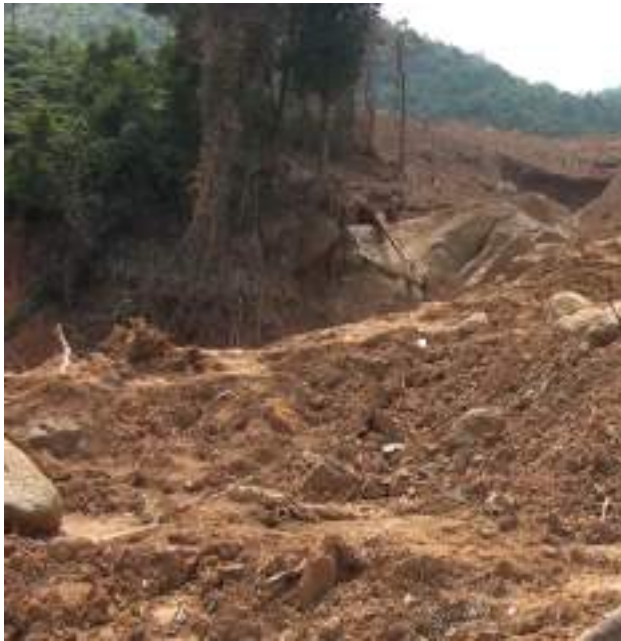
Landslide in Kurichyar Mala, Wayanad

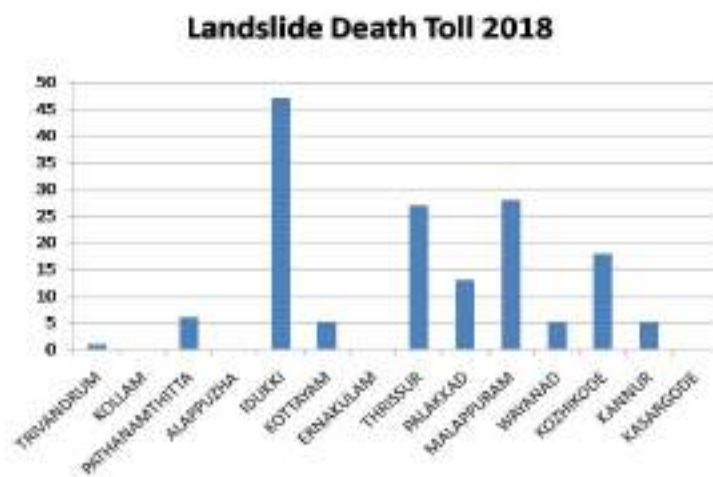
District	Number of deaths
Tvm	1
Kllm	0
Ptta	6
Allp	0
Idukki	47
Kttym	5
Erkm	0
Thrissur	27
Palakkd	13
Malappuram	28
Wayanad	5
Kozhikode	18
Kannur	5
Kasargode	0
TOTAL	155

Fig.1: Death toll: district-wise, from 1/06/2018 to 31/08/2018 (source: KSDMA)

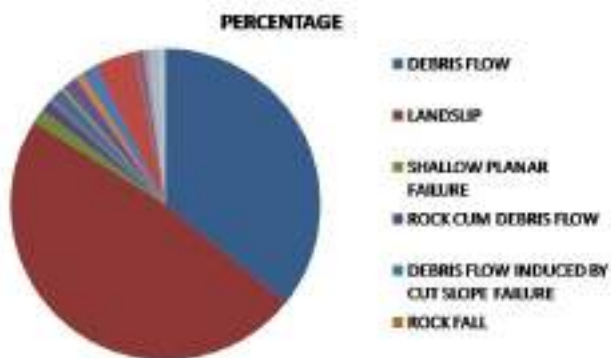
NUMBER
DEBRIS FLOW	516
LANDSLIP	683
SHALLOW PLANAR FAILURE	22
ROCK CUM DEBRIS FLOW	15
DEBRIS FLOW INDUCED BY CUT SLOPE FAILURE	3
ROCK FALL	3
ROCK CUM DEBRIS	17
STREAM BANK EROSION	1
STREAM BANK FAILURE	6
SUBSIDENCE	20
DEBRIS SLUMP	1
EARTH SLIDE	10
DEBRIS SUBSIDENCE	22
SOIL SLIDE	62
DEBRIS CUM SOIL FLOW	1
ROCK CUM DEBRIS SLIDE	12
RIVER CUT OR BANK FAILURE	1
SOIL FLOW	1
ROCK SLIDE	1
EARTH FLOW	4
EARTH SUBSIDENCE	3
CHANNEL EROSION	1
EARTH CREEP	2
ROCK CUM DEBRIS TOPPLE	1
CRACKS	9
SOIL SUBSIDE	1
SOIL PIPING	1
DEBRIS FLOW(MULTIPLE)	2
SOIL SUBSIDENCE	6
BANK EROSION	1
SLUMP	1

Fig.2. Types of mass wasting in Kerala 2018

The movement of a mass of rock, earth or debris down a slope is scientifically called a mass wasting. Landslide is one of the types of mass wasting observed in nature. Debris flow, landslips, rock fall, slab slide, soil piping, land subsidence etc. are some other types that happened in the state. In Kerala, the most commonly observed types of mass wasting are debris flow (*Urul pottal*) and landslips (*Mannidichil*). We use the term landslide as a generic term hereafter. The various types of mass wasting that happened in Kerala in 2018 are shown in fig.2.

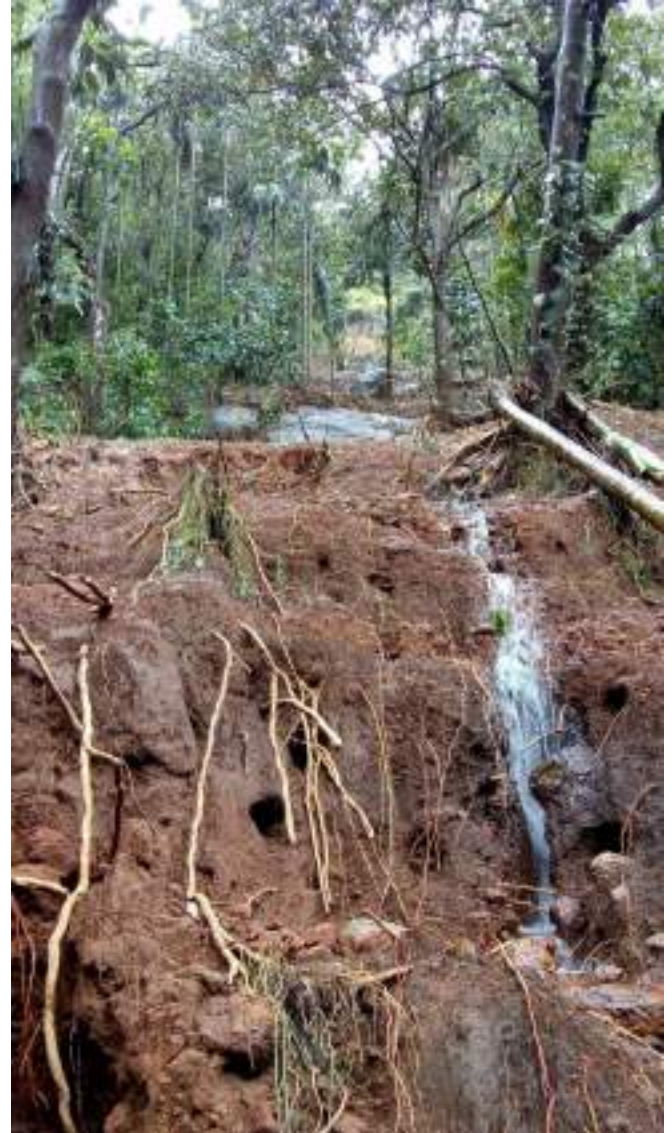
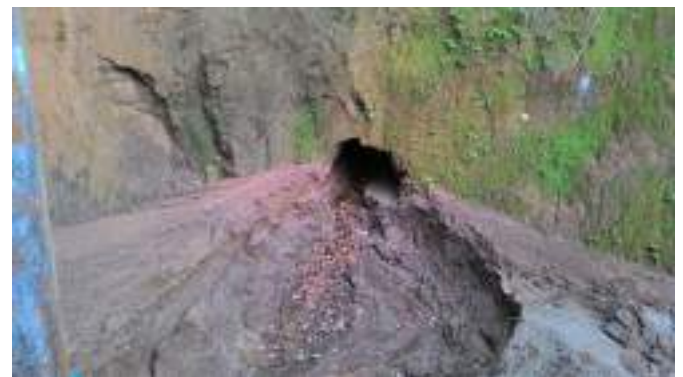
Fig.3. Soil piping in Muttill Mala, Wayanad

The phenomena of Soil Piping plays an important role in inducing landslides. The surface material seen in the hilly parts of Kerala are unconsolidated and unsorted. The underground flow removes the clay content and causes the formation of tunnels which gets interconnected in due course of time. These interconnected tunnels act as path for water discharge and soil erosion, called piping. Such pipe-like parts may lead to the occurrence of landslides. Hence the phenomenon of soil piping is an indicator of landslide risk (Fig.3). This scenario is existing in many places; for instance, in Ettamkallu of Thrissur District.

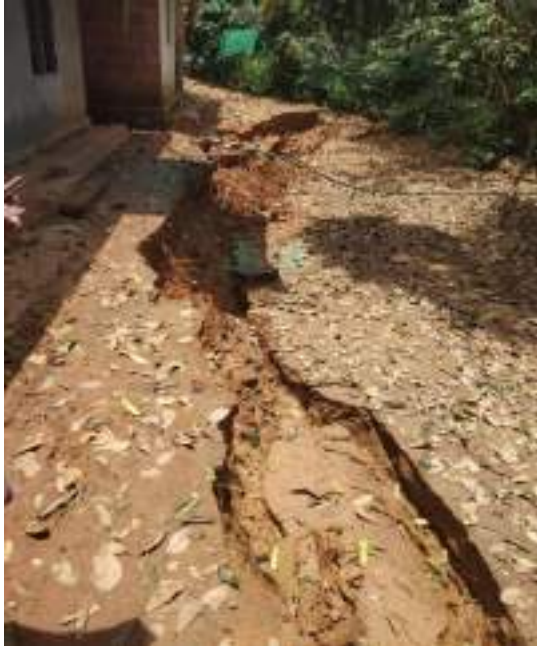
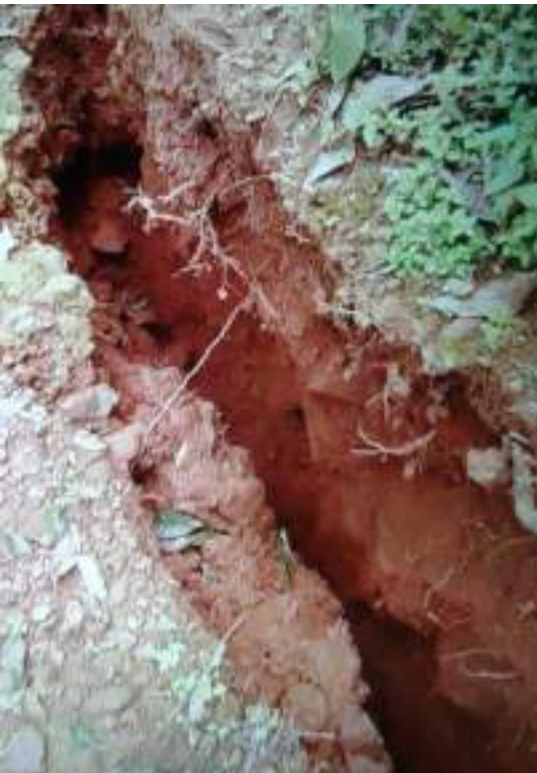
Fig.4. Slab slide occurred in Wayanad district (2018)

Slab slide (*Bhumi pilaral*) is the formation of crack on the surface of the earth.

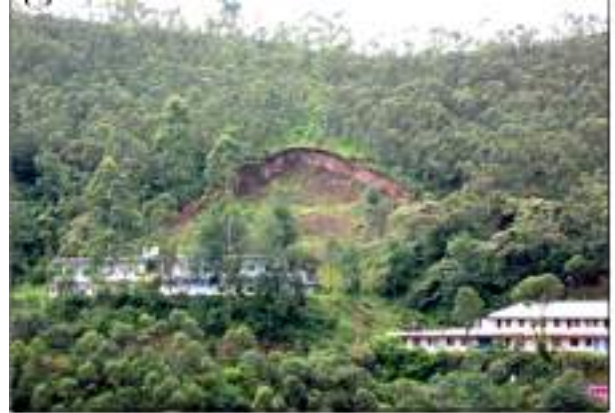
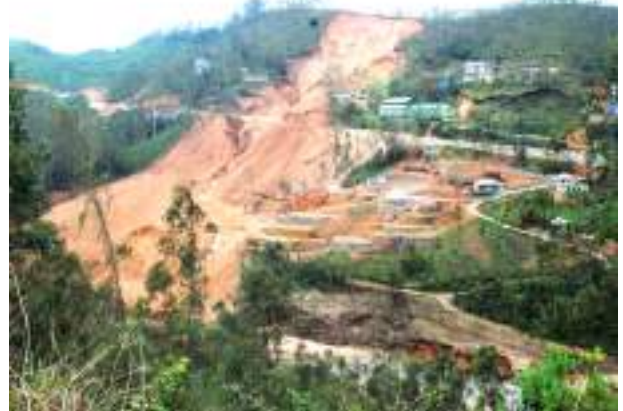
Fig.5. Landslide at Munnar Arts college in 2005 and 2018

A landslide had occurred behind the Government College, Munnar on 25th July 2005. A portion of the college building was destroyed. Being a holiday, no casualties happened in the campus.

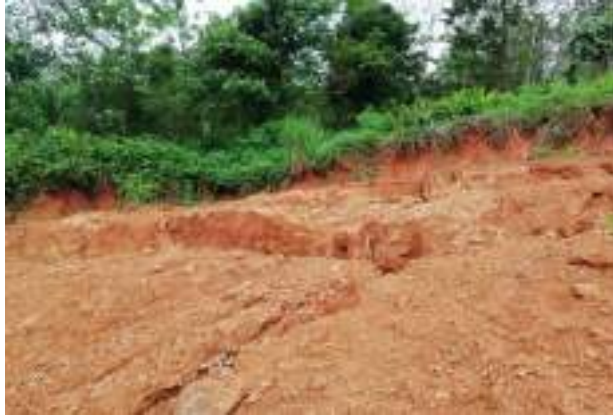
Fig.6. Young landslide (2018)

Young landslides : Recently in many places a series of small step like subsidence (a vertical offset of say 15 cm) is found to appear in sloppy terrain during rain. Also many places witnessed the phenomenon of criss-cross cracking of the ground. They were 3 to 4 m deep cracks running for 30 to 40 m length with width less than 1 m. These cracks and offsets were found to appear in different parts of a big slope, and in later years the whole mass is washed out (Fig.6). This phenomenon observed in many places over the years was described as 'young landslides' by Dr. S. Chandrakaran.

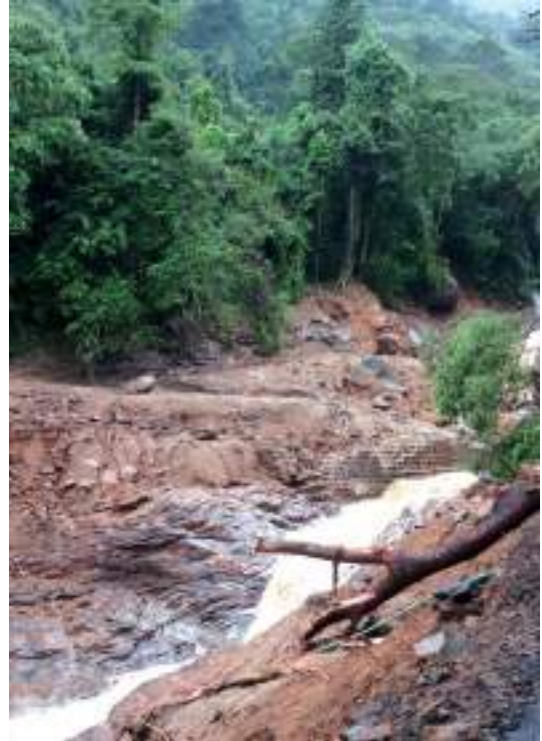
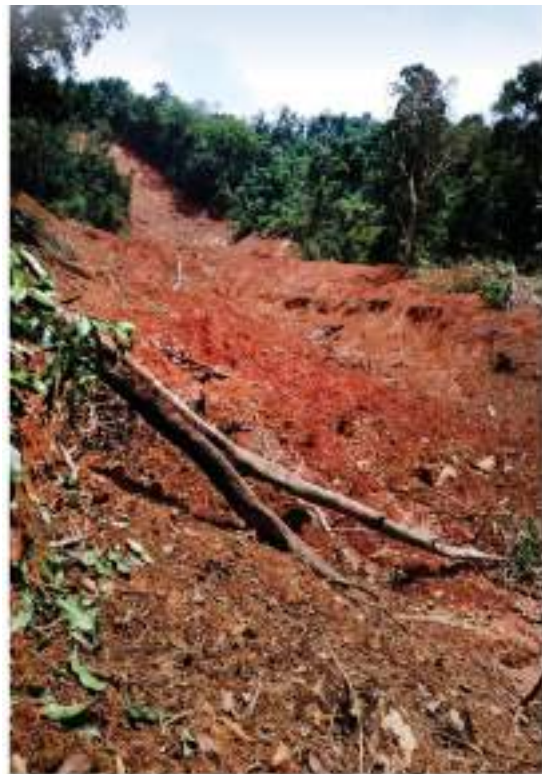
Fig.7. Landslide in Kottiyoor forest area

Being part of Western Ghats about 296 forest places out of 119 ranges were affected by landslides and flood of 2018. It destroyed roads, bridges, office buildings, suspension bridges, protective walls, farms, Govt. vehicles, camera traps, solar fences, timber depot, teak plantations and caused the death of 8 elephants, 2 tigers and many other animals and reptiles.

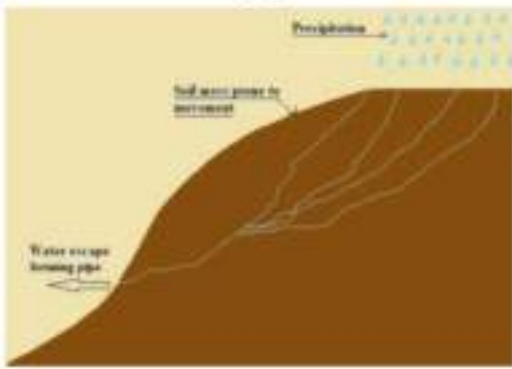
Fig. 1. General mechanism of landslide.

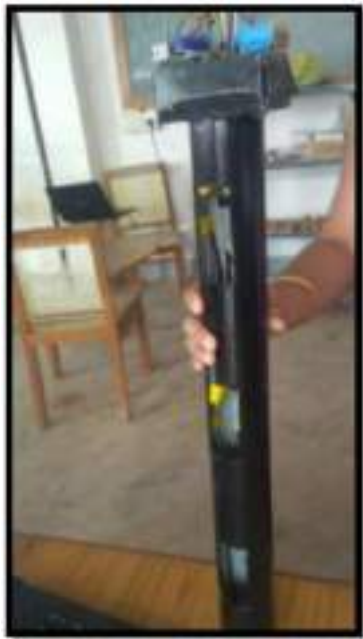
Fig. 6.Sensor pillar modal.

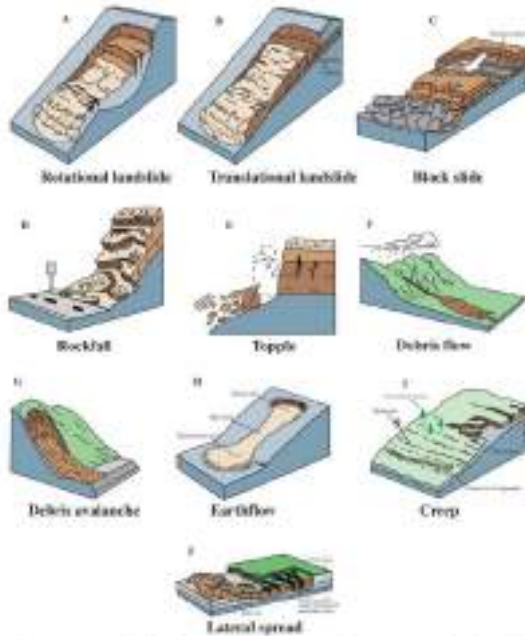
Fig 1. Schematic Illustration of the major types of Landslide Movements, [1]

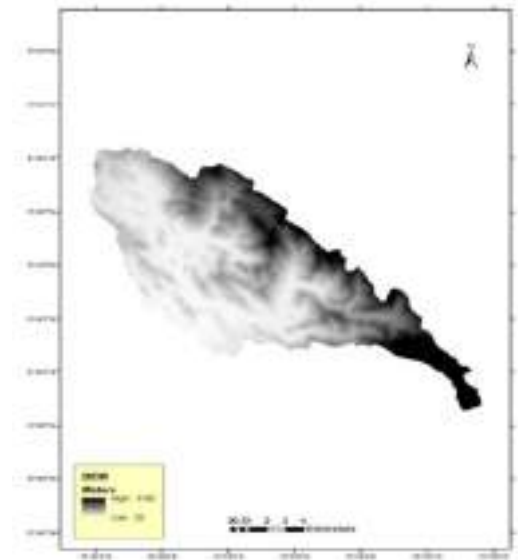
The Digital Elevation Model of the study area which shows the variation in elevation levels is modelled using GIS technology (Fig 5).

Fig.5. Digital Elevation model of study area

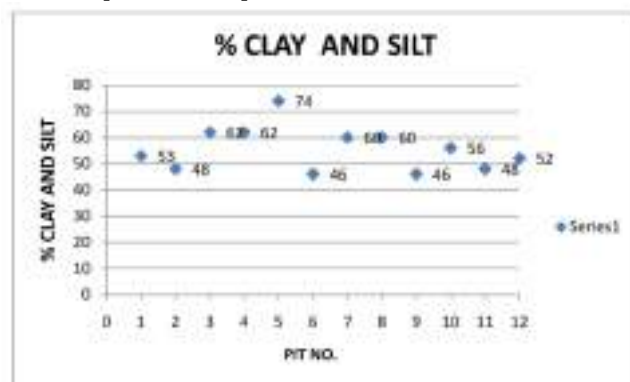
Fig 6. % clay + Silt for each sites

Test data proves the fine nature of the soil with a maximum of even 74% of silt + clay. So there is every chance of occurrence of Liquefaction also to cause Landslide.

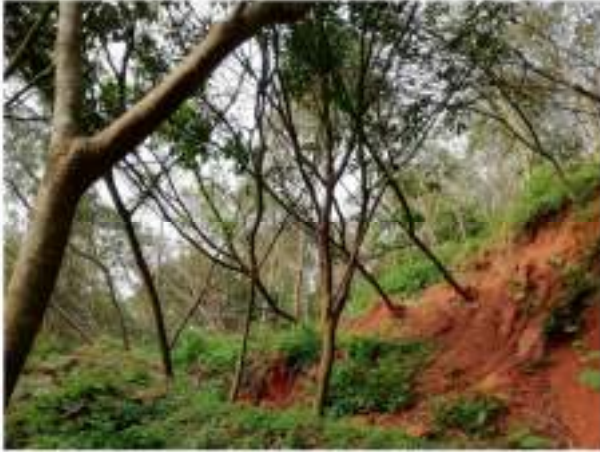
Another factor is the clearing of the slope for cultivation of cash crops like rubber. This large scale cutting itself instabilises the slope. Roots of later grown trees are not as deep as naturally growing trees of the slope many times. Many short rooted plants grown are leading to the socking of the upper layer of soil since water will find its way through the vicinity of the roots. Another aspect is the terracing of the land. It hampered the smooth flow of drains, which is way to discharge rainwater and thus preventing stagnation and infiltration. These lead to soaking of the soil and make soil slope saturated and pore pressure built up.

Fig.7 Rubber plantation of Vattapara

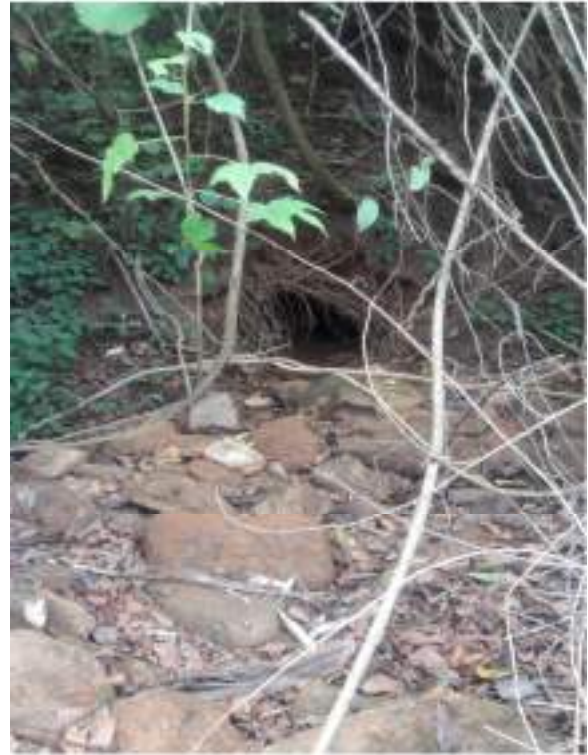
Subsurface flow through soil pipes can also instabilize a slope. It leads to the continuous internal erosion. Finer soil like clay and silt are prone to erosion and it is left unnoticed from the surface. Electrical resistivity methods are used to study on the presence, length and distribution of this conduits. They are one of the major reasons of the slope failures.

Fig.9 Piping formed at Puthenkadu
