**Government of India  
Central Water Commission  
Hydrological Studies Organisation  
Hydrology (S) Directorate**

**STUDY REPORT  
KERALA FLOODS OF AUGUST 2018**

**September, 2018**

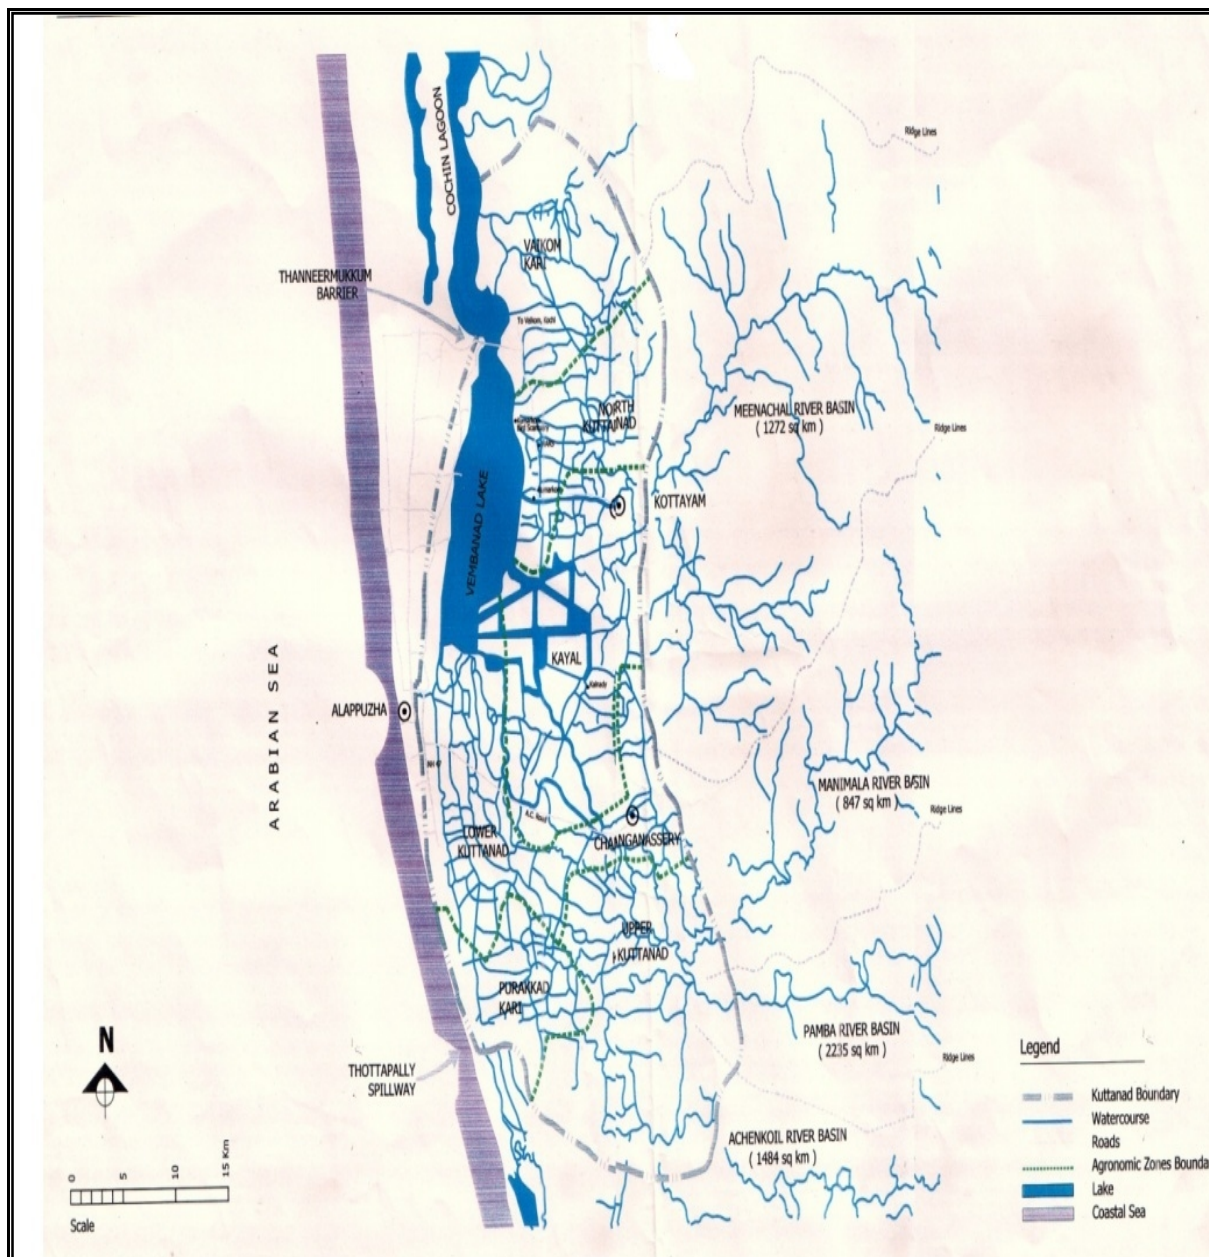
**Fig.10: Index map of Vembanad Lake**

Four major west flowing rivers namely Achenkovil, Pamba, Manimala and Meenachil drain directly into the southern part of Vembanad Lake while a southern branch of Periyar (further north of Muvattupuzha) drains into Cochin Kayal and finally into the Arabian sea through Kochi outlet. The Vembanad Lake is bordered by Alappuzha (Alleppey), Kottayam and Ernakulam districts of Kerala covering an area of about 200 sq km and extending 80 km in a NW-SE direction from Munambam in the north to Alleppey in the south. The width of the lake varies from 500 m to 4 km and the depth from 1m to 12m. An index map of Vembanad lake is given in Fig.10.
