# GEOTECHNICAL IMPACTS OF AUGUST 2018 FLOODS OF KERALA, INDIA

Event: August 2018

**Geotechnical Extreme Events Reconnaissance**  
*Turning Disaster into Knowledge*  
**Sponsored by the National Science Foundation**  
**GEER Association Report NO - 058**

**Date: 10-17-2018**

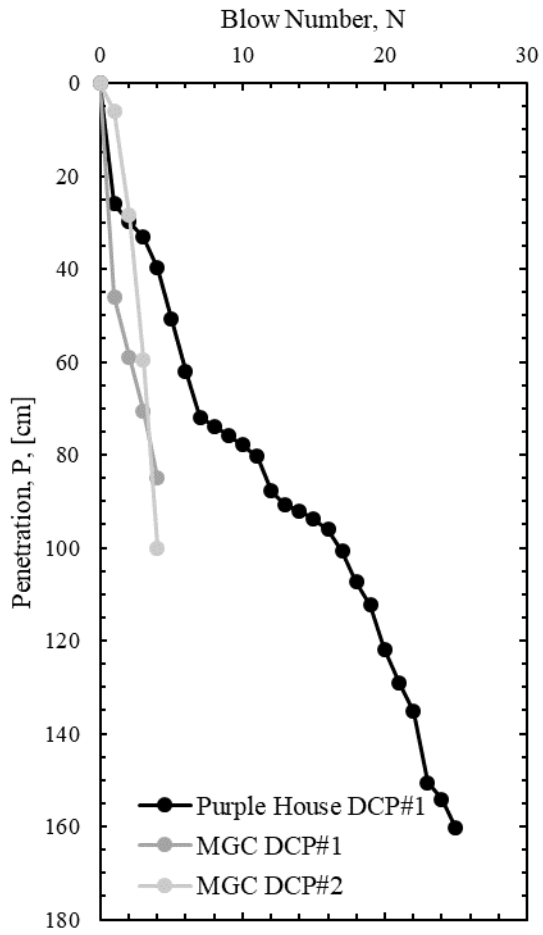
Dynamic cone penetration tests were performed and electromagnetic spectrum (350-2500nm) were collected at the Munnar Government College Landslide site. The data were collected within a small portion of the slide next to the partially collapsed building. The results from dynamic cone penetration soundings are reported in Figure 2.5 and the spectrum are presented in Figure 2.6. The path that was followed during data collection is presented in Figure 2.7. A crust was observed over the mass wasted soil within the landslide mass. This crust enabled the GEER team to collect data on top of the mass wasted soil, however, caution was taken because the soil underneath the crust was classified as being very soft. One of the Indian counterparts

*Figure 2.5: Dynamic cone penetration soundings at the Munnar Government College site. Weakest sounding from Alleppey Purple House is shown for comparison.*

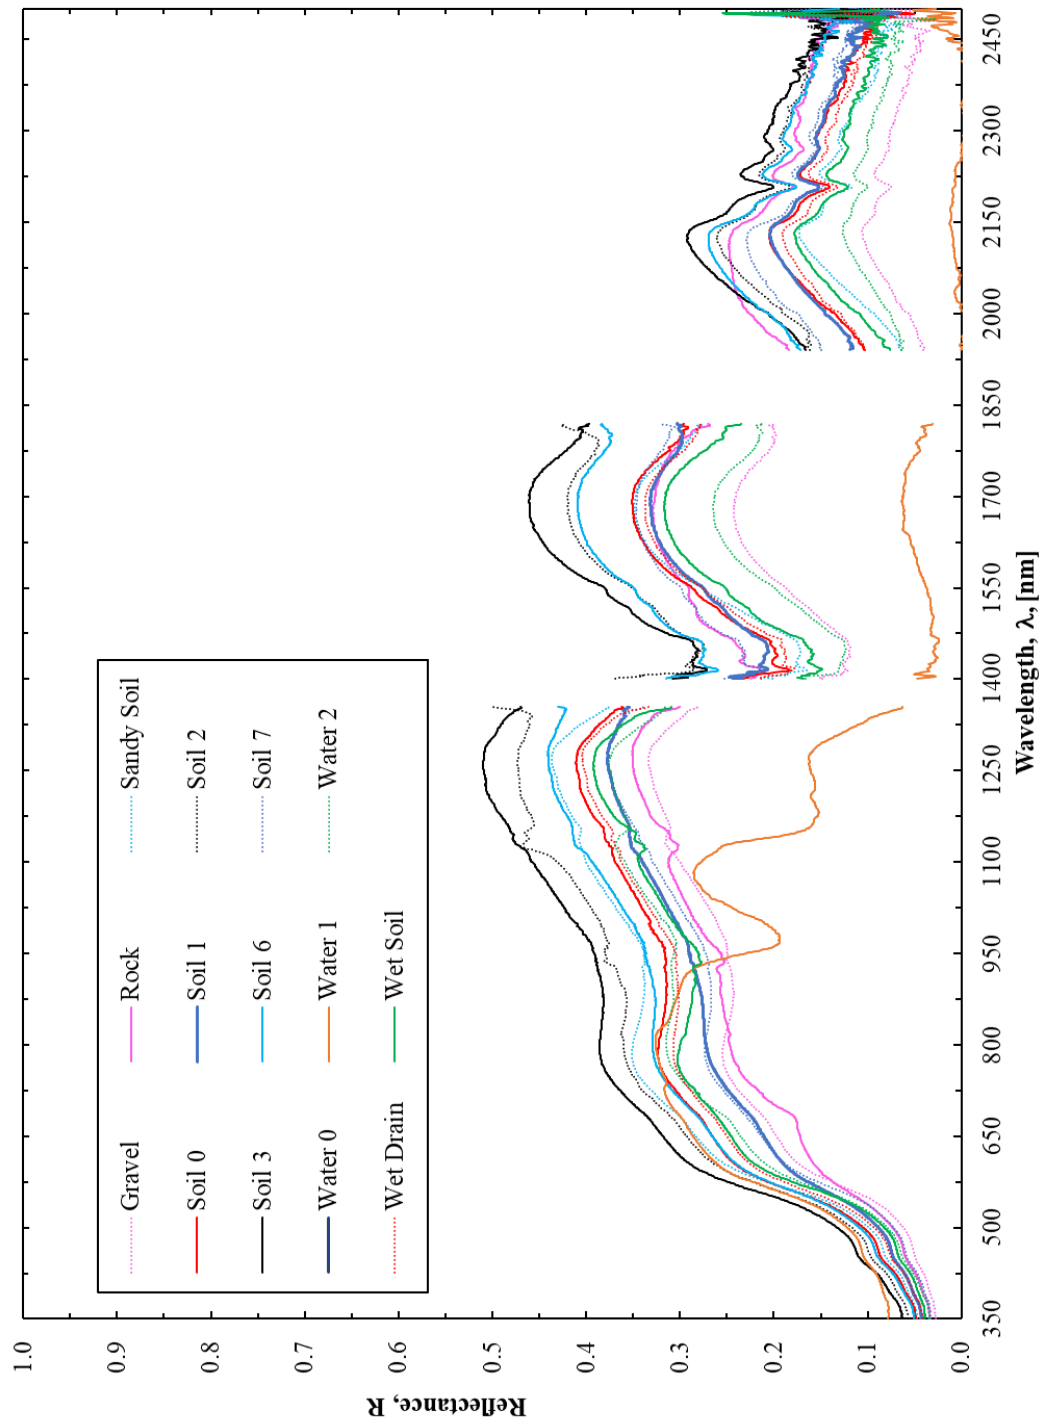
**Figure 2.6:** Electromagnetic spectrum collected at the Munar Government College Landslide site. Approximate positions of data collection presented in Figure 2.7.

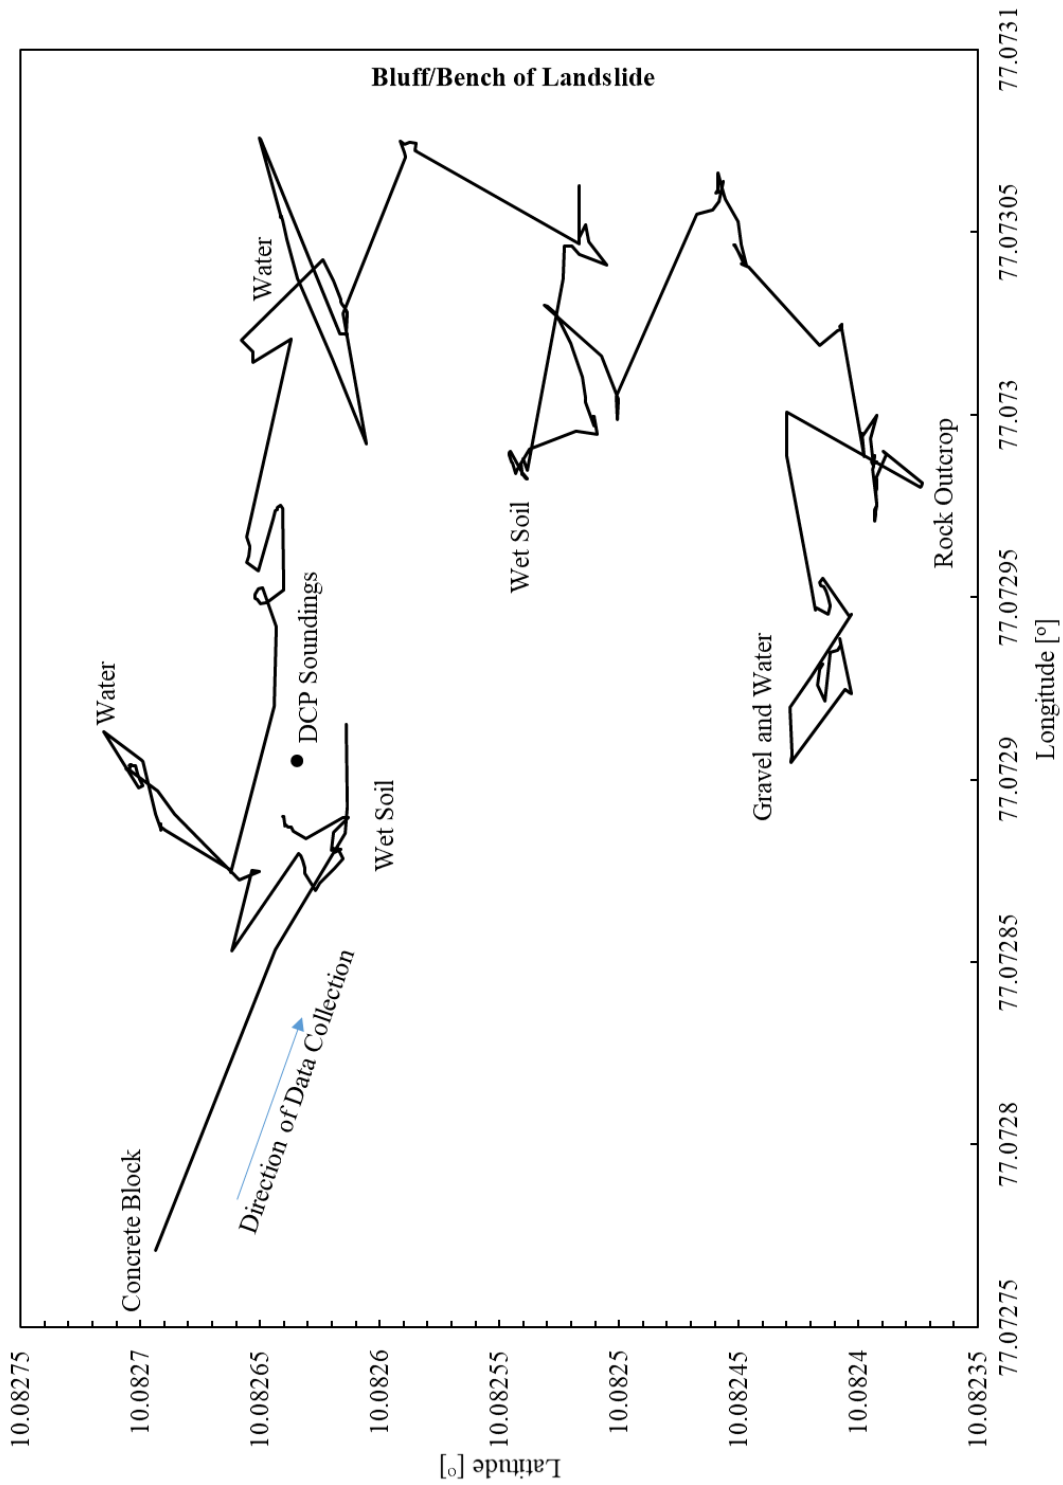
Figure 2.7: Data collection path for collection of the electromagnetic spectrum and DCP data.

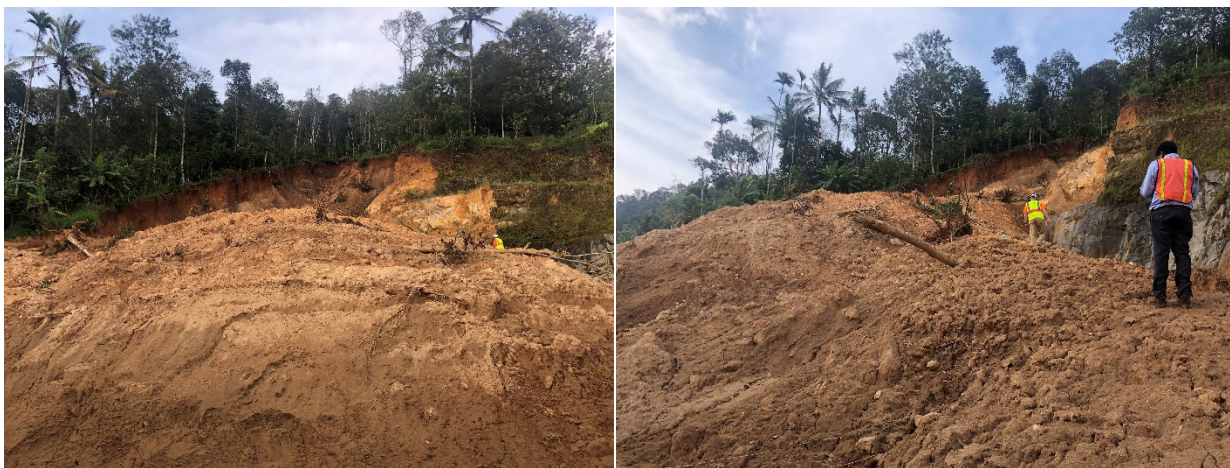
The Kattappana Landslide was encountered while in transit from the Idukki Landslide (Latitude=9.79655°, Longitude=77.0685°) to the collapsed house in Mavady (Latitude=9.8747°, Longitude=77.1194°). Time was limited on this site because the GEER team and Indian-counterparts were expected to meet a news crew at the location of the collapsed house prior to sunset. The team was on site at this location for approximately 10 minutes from 4:40-4:50pm on the afternoon of September 6, 2018 (Figure 2.9). While onsite Dr. Coffman took several photographs from different vantage points. These photographs were used to develop a three-dimensional reconstruction of the landslide (Figure 2.10). It would have been nice to spend more time at this landslide because the landslide 1) occurred at a location of terracing, 2) appears to be the result of undercutting of the toe of the landslide and 3) failed along a predetermined failure plane that starts at the soil/rock interface that is shown in the photographs in Figure 2.9. As documented in a Twitter post shown in Figure 2.11 (ANI, 2018), the Kattappana Landslide blocked the Thodupuzha-Puliyamanmala roadway (also referred to as Highway 33 or National Highway 185) preventing traffic from Kumily to Idukki.

***Figure 2.9:*** Photographs of the Kattappana Landslide located at (notice Dr. Coffman within the slide extents preparing to take photographs, Latitude=9.79655°, Longitude=77.0685°).

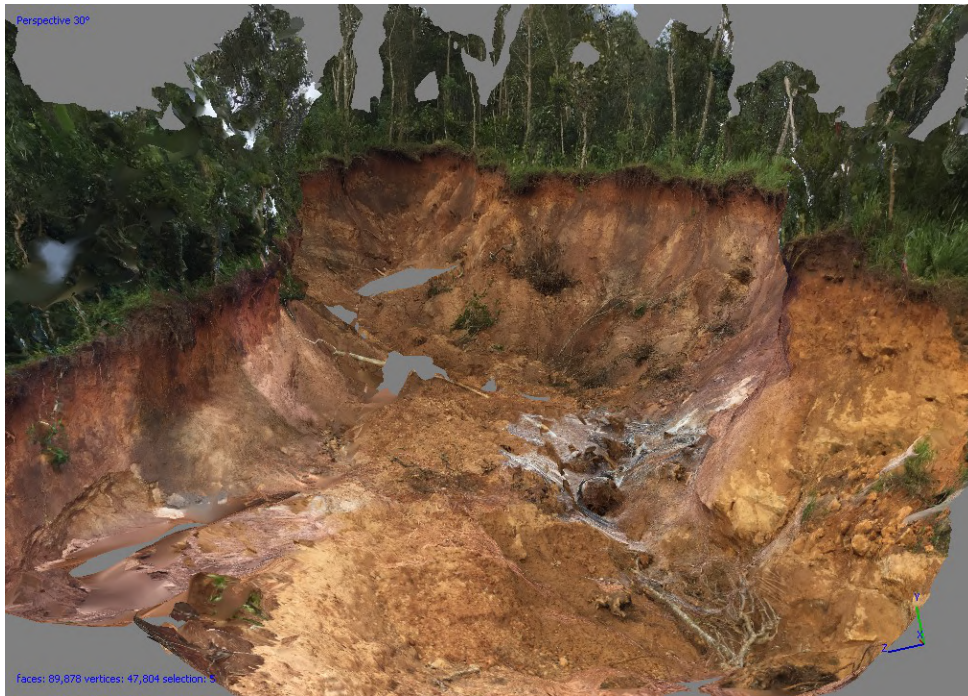
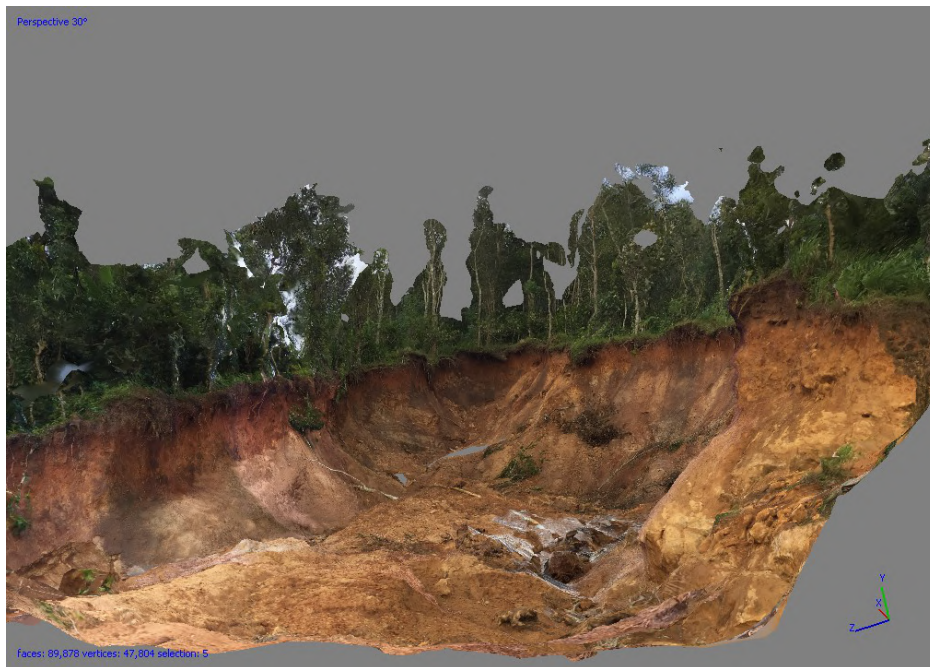
**Figure 2.10:** Three-dimensional reconstruction of Kattappana Landslide by means of Photoscan. (a) left side right side isometric projection, (b) right side isometric projection (Latitude=9.79655°, Longitude=77.0685°).

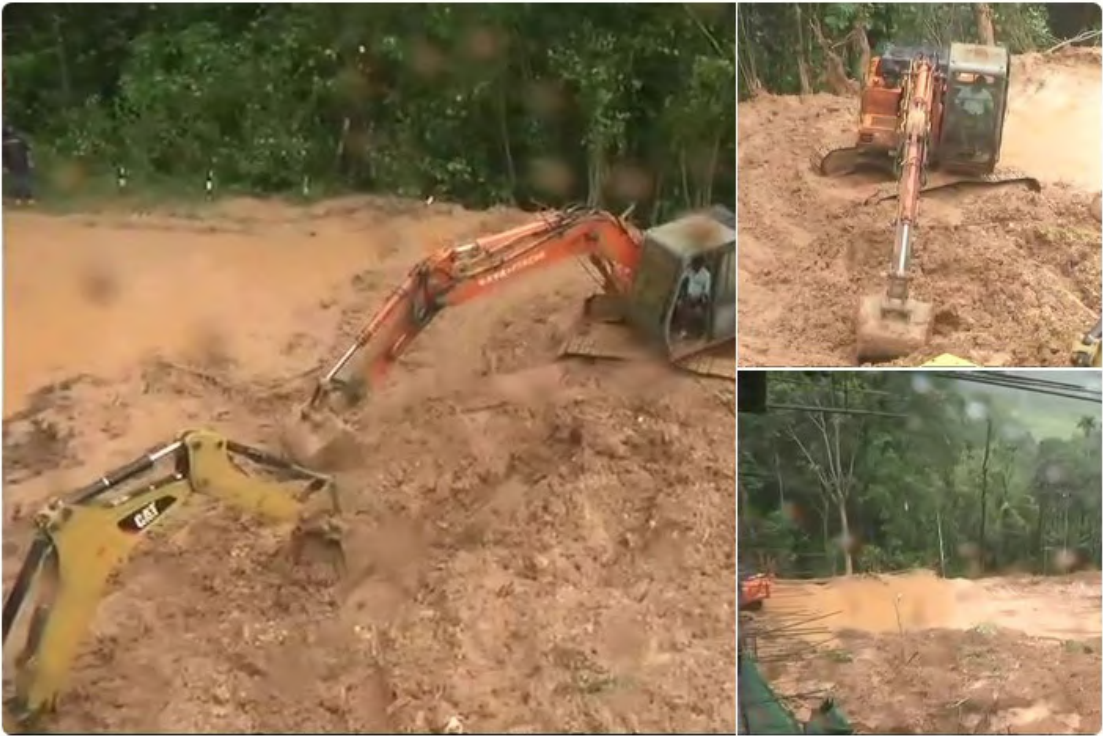
Kattappana: State highway to #Idukki city from Kumily is blocked due to landslide, clearance operation underway. #KeralaFloods

*Figure 2.11: Roadway clearing operations at the Kattappana Landslide. The horizontal rebar in the bottom right photograph are also present in many of the photographs taken by the GEER team. Source: Twitter.*

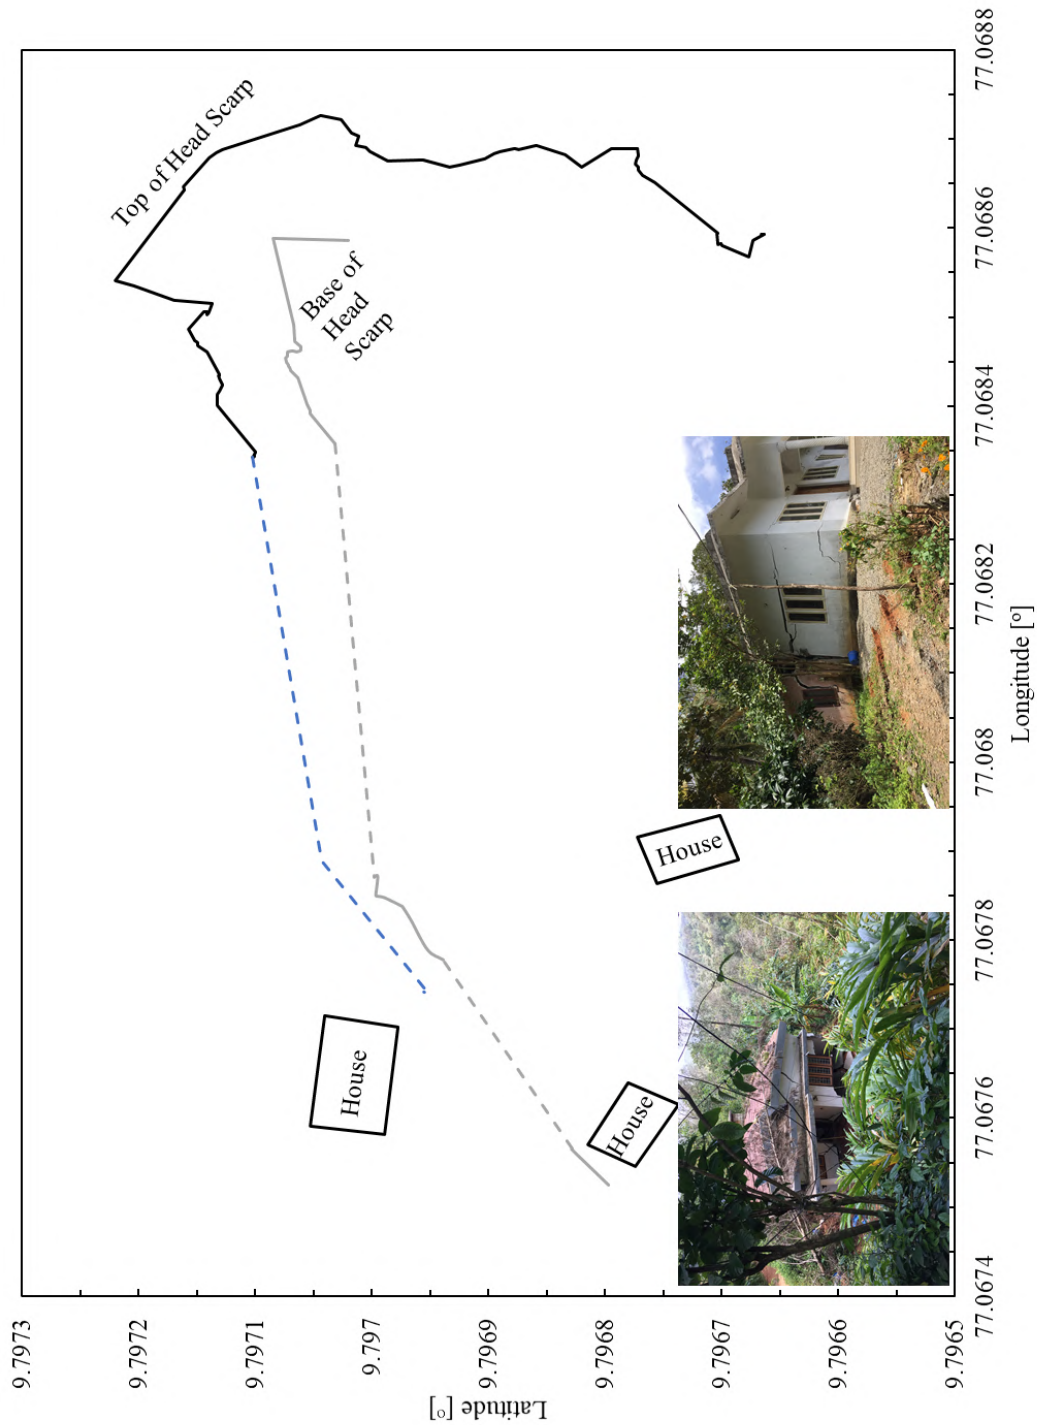
**5. Mapping of landslide and structural damage in Idukki:** On the afternoon of September 6, 2018, the GEER team and Indian counterparts traveled to landslides located in the Idukki district. The most prominent landslide was mapped by means of global positioning measurements (Figures 2.12 and 2.13) and documented by means of photographs (Figure 2.14). Like with the structural reconstruction of the purple house that is mentioned in the Alleppey section, one of the houses

**Figure 2.12:** GPS coordinates (latitude and longitude) of the top and toe of the headscarp of the largest Idukki landslide that was investigated. Locations and photographs of houses within the landslide included for completeness. Dashed lines represent interpolated landslide extents.

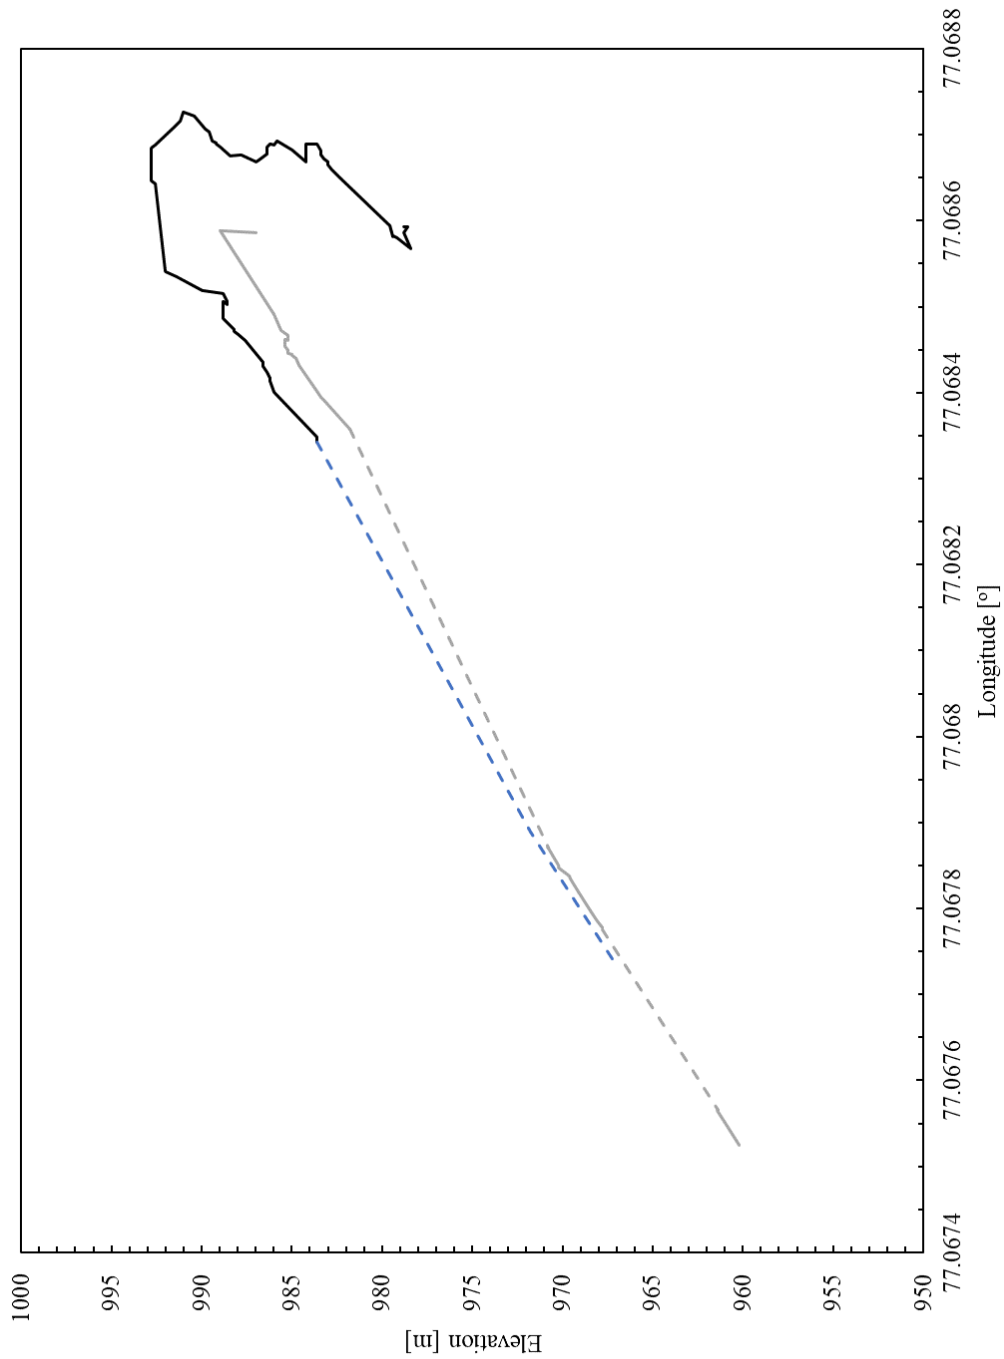
**Figure 2.13:** GPS coordinates (elevation and longitude) of the top and toe of the headscarp of the largest Idukki landslide that was investigated. Dashed lines represent interpolated landslide extents.

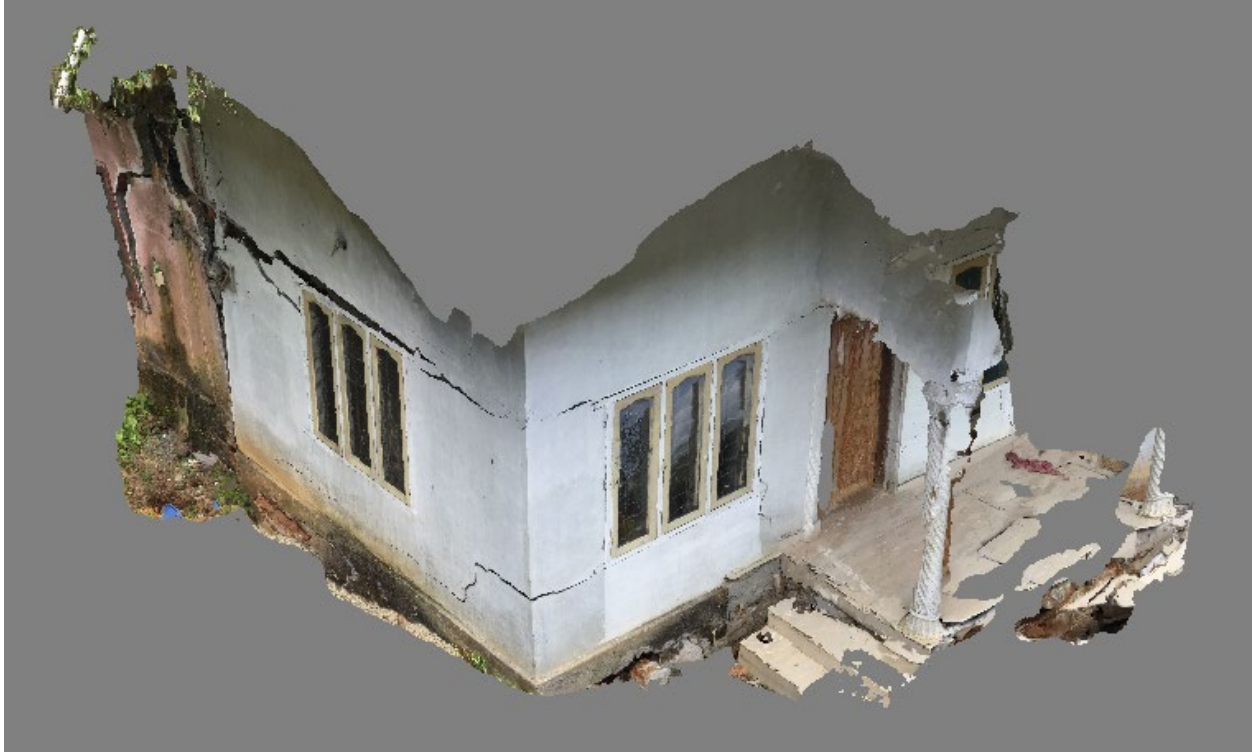
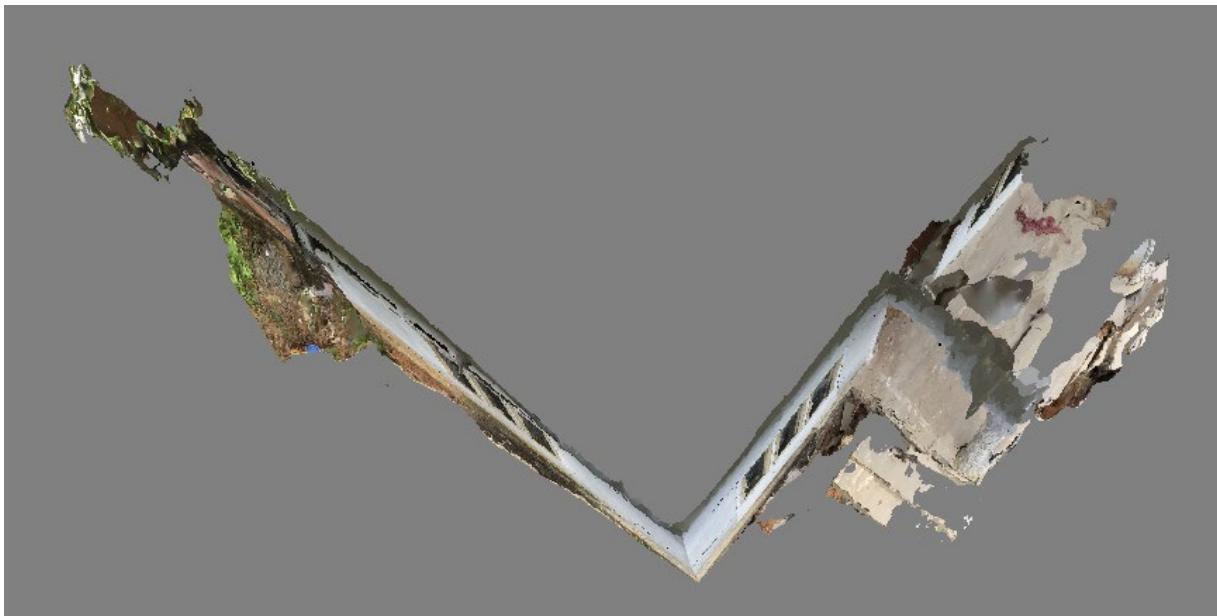
located within the large landslide was also reconstructed using PhotoScan (Figures 2.15, 2.16, 2.17, & 2.18). This house was selected because of 1) the extensive damage to the structure and 2) for the possibility of doing forensic damage investigations by means of the cracking pattern. As shown in Figure 2.14, it appears that the structure was built in multiple stages and most of the damage occurred at the connection between the original structure and the addition to the original structure. The addition/original structure damage pattern did not appear to start or progress from a location of head scarp movement or block-wedge movement. Therefore, it is believed that the damage location was a function of different modulus and rigidity values for the different portions of the structure.

**Figure 2.16:** Three-dimensional reconstruction of one of the houses within the Idukki Landslide by means of Photoscan. (a) Front left isometric projection, (b) top left isometric projection (9.7962622°N; 77.0681814°E).

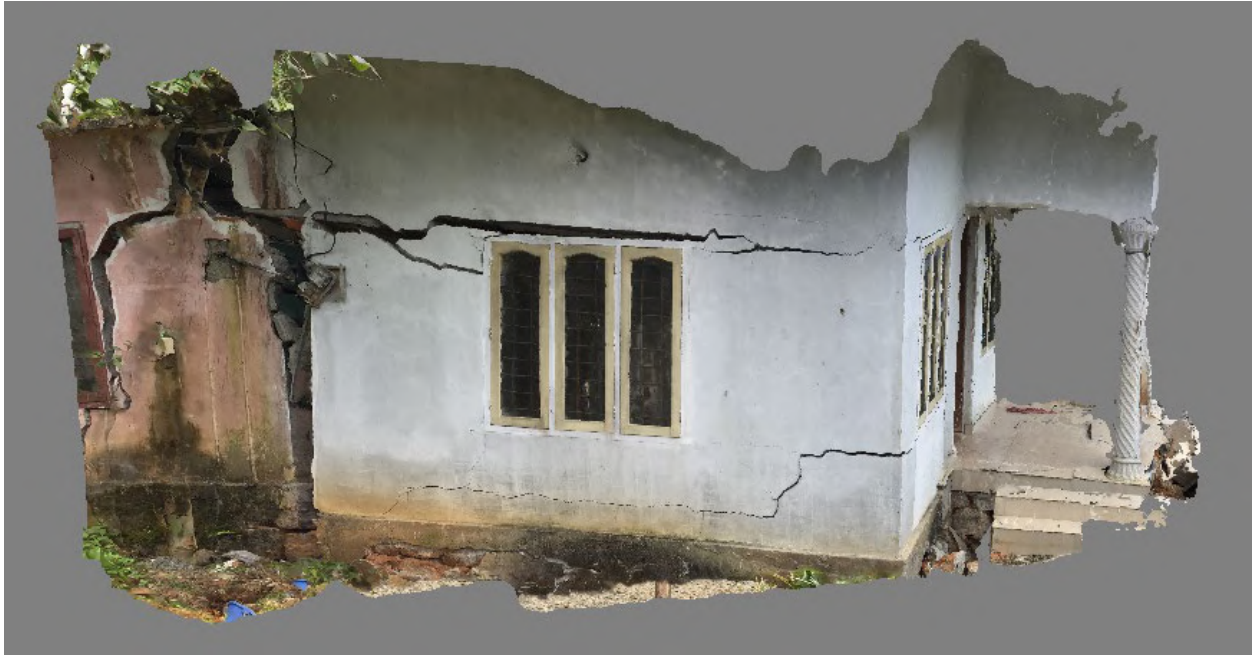
**Figure 2.17:** Left side isometric projection of the three-dimensional reconstruction of one of the houses within the Idukki Landslide by means of Photoscan (9.7962622°N; 77.0681814°E).

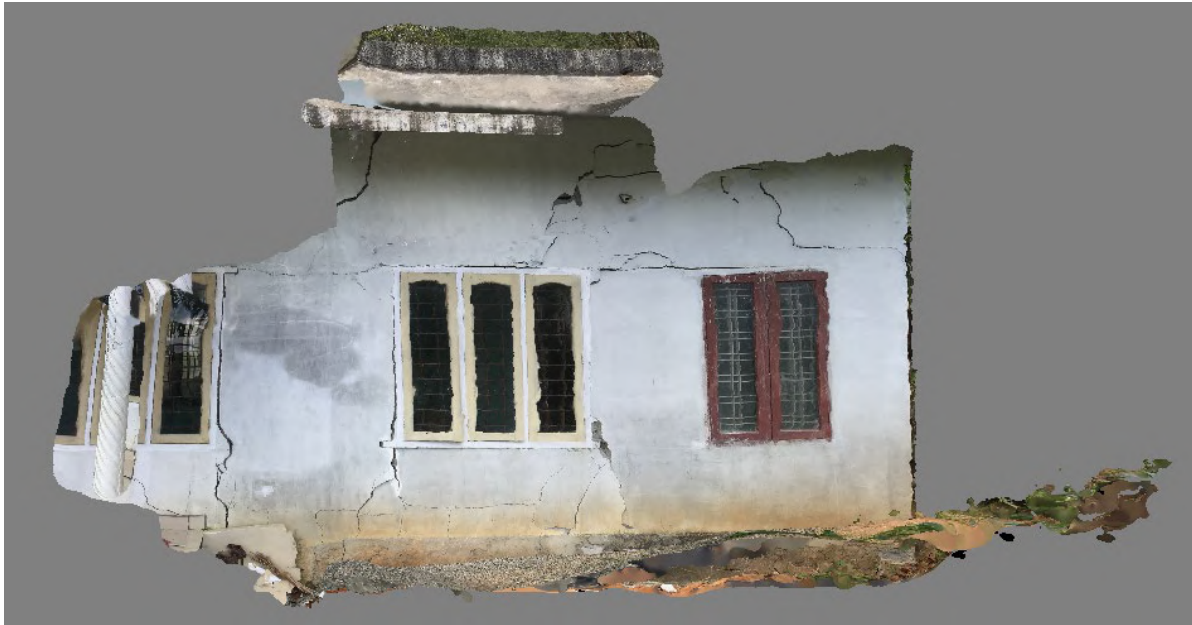
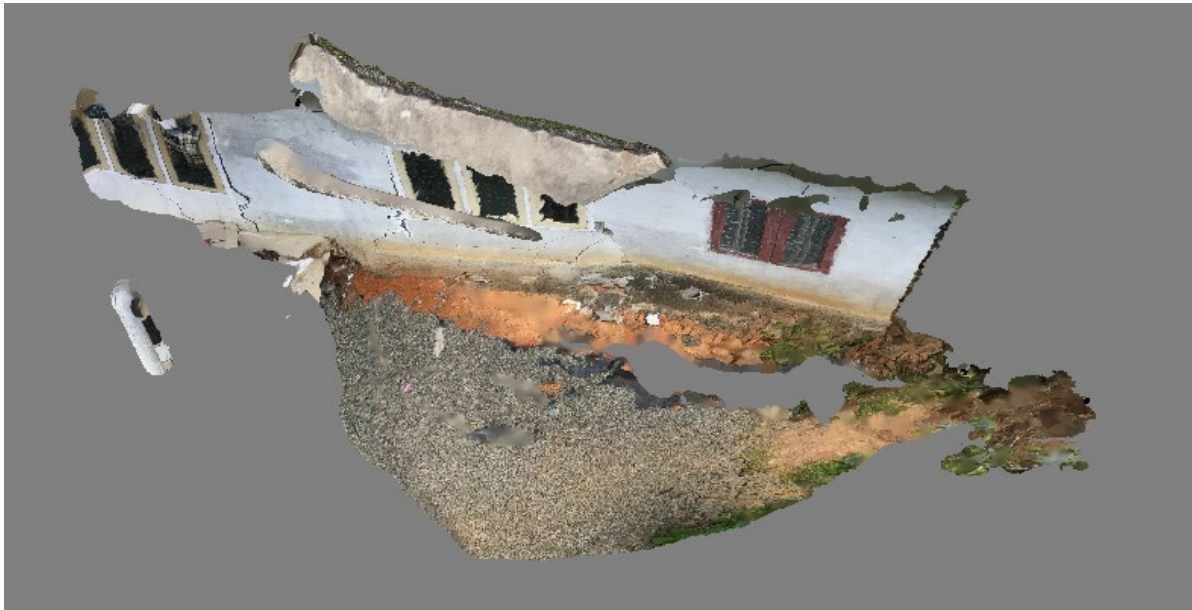
**Figure 2.18:** Three-dimensional reconstruction of one of the houses within the Idukki Landslide by means of Photoscan. (a) Front right side isometric projection, (b) top right side isometric projection (9.7962622°N; 77.0681814°E).

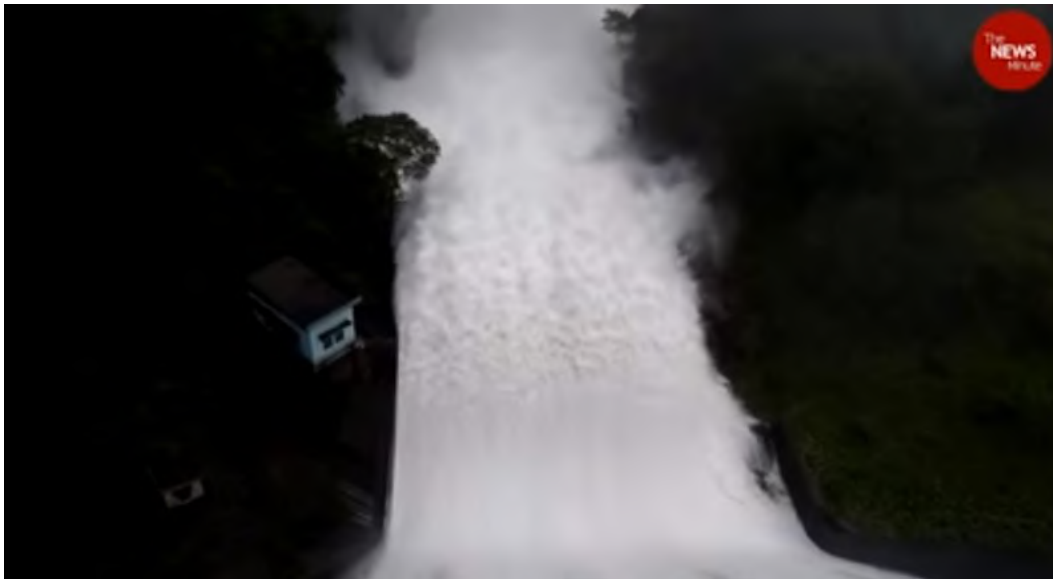
**Idamalayar Dam:** The Idamalayar dam is gravity concrete structure with a length of 373m at the crest and 102.80m height. The location of Idamalayar dam and reservoir is shown in Figure 3.1. Figure 3.2 shows a downstream and upstream view of the dam. Idamalayar dam was commissioned in 1987. The dam and the reservoir is used for power generation. The water from the reservoir is transported through tunnel, surge shaft, penstocks to the power station that is 1700 m away from the reservoir. The surface power station produces around 75 MW of power from the reservoir. The shutters of the Idamalayar dam was open on August 9<sup>th</sup> at 5 am as the reservoir hit its full capacity of 169 meters (Figure 3.3).

*Figure 3.3: Shutters of Idamalayar dam in Kerala opened as reservoir hits full capacity source: The News Minute*

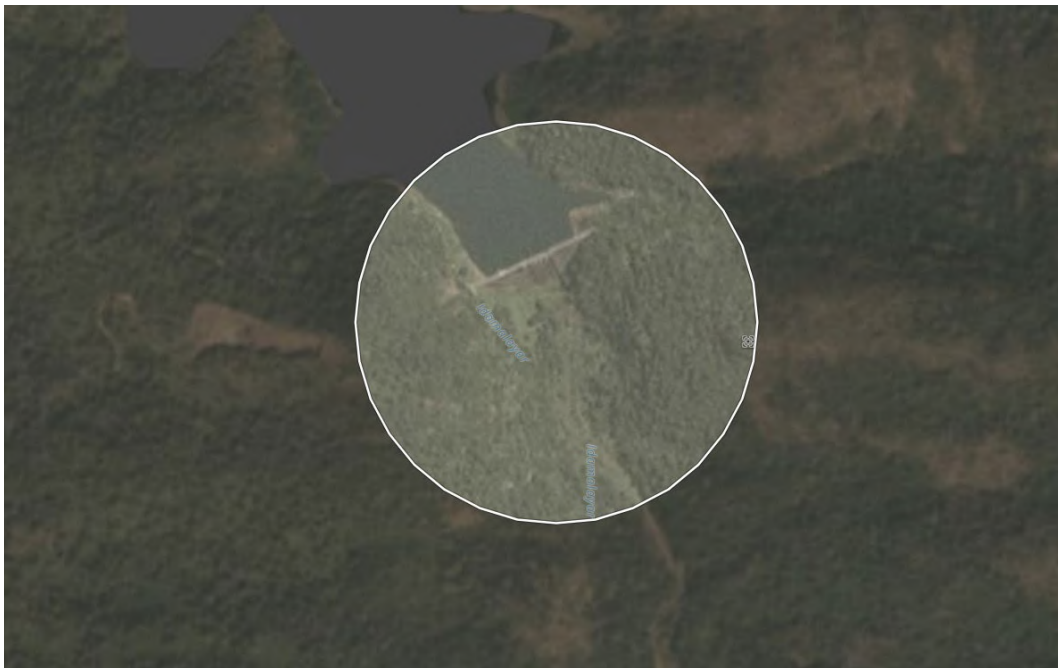
However, looking at the available high-resolution satellite images from Planet lab indicates that these landslides were formed after the opening of the shutters. Figure 3.4 is a planet lab imagery of Idamalayar dam from July 1, 2018. It is evident from the image that the dam shutter is closed and the downstream channel is vegetated. Figure 3.5 is a planet lab imagery of Idamalayar dam on September 3<sup>rd</sup>, 2018 and it documents the landslides that are occurring in the downstream channel at close vicinity of the dam. The initial estimates indicate that the landslide is occurring less than 150m downstream of the dam. The width of the slide is roughly 100m.

*Figure 3.4: Planet lab imagery of Idamalayar dam from July 1, 2018.*

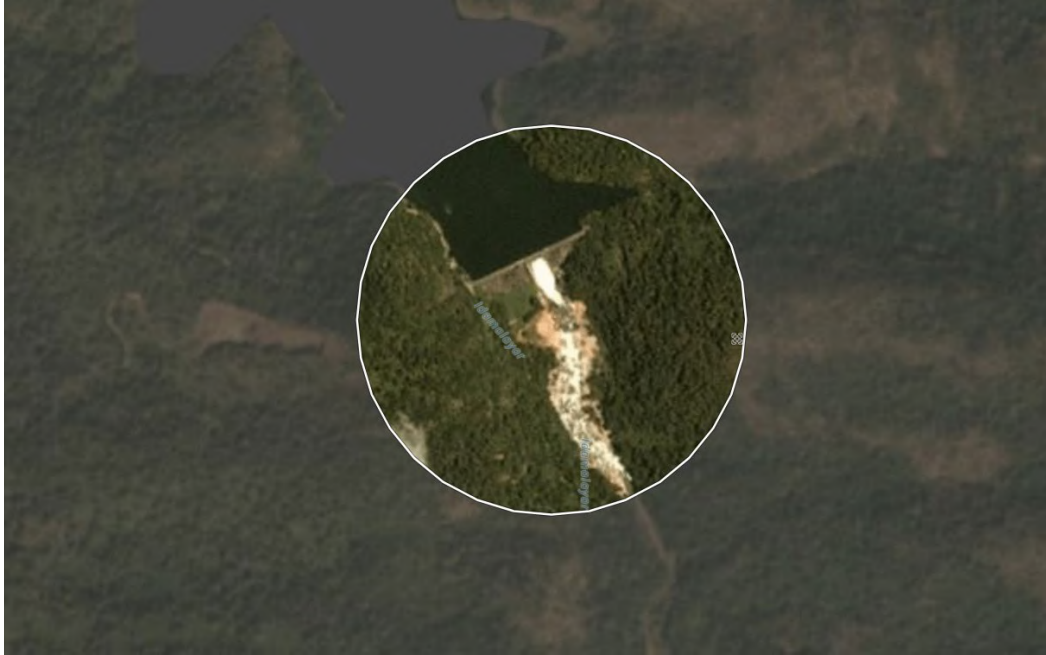
During the visit to the Idamalayar dam site, the GEER team noticed that there are some landslides and rock fall occurring downstream of the reservoir close to the dam. It was evident that these landslides had occurred from the recent opening of the shutters and the heavy flow of the water had under-cut the banks of the downstream channel. The GEER team was not allowed to take photographs at the dam sites and therefore, couldn't document it.

*Figure 3.5: Planet lab imagery of Idamalayar dam from September 3, 2018.*

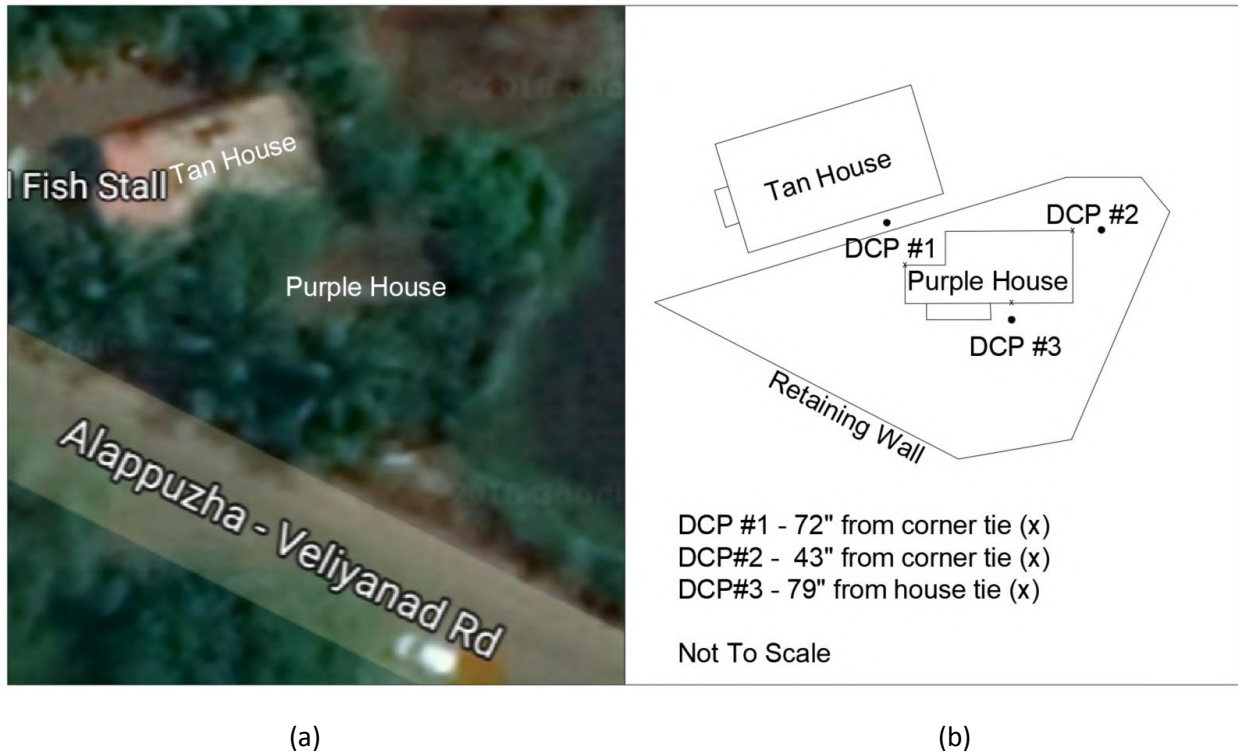
**Figure 4.2:** a) Google Maps (2018) image of the Tan/Purple Houses and b) a schematic of the relative locations of the DCP point locations.

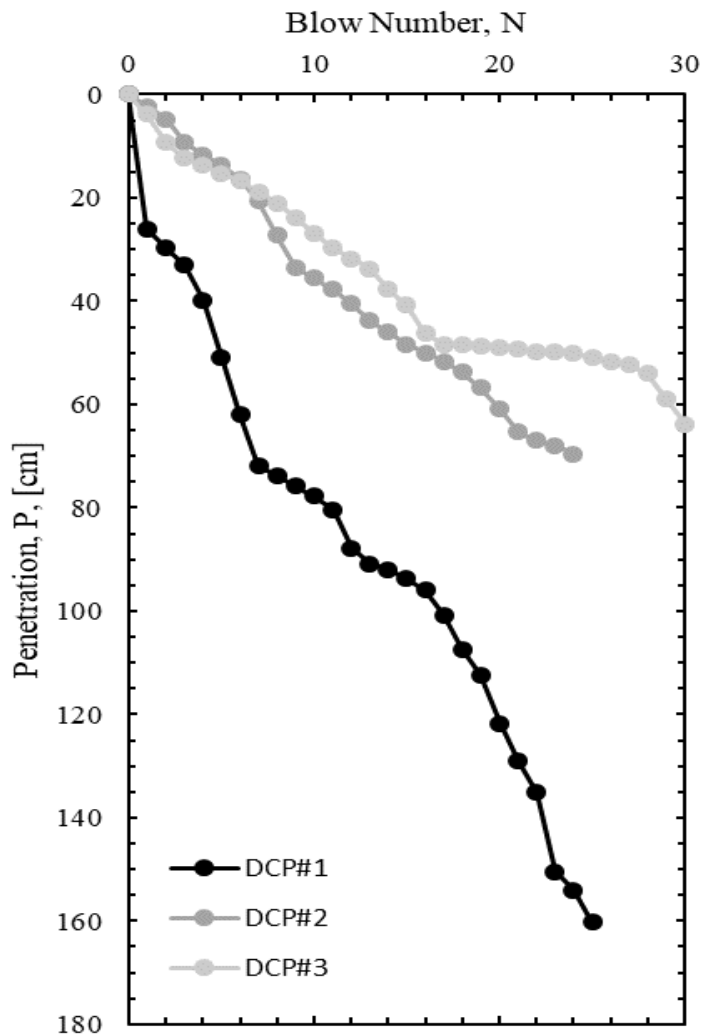
*Figure 4.3: DCP sounding data for the three (3) DCP soundings at the purple house.*

As shown in Figure 4.3, the lowest blow counts values were observed near the sunken corner of the purple house (DCP#1). However, as shown previously in Figure 4.2, the DCP#1 test was also collected near the central portion of the newer tan house. This observation, of the proximity of the DCP sounding to both houses, led to the following question: why was there differential settlement of the purple house but no differential settlement of the tan house? The rationale for the corner of the purple house settling and rotating while the tan house did not settle nor rotate are listed below.

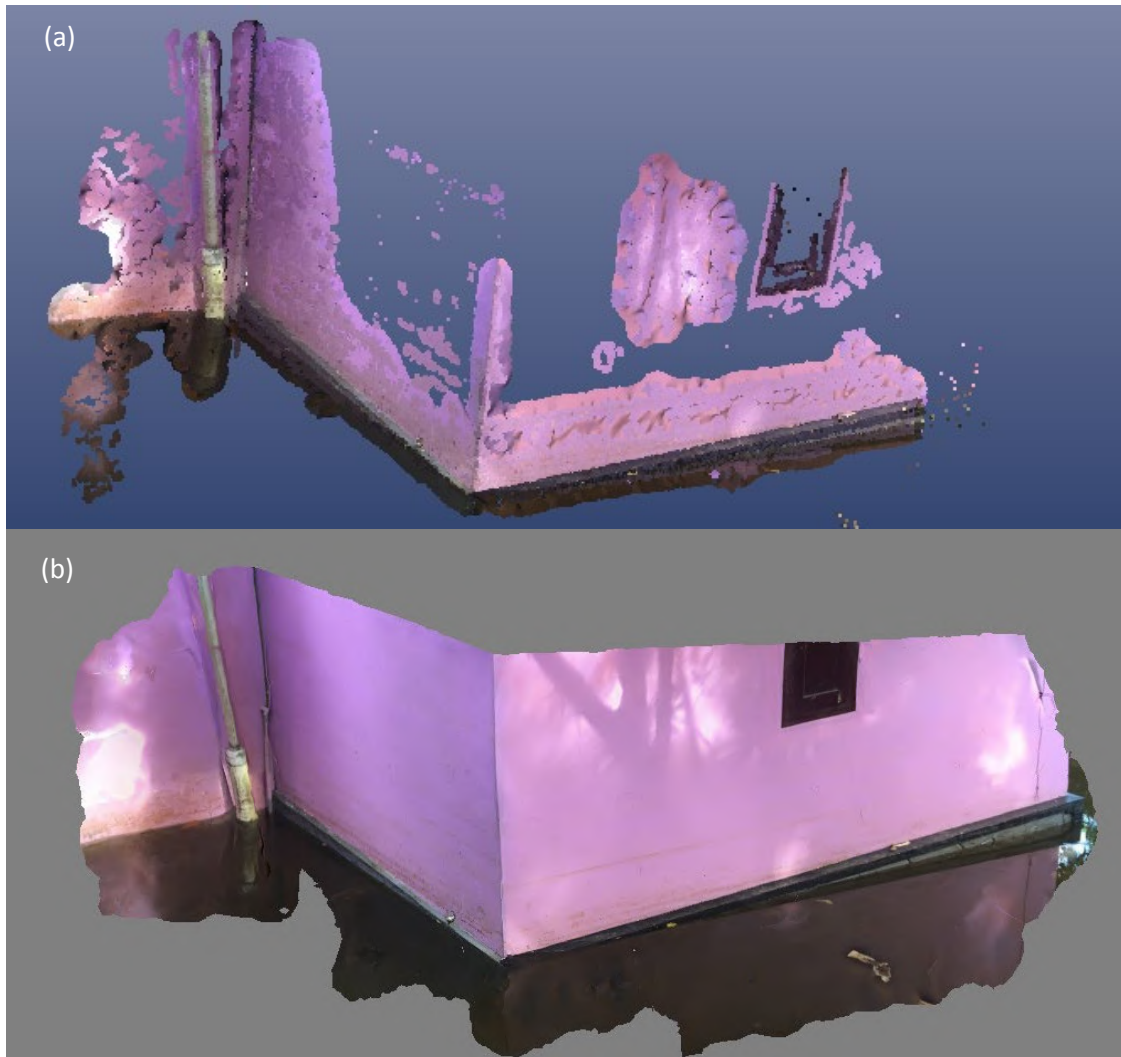
As previously mentioned, the Northwest corner of the purple house was observed to have settled. However, direct measurement of the amount of settlement was not available due to 1) cost constraints associated with airline baggage restrictions preventing transport of a four-foot long level or total station and 2) the flood waters presenting a health hazard. Therefore, the tilt of the foundation was not measured by manual means. Instead 12 photographs of the purple house were acquired from multiple vantage points that were acquired from safe distances away from the flood waters. Post-processing of the photographs in PhotoModeler (PhotoModeler, 2018) and PhotoScan (PhotoScan, 2018) software packages yielded differing results. As shown in Figure 4.4, a more dense point cloud was obtained from the PhotoScan software program than from the PhotoModeler software program. This finding surprised Dr. Coffman because of previous success by the group

**Figure 4.4:** a) PhotoModeler and b) PhotoScan renderings of draped images overlain on the three-dimensional point cloud data that were developed from the 12 acquired photographs with different viewing angles.

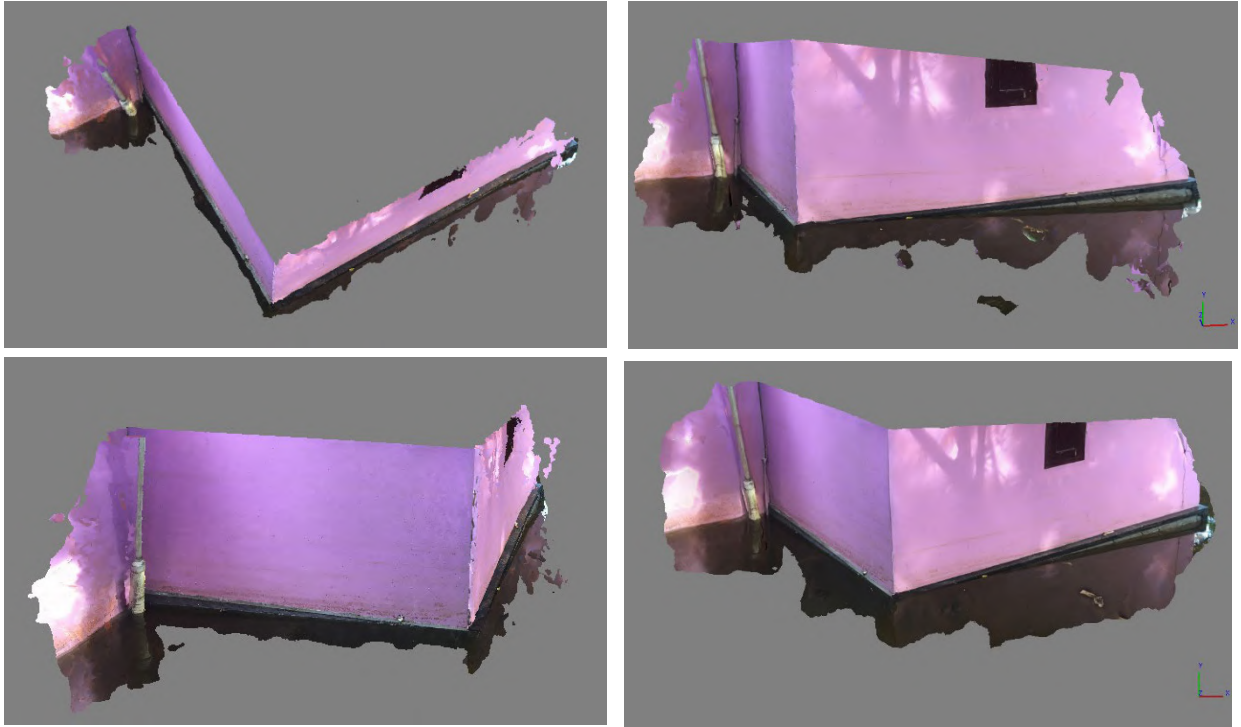
Following development of the three-dimensional point cloud data in PhotoScan (Figure 4.5), the three-dimensional point cloud data were extracted from the PhotoScan software. The point cloud data were then imported into the open-source program CloudCompare (2018) to determine the amount of differential settlement of the corner of the purple house. By using the point cloud points associated with the water surface as a datum, the North wall of the purple house was observed to have rotated by  $1.7^\circ$  and the West wall of the purple house was observed to have rotated by  $2.0^\circ$ .

**Figure 4.5:** Multiple views of PhotoScan renderings of draped images overlaid on the three-dimensional point cloud data that were developed from the 12 photographs acquired from different viewing angles.

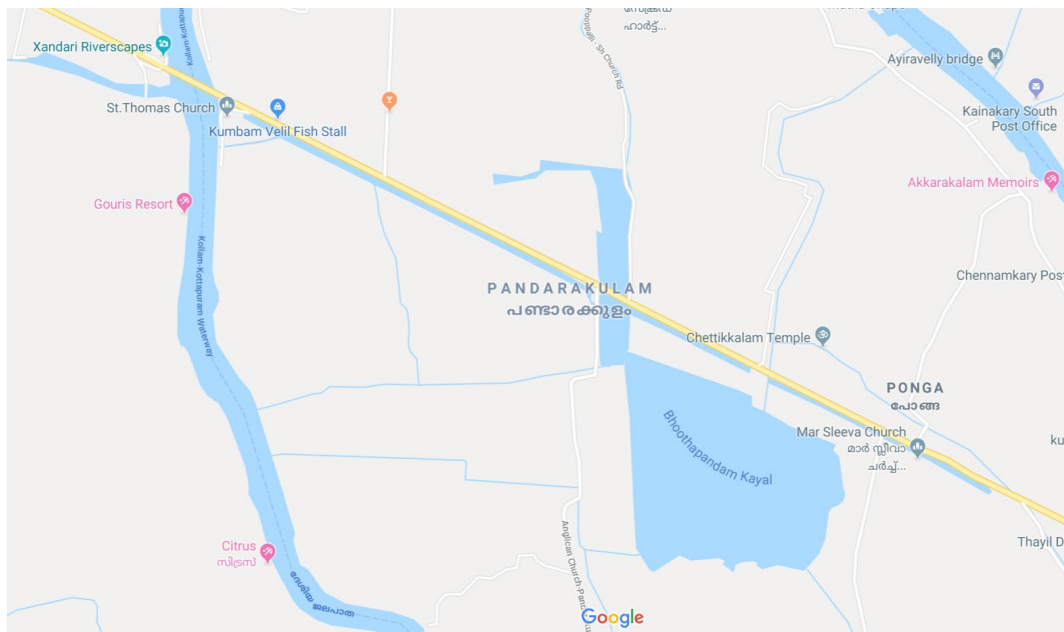
**Figure 4.8:** a) Google Maps (2018) image showing the 1.83 mile distance between the Kumbam Velil Fish Stall (location of single-story tan and purple houses) and the Mar Sleeveva Church of Ponga (location of church and two-story concrete homes).
