# GEOTECHNICAL IMPACTS OF AUGUST 2018 FLOODS OF KERALA, INDIA

Event: August 2018

**Geotechnical Extreme Events Reconnaissance**  
*Turning Disaster into Knowledge*  
**Sponsored by the National Science Foundation**  
**GEER Association Report NO - 058**

**Date: 10-17-2018**

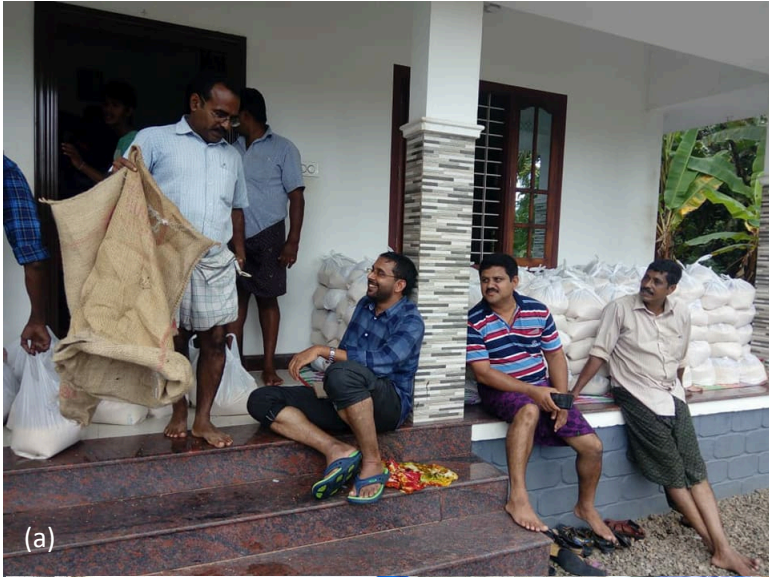
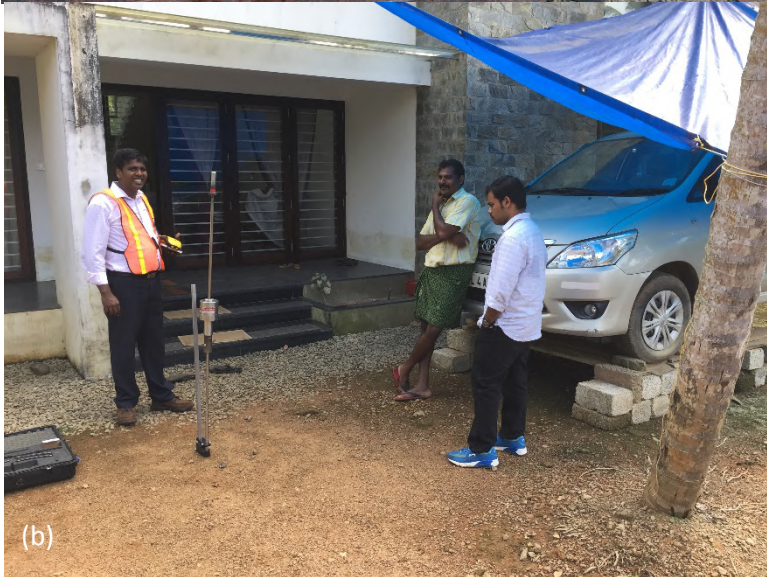
Photographs of the two-story houses (identified as the white and gray houses) are shown in Figure 4.9. Based on conversations with the residents of the homes, the second story of the white house was constructed from lightweight concrete and the gray house was constructed on a mat foundation. For completeness, photographs of the blue prints for this house, which were provided by the owner of the house, are included as Figure 4.10. The residents also stated that the original building of the Mar Sleeveva Church (Figure 4.11), located across SH11 from the houses, was constructed on 30-foot long concrete piles and the ancillary building was constructed on six- to eight-foot long sections of coconut trees placed in nine-pile groups. The location of the DCP soundings around the white and tan two story homes are provided in Figure 4.12. The DCP sounding data from the four soundings that were performed at this site are provided in Figure 4.13.

**Figure 4.9:** Photographs of the a) white and b) gray houses located across from the Mar Sleeva Church. Photograph of white house provided by Thomas Mampra.

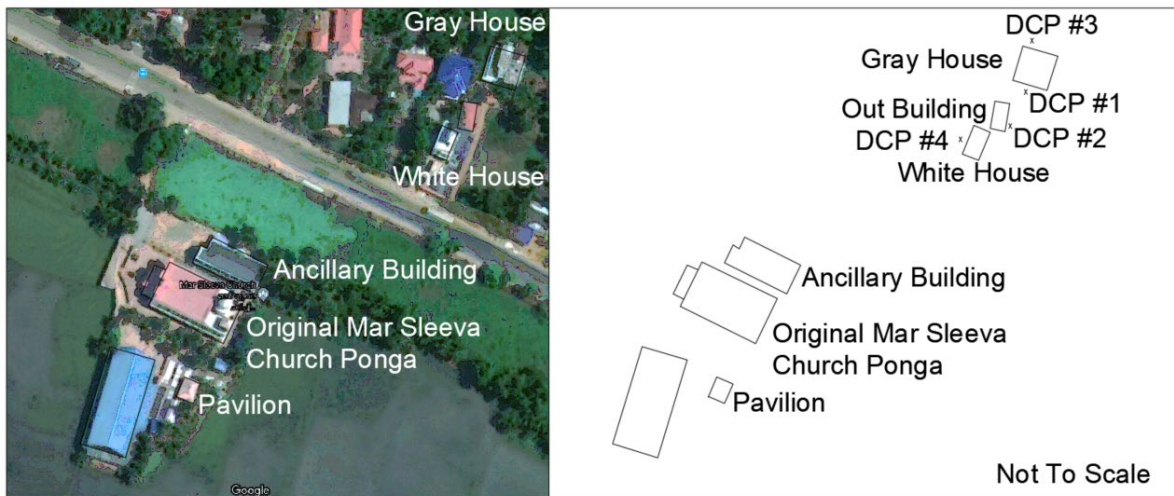
**Figure 4.12:** a) Google Maps (2018) image of the Mar Sleeva Church and the White/Gray houses, and b) a schematic of the relative locations of the DCP point locations near the White/Gray houses.

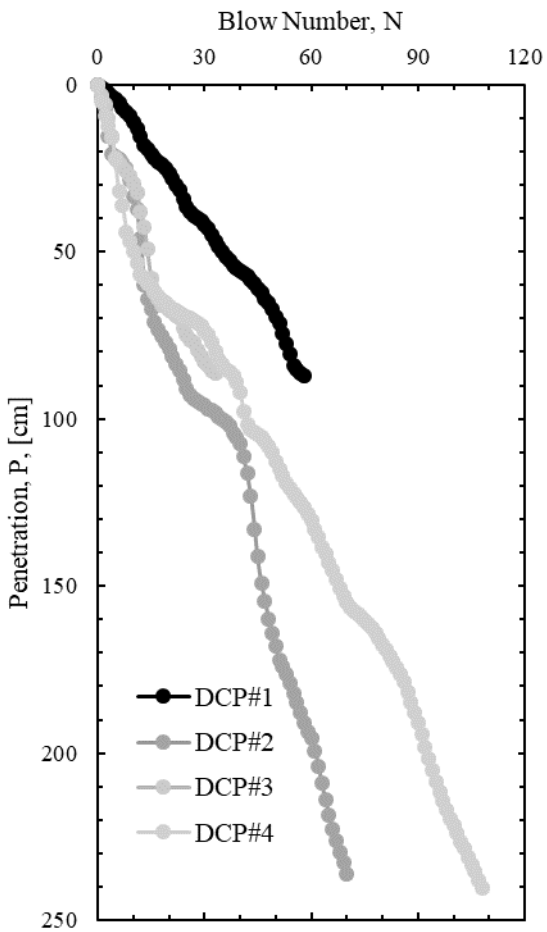
**Figure 4.13:** DCP sounding data for the four (4) DCP soundings at the white/gray house.

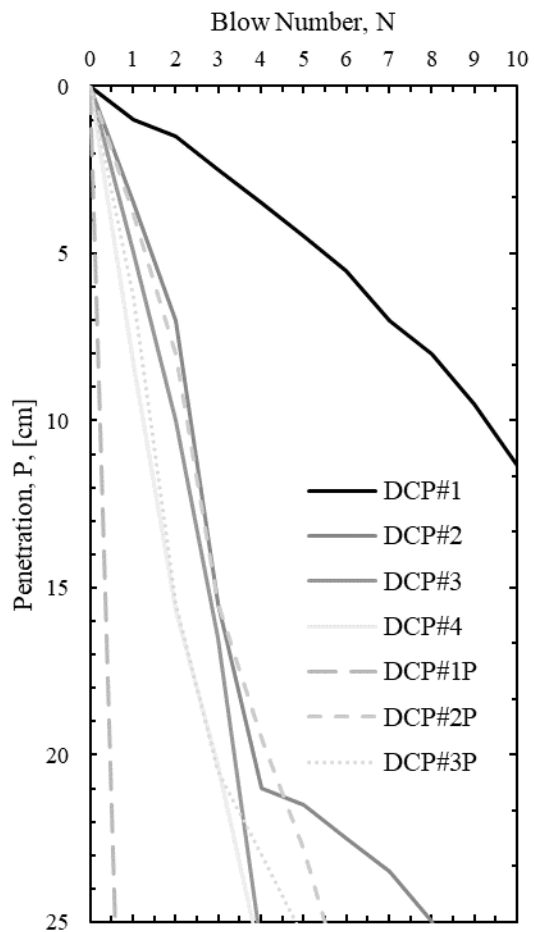
**Figure 4.14:** DCP soundings at the white/gray houses compared with those at the purple (P)/tan houses.

By comparing the data in Figure 4.14, it is apparent that the strength of the soil located at the Northwest corner of the purple house was significantly weaker than all of the other soundings. It was also apparent that the soil located outside of the front door of the Gray house was significantly stronger than all of the other soils. The remainder of the soils were comparable for the first 25cm. It is fitting that all of the other soil strengths were similar because all of these other soils were comprised of agricultural rice patty soils except for the sounding located next to the white house that was driven through approximately one-foot of fill material. Based on the similarity of the observed strengths, these soils were most likely borrow soils from a nearby area.

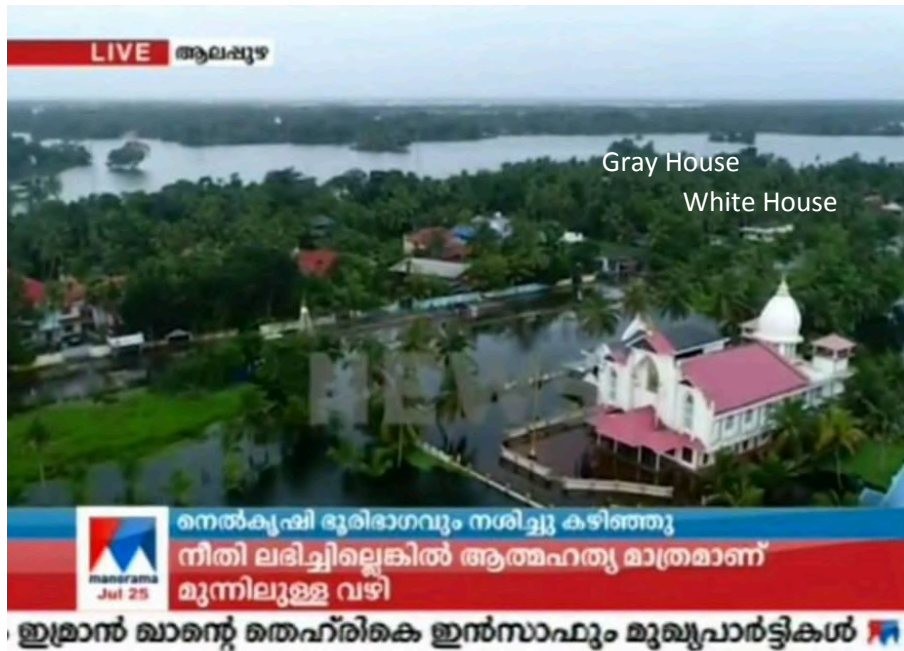
*Figure 4.16: Photograph of the Mar Sleeva Church Ponga when subjected to flooding. Gray house and white house identified in background. Photograph provided by Mar Sleeva Church Ponga.*

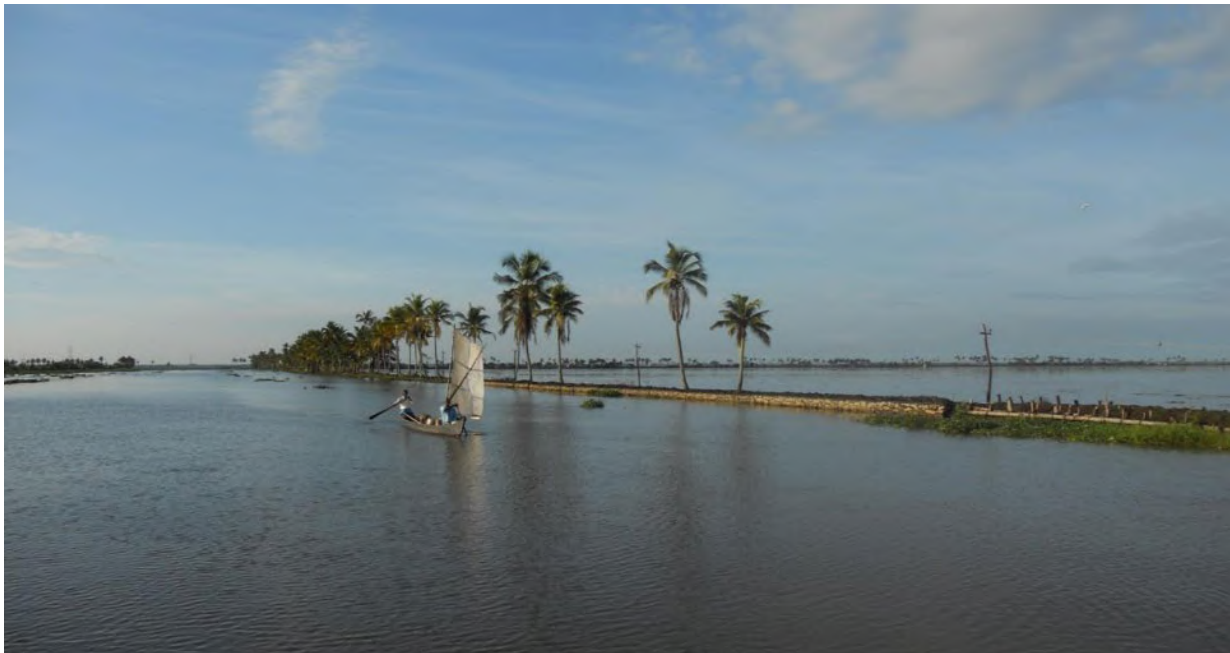
Typically, the Kayal/wetland rice fields are separated from the lake with a bund/ embankment with coconut trees grown on these bunds (Figure 5.2). The cultivation of rice below sea level in Kuttanad was developed by the local farmers and has several similarities with the Dutch polder system (MSSRF, 2007). On the Kayal side, the farmers build their house on a filed piece of land or a natural elevated land as shown in Figure 5.3.

*Figure 5.2: Coconut trees on the bund that separate the Vembanad Lake (on the left of bund) from the Kayal (on right of bund). Source: [www.fao.org/3/a-bp793e.pdf](http://www.fao.org/3/a-bp793e.pdf)*

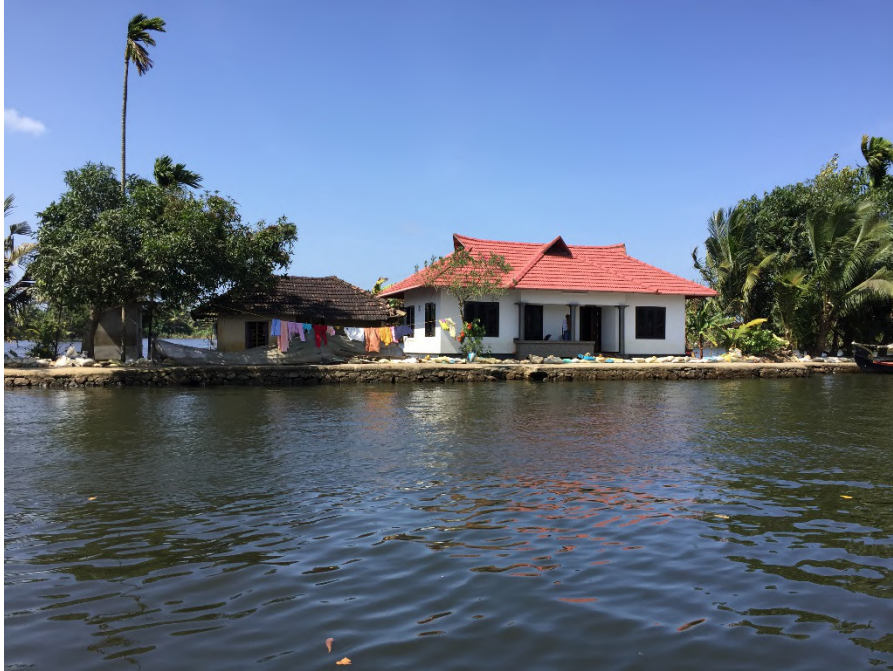
Figure 5.3: On the foreground is the lake and on the background of the house is the wetland rice fields (Kayal).

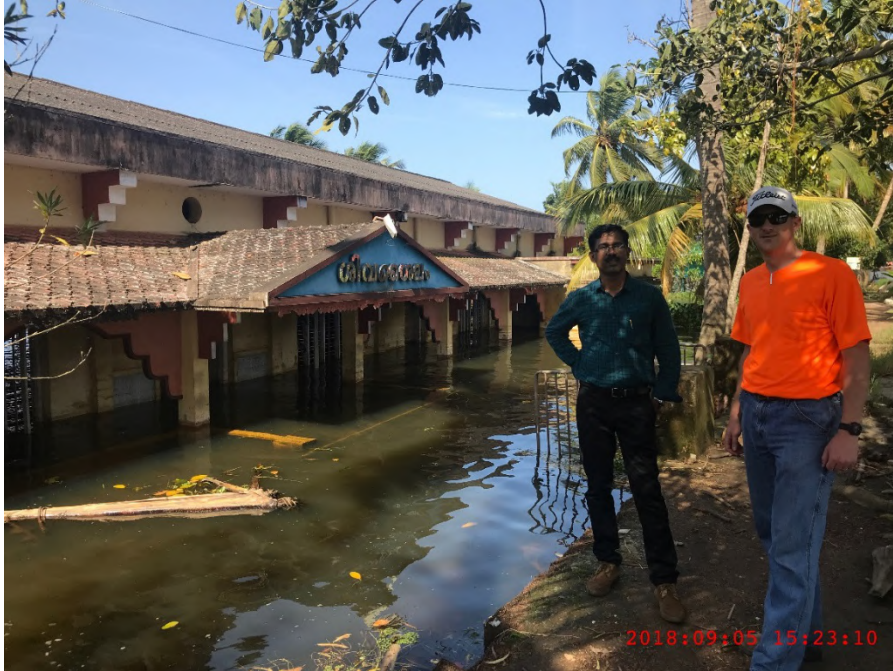
The August 2018 flood resulted in the collapse of bund at several locations. Apart from the heavy rainfall and opening of shutters of almost all major dams, it was high tide time in the Arabian Sea and therefore, flood water could not get discharged. Most of the bund collapse were minor and could be fixed in couple days (Figure 5.4). However, one major failure of the bund occurred near Kainakari (@ 9.5029947<sup>0</sup>N 76.3749555<sup>0</sup>E) (Figure 5.5). This caused the water from the river to enter the below MSL Kuttanad area and these areas remain inundated even during the GEER team visit (roughly 12-15 days after the rain event) (Figures 5.6, 5.7, & 5.8).

Figure 5.8: Entrance of the flooded community hall @ 9.5033389°N 76.3772861°E

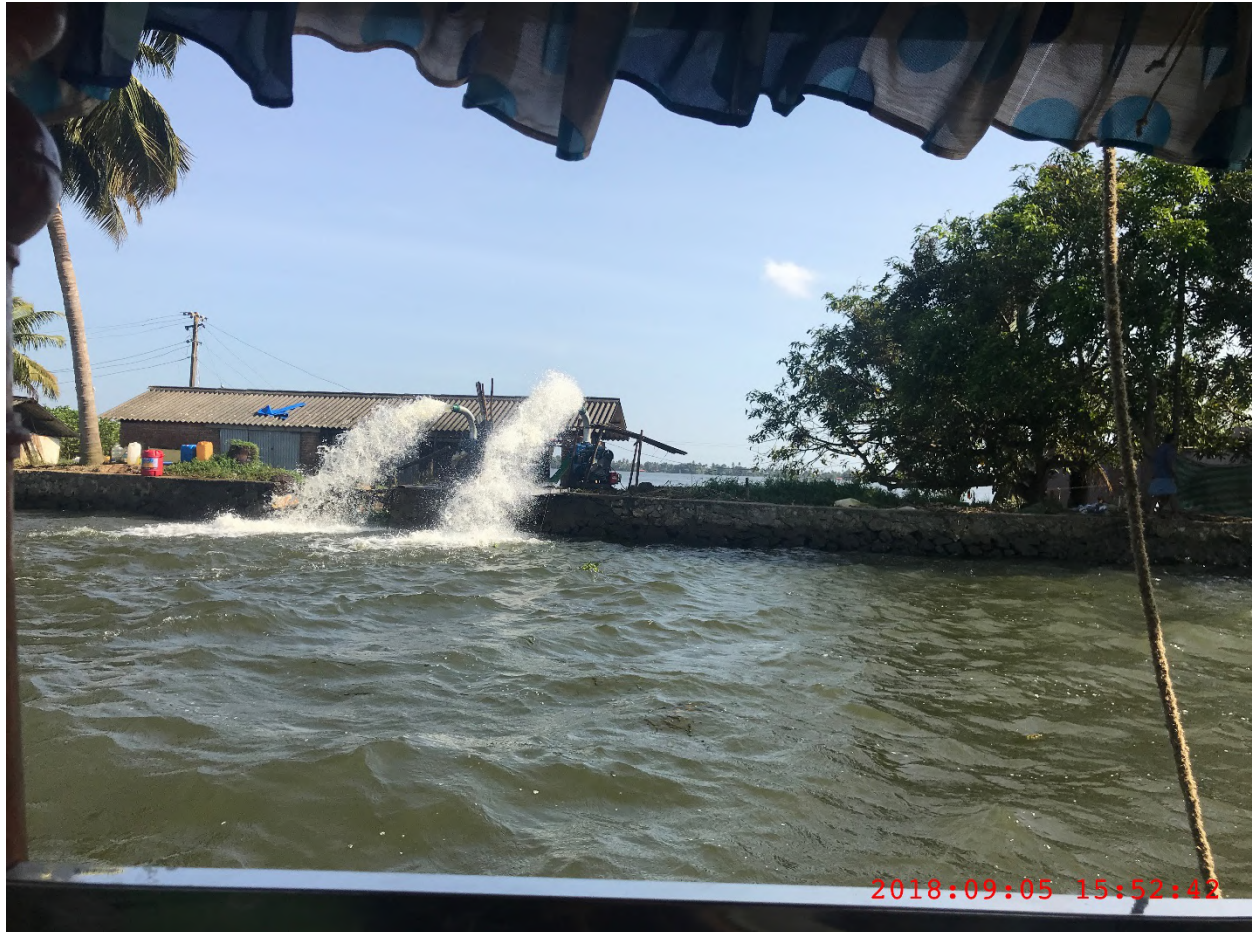
*Figure 5.10: Water being pumped from the fields to the lake @ 9.5166260°N 76.3810643°E*

The GEER team witnessed the reconstruction of the major bund failure. The reconstruction was labor intensive and was done using locally available construction material (Figure 5.5). The government had taken measures to pump the water from the flooded fields as the bund was being reconstructed as shown in Figure 5.10.

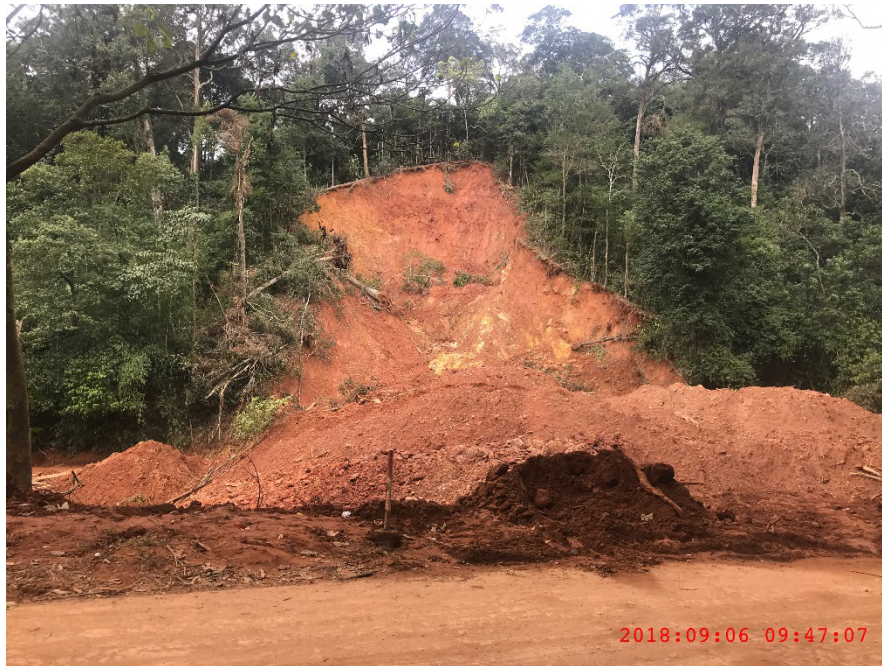
*Figure A-1: Landslide that blocked the road @ 9.8263274° N 76.9197930° E*

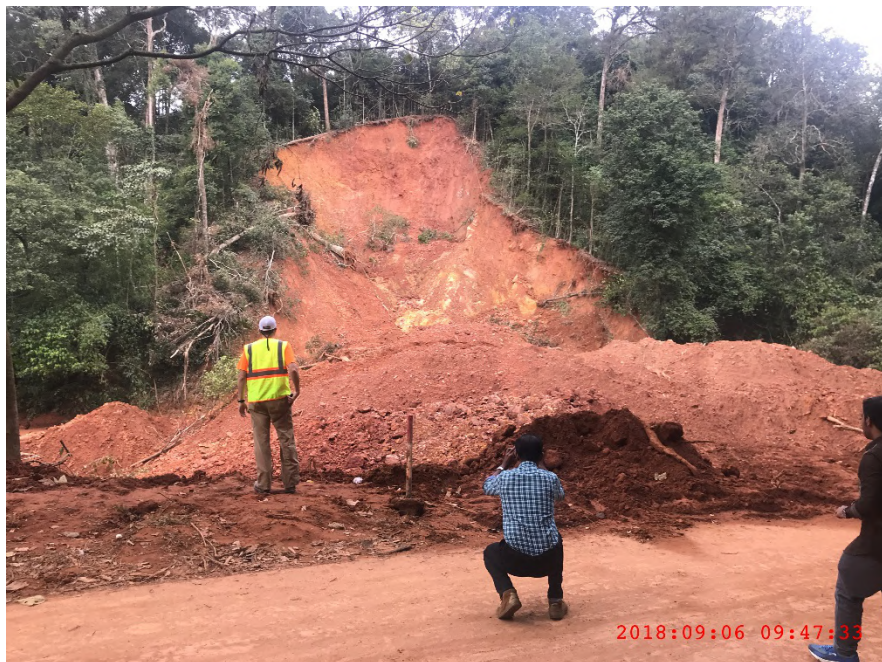
*Figure A-2: Landslide that blocked the road @ 9.8263274° N 76.9197930° E*

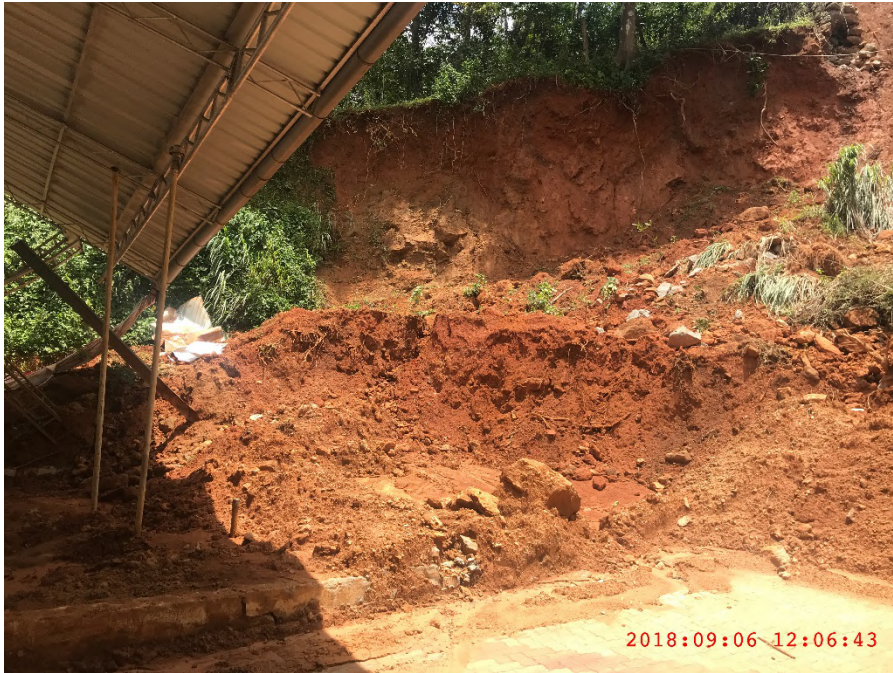
Figure A-3: Landslide near a gas station @ 9.8549653° N 76.9619187° E

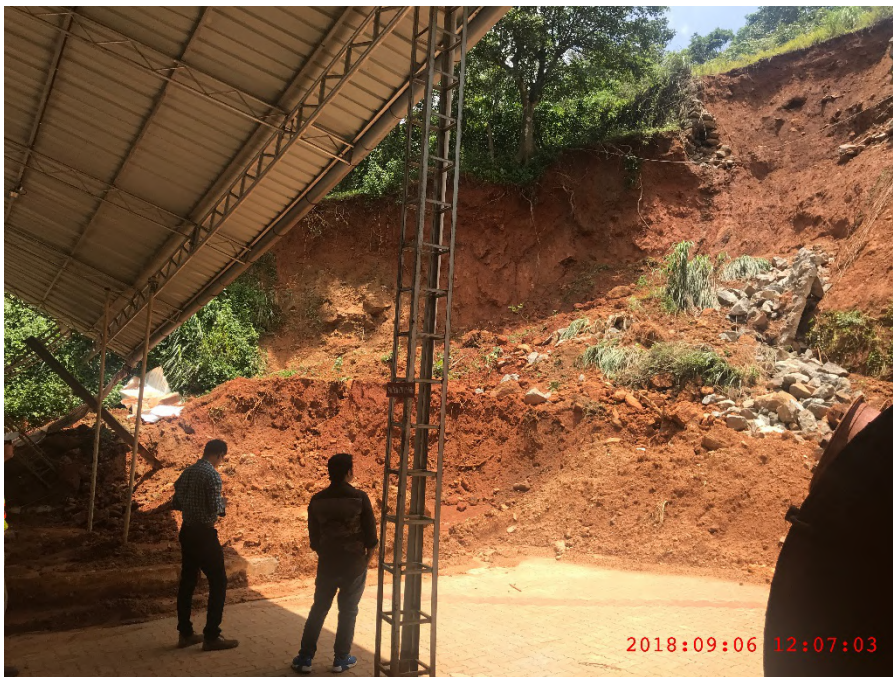
Figure A-4: Landslide near a gas station @ 9.8549653° N 76.9619187° E

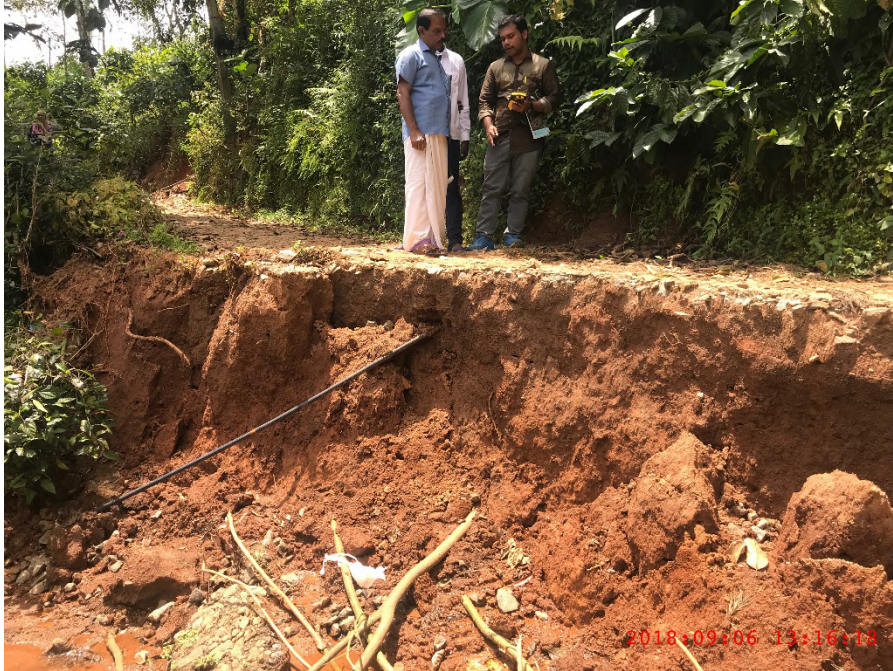
*Figure A-5: Landslide scarp @ 9.7968694° N 77.0675658° E*

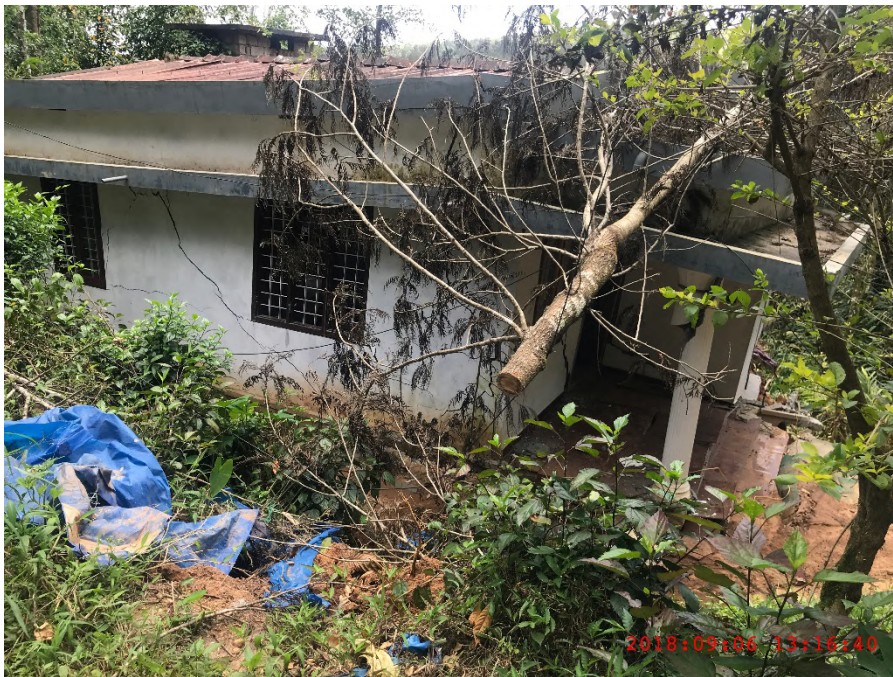
*Figure A-6: House destroyed in the landslide @ 9.7968694° N 77.0675658° E*

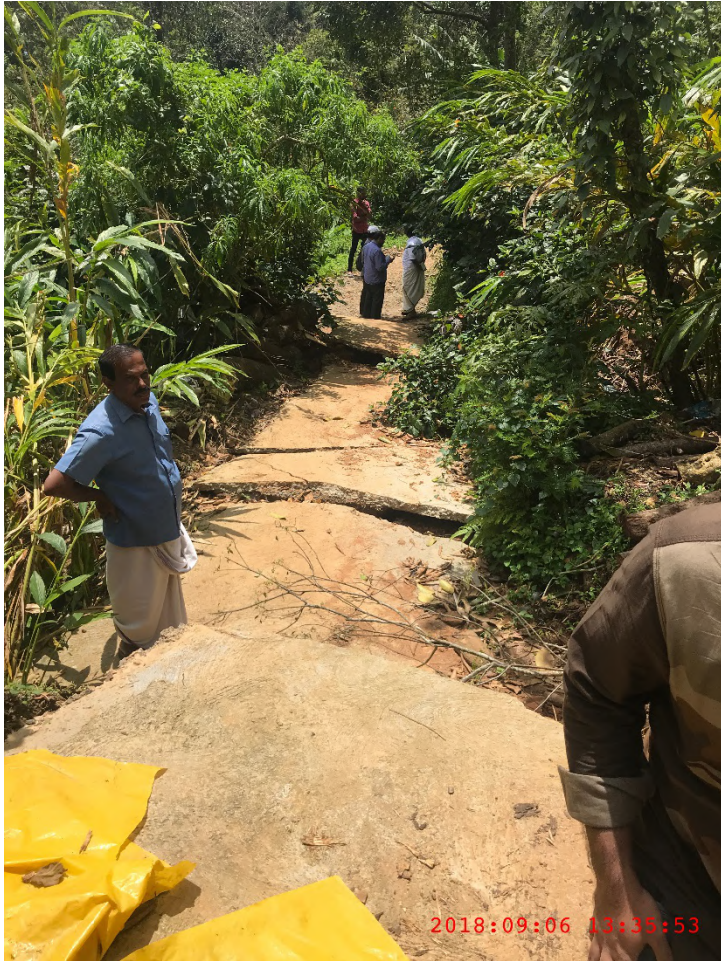
*Figure A-8: Driveway to the house destroyed in landslide @ 9.7962622° N 77.0681814° E*

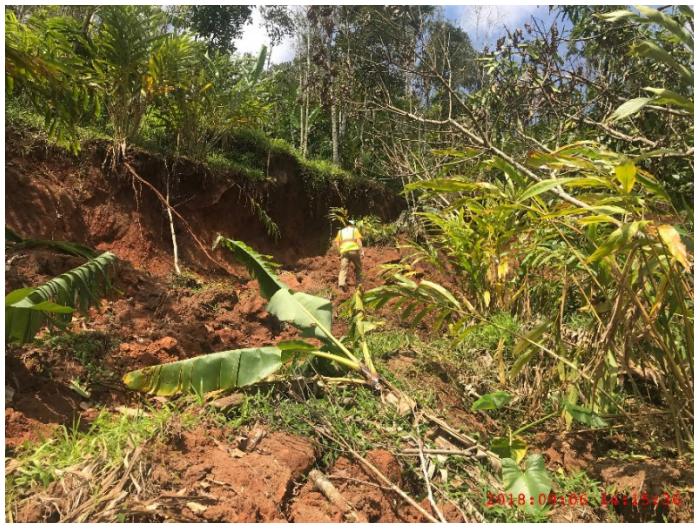
Figure A-10: Landslide scarp @  $9.7970015^{\circ}$  N  $77.0683650^{\circ}$  E

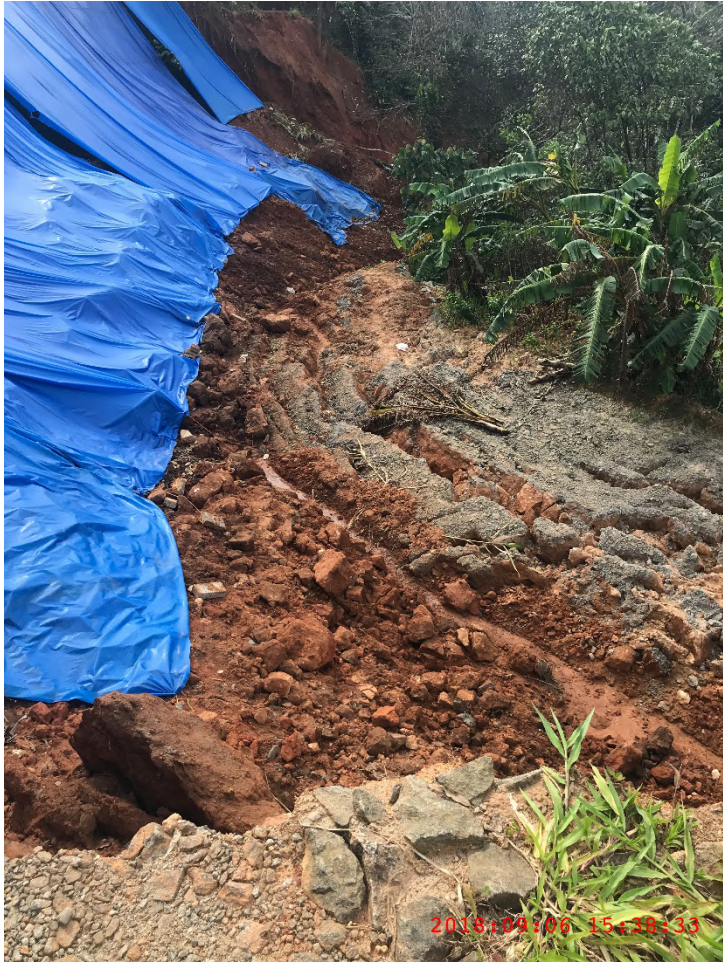
*Figure A-12: Head of the landslide @ 9.7925131<sup>o</sup> N 77.0680889<sup>o</sup> E*

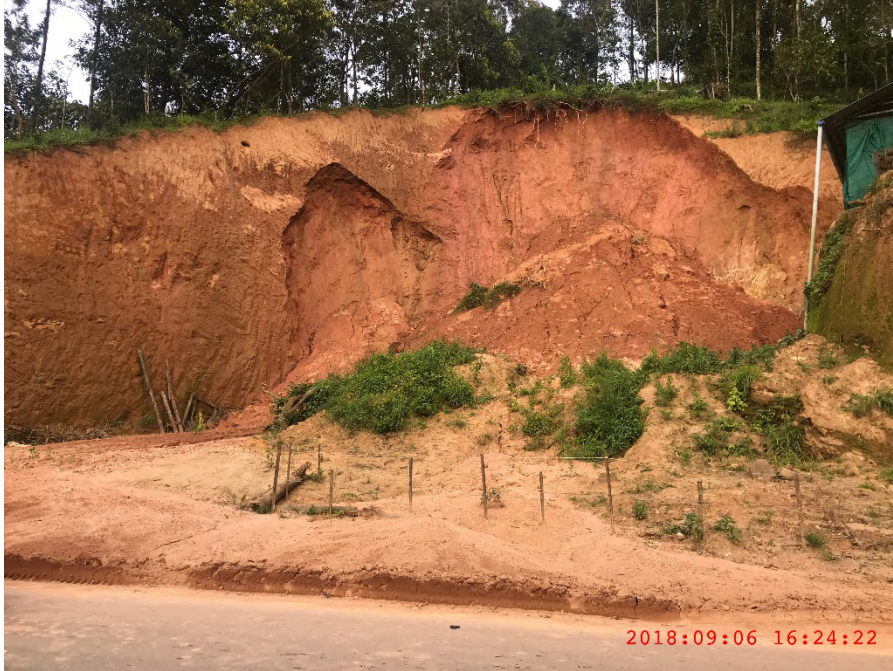
*Figure A-13: Minor landslide @ 9.7694732<sup>o</sup> N 77.0890198<sup>o</sup> E*

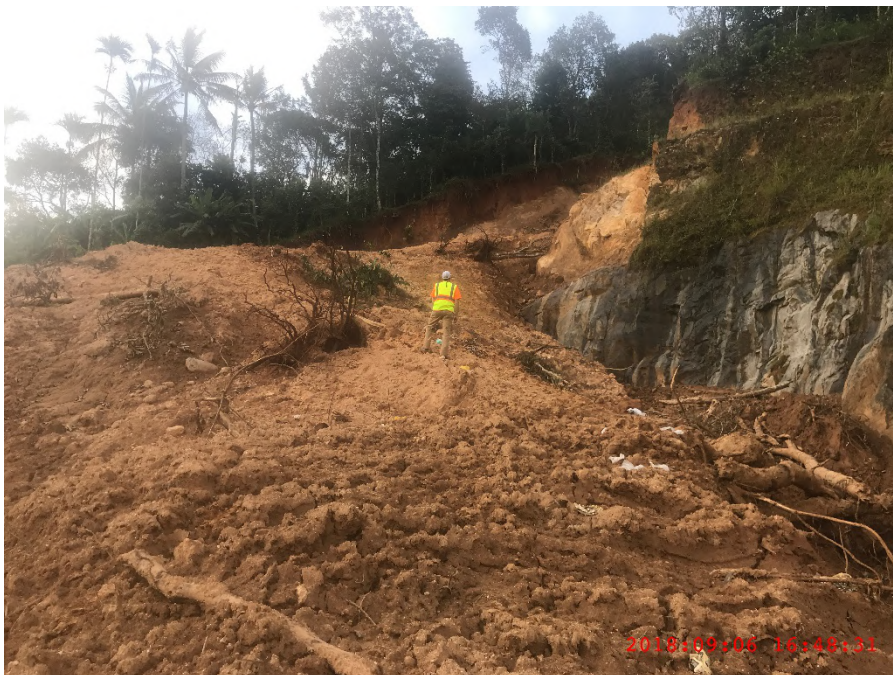
*Figure A-14: Major landslide that buried a two storey building that was in construction @ 9.7644641<sup>o</sup> N 77.1096940<sup>o</sup> E*

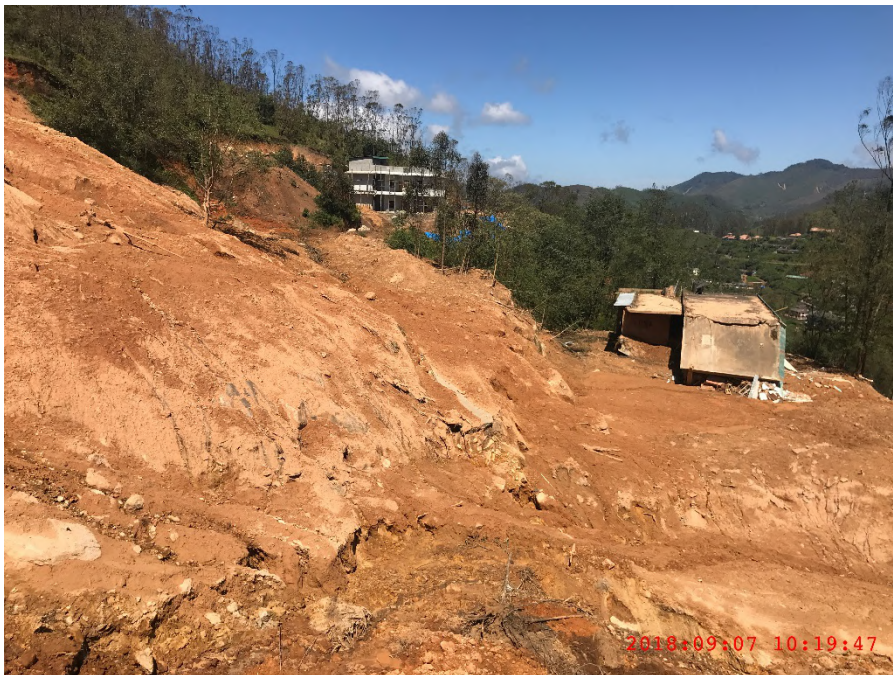
*Figure A-17: Munnar college landslide showing the destroyed college building @ 10.0822577° N 77.0734317° E*

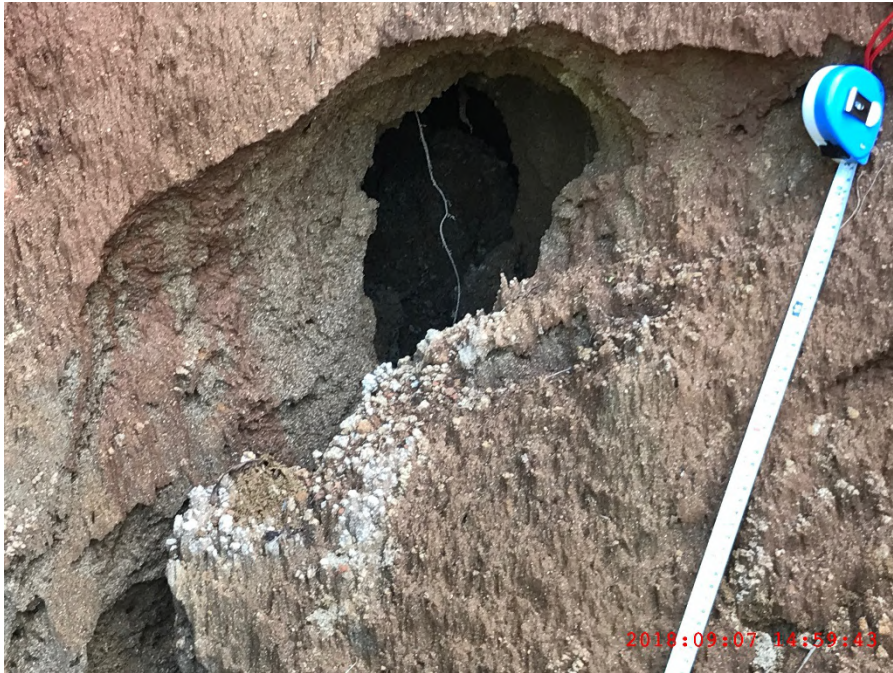
Figure A-20: Example of soil pipping @  $10.0088136^{\circ}$  N  $77.0257626^{\circ}$  E

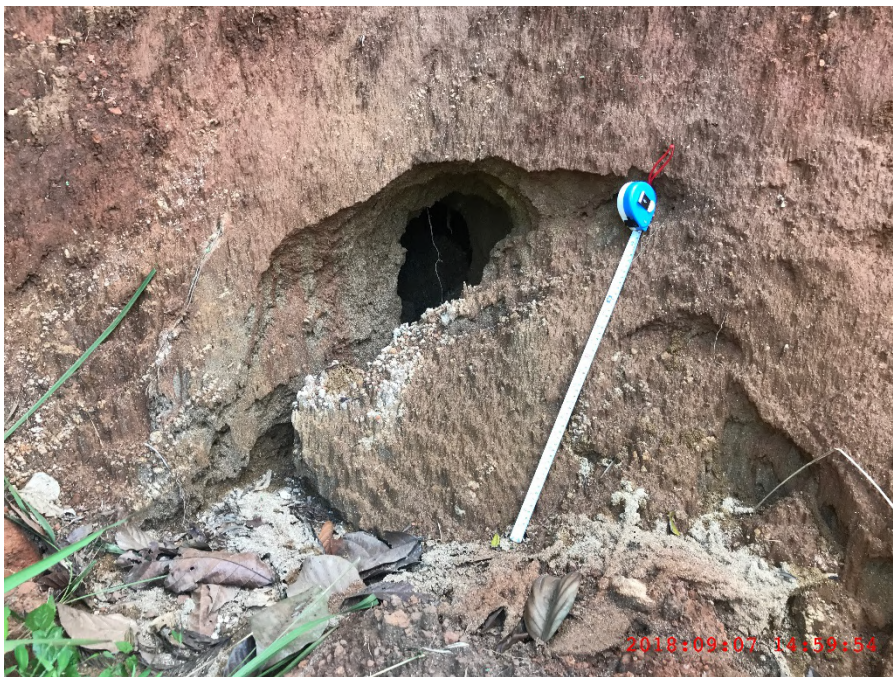
Figure A-21: Another view of the pipping @  $10.0088132^{\circ}$  N  $77.0257597^{\circ}$  E

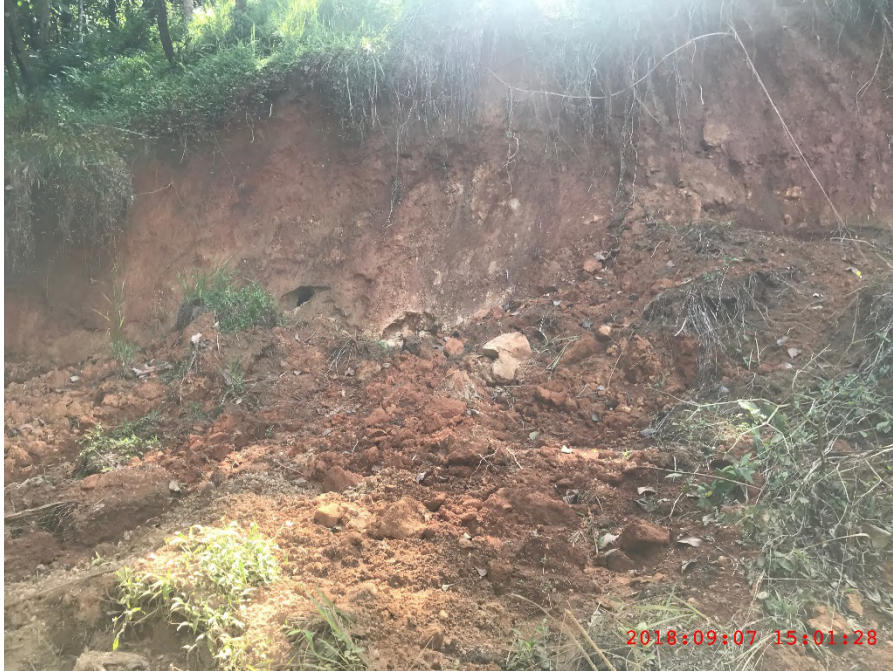
*Figure A-22: Another case showing soil pipping @  $10.0088800^{\circ}$  N  $77.0258132^{\circ}$  E*

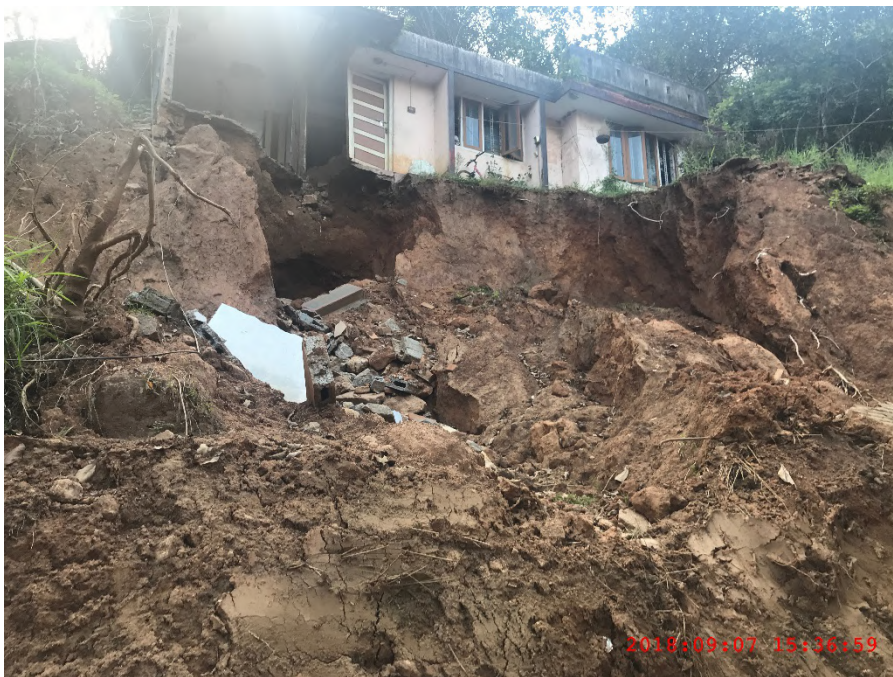
*Figure A-23: A landslide case with large pipping channel @  $9.9756943^{\circ}$  N  $77.0216695^{\circ}$  E*

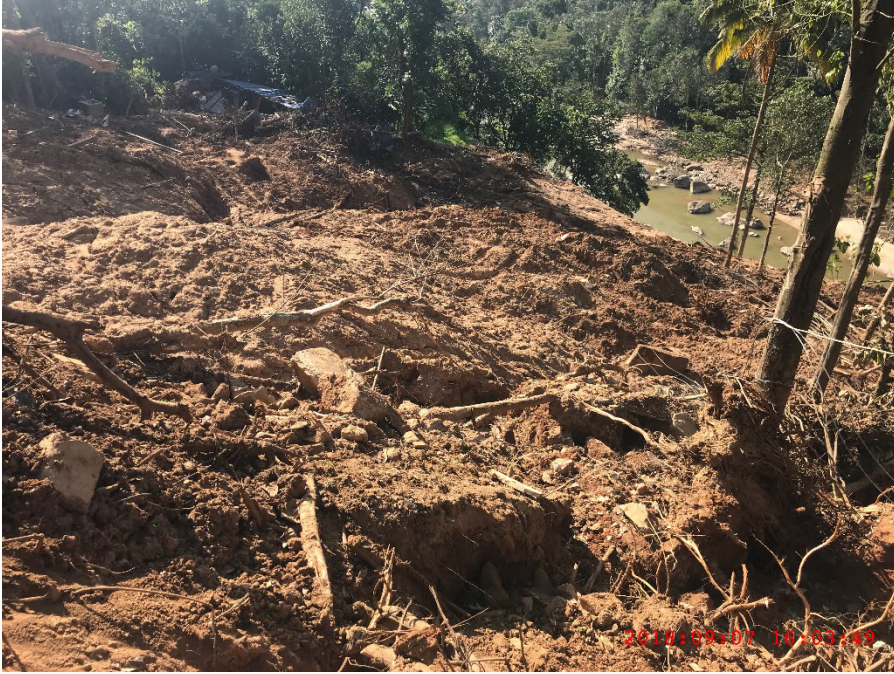
*Figure A-25: Panniyarkutty landslide that destroyed three houses and killed five people @ 9.9749966° N 77.0429146° E*

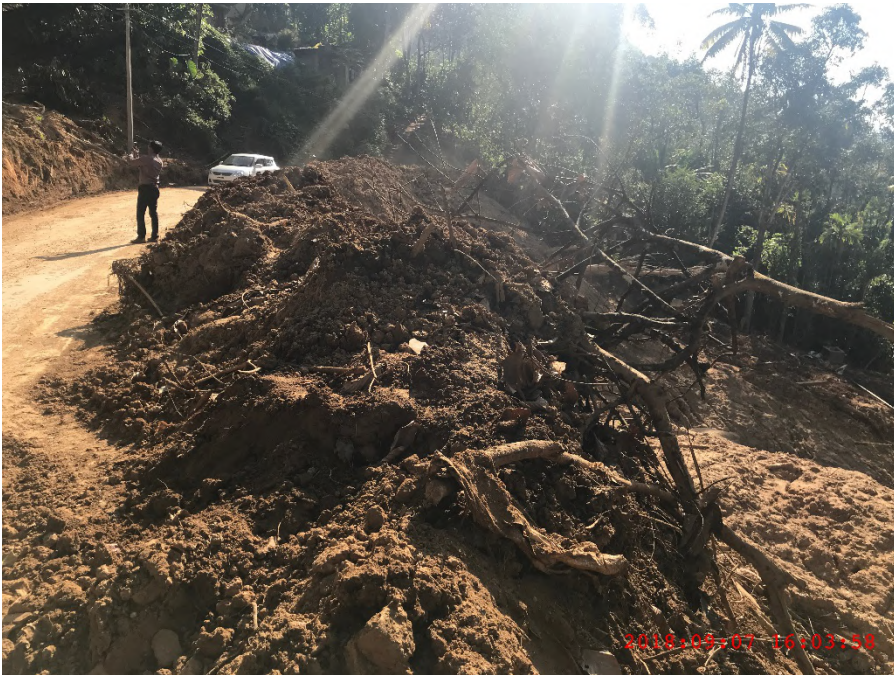
*Figure A-26: Panniyarkutty landslide @ 9.9749966° N 77.0429146° E*

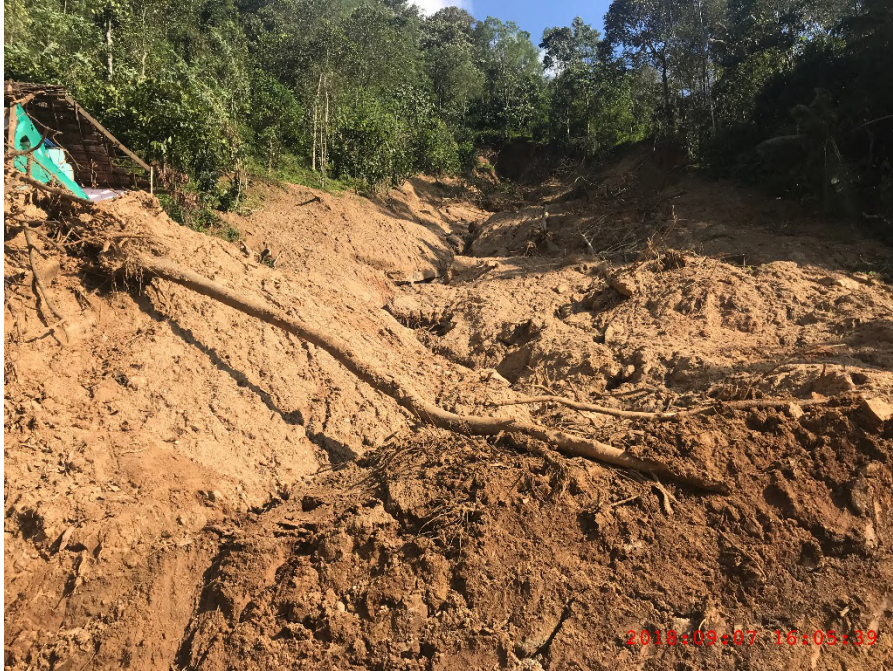
*Figure A-27: Origin of the Panniyarkutty landslide @ 9.9748956° N 77.0427662° E*

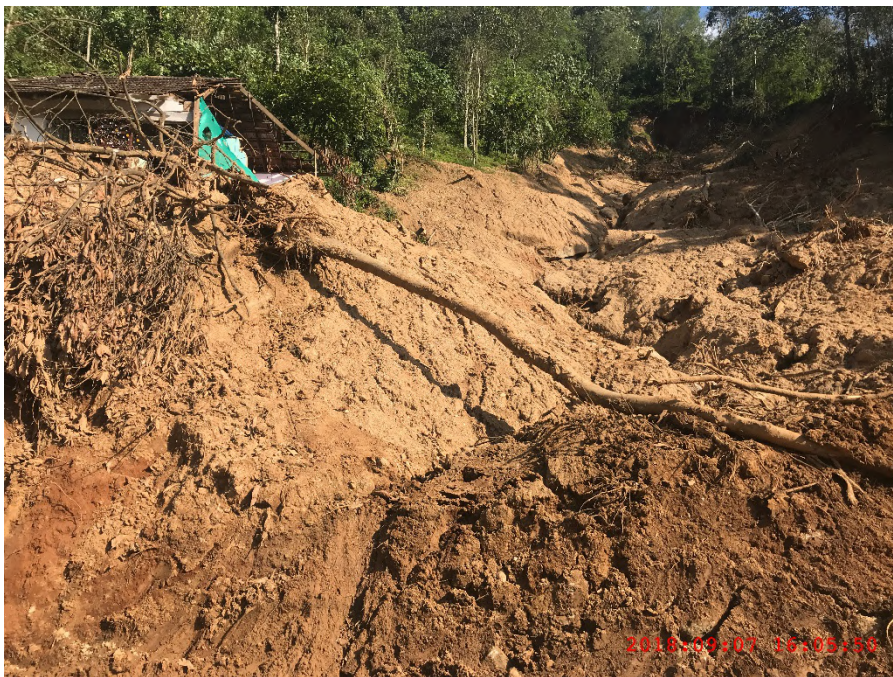
*Figure A-28: Seen on the left is a house that has been destroyed in Panniyarkutty landslide @ 9.9748956° N 77.0427662° E*

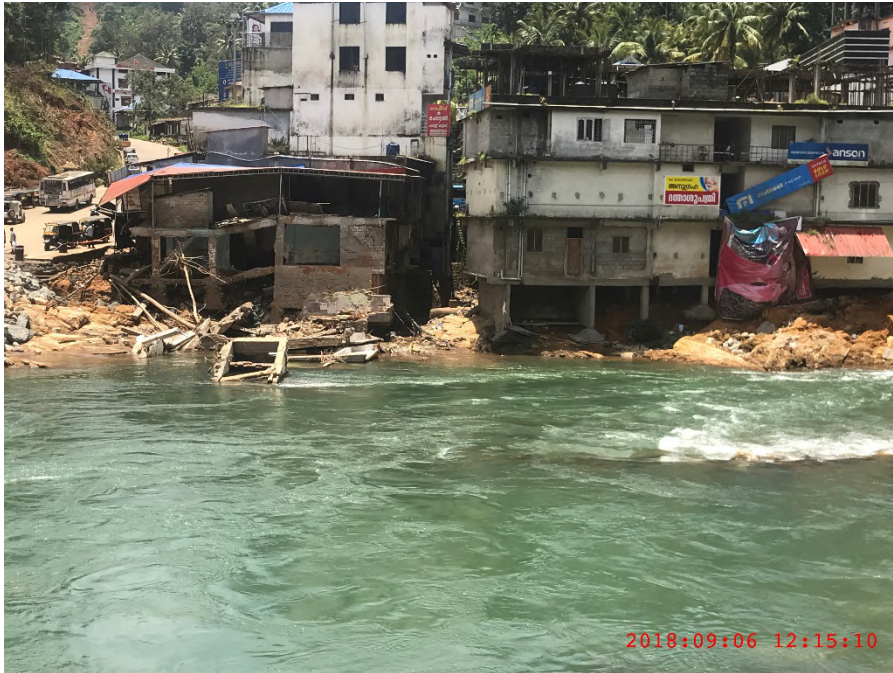
Figure B-2: River erosion @  $9.8575868^{\circ}$  N  $76.9636007^{\circ}$  E

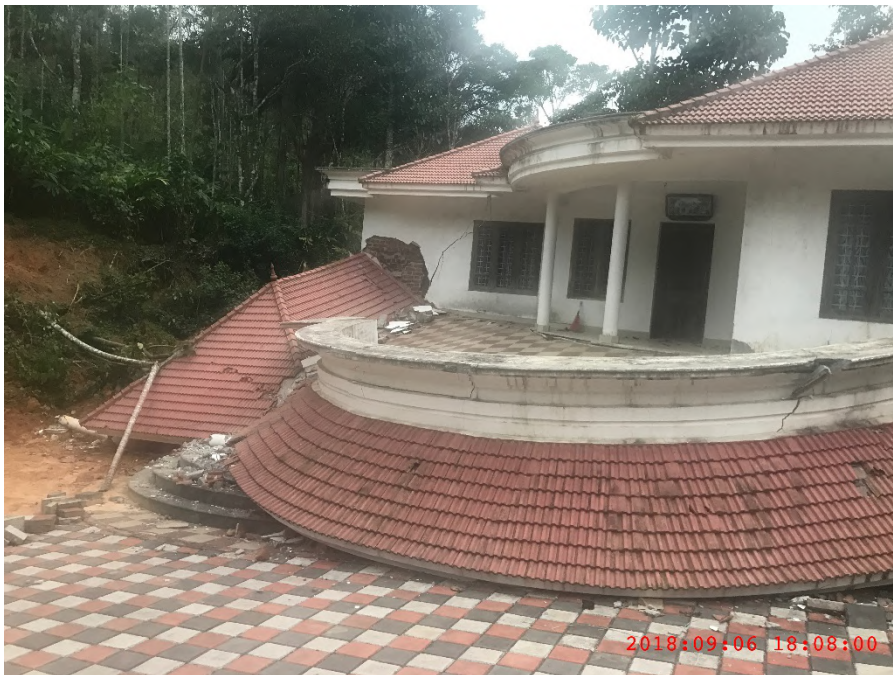
*Figure C-5: Building destroyed due to ground movement. An entire floor has been subsided @ 9.8747156° N 77.1193791° E*

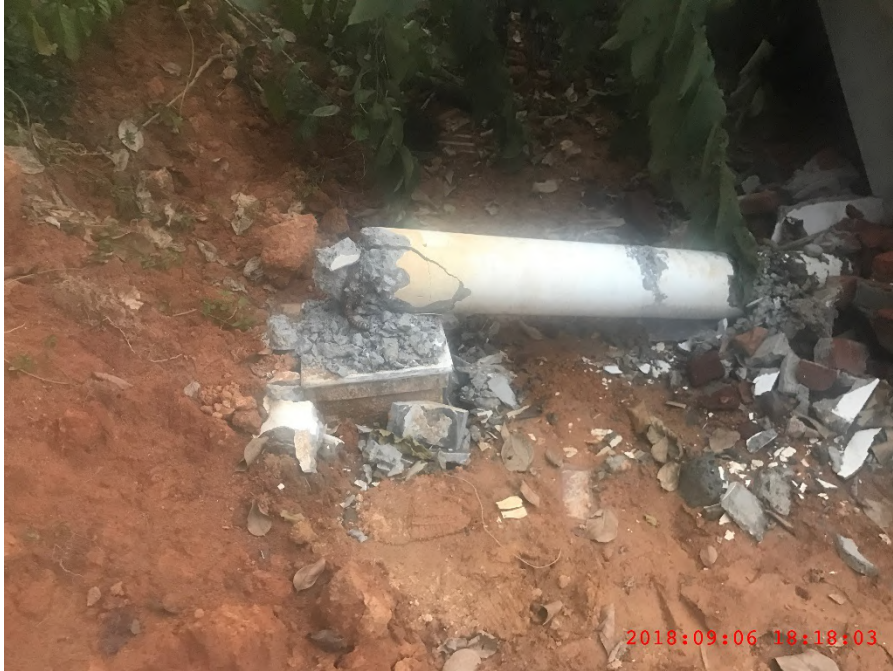
*Figure C-6: Column of the building destroyed due to ground movement @  $9.8746397^{\circ}$  N  $77.1193175^{\circ}$  E*
