Report on 9 year continuous Lightning strike damage in the house of Sri. Shivadasan Nair,
Aneesh Bhavan, Near Kaithakootu Reethu Palli, Puthoor, Kollam District

Ref: Government Ltr. No. 153/K2/2017/DMD dated 17-01-2018

Investigation Series 2018
23-03-2018

Anupama N
Hazard Analyst

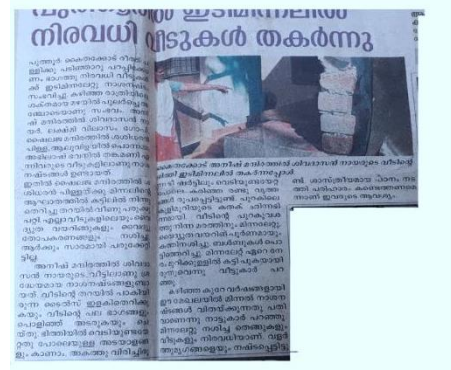
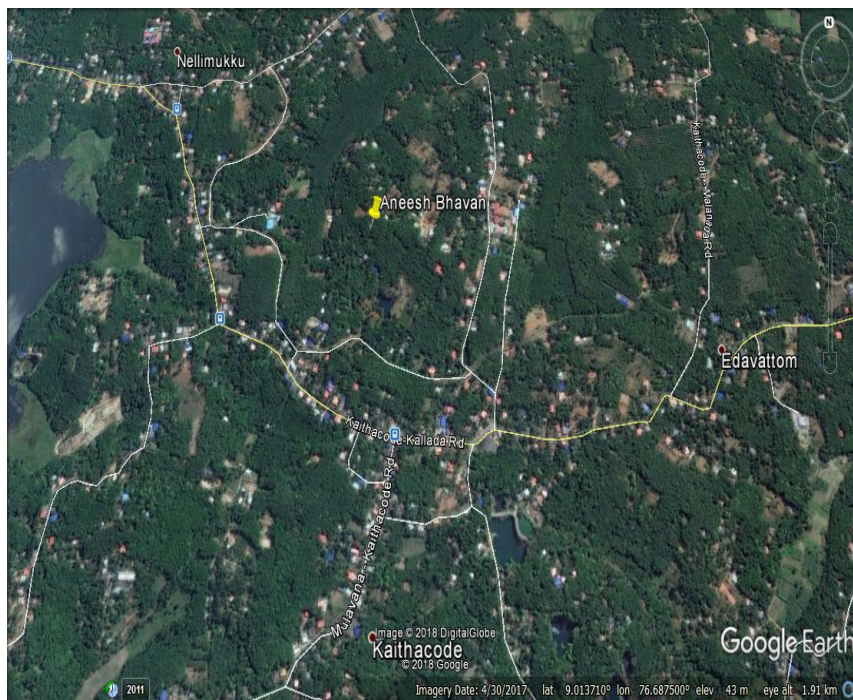
Image showing the area with location of Lightning

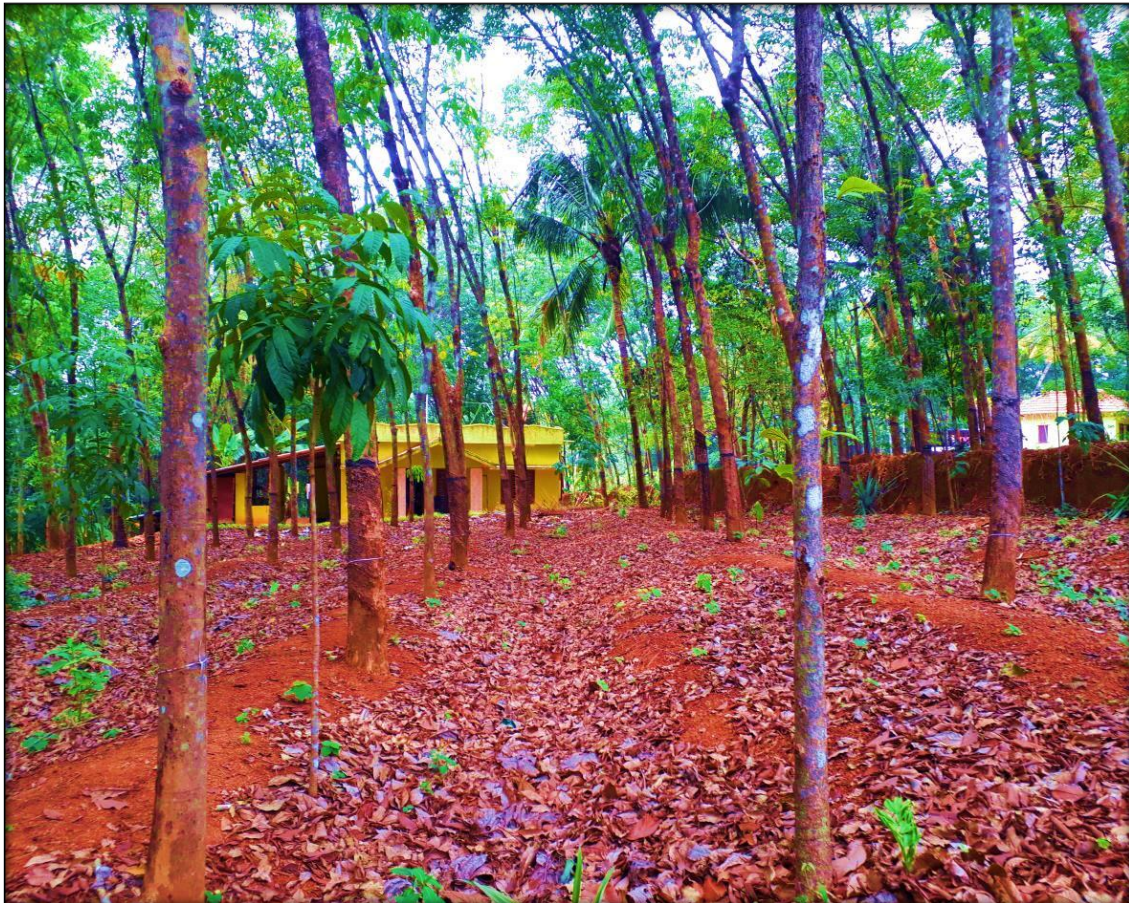
- The proximity of the house to the large number of tall trees (Rubber trees and other tall trees seen around the house) is an important reason for the lightning strikes. From the field evidences, it is suspected that lightning conducted through the tree, travelled through the ground and propagated into the electrical circuit of the house.

- Evidences also lead to believe that side-flashing events may be a cause of these continuous damages, specifically affecting the house.
- Proximity to electric posts and the undulating topography of the house may also be contributing to the exposure of the house to frequent lightning.

- The house has to establish a comprehensive structural earthing
- In order to avoid the flash current from reaching the house through ground, a ring conductor needs to be established
- Lightning grade surge protectors shall be installed to prevent damage to electrical and electronic gadgets
