**Landslide Susceptibility Assessment and Preparedness Strategies,
Thiruvambaadi Grama Panchayath,
Kozhikode District, Kerala.
(DM/328/2016/SDMA dated 6-10-2016)**

**Submitted by
Dr. S Sreekumar
2019**

Associate professor (Retd.) and Principal Investigator
PG & Research Department of Geology and Environmental Science,
Christ college (Autonomous), Irinjalakuda, Calicut University

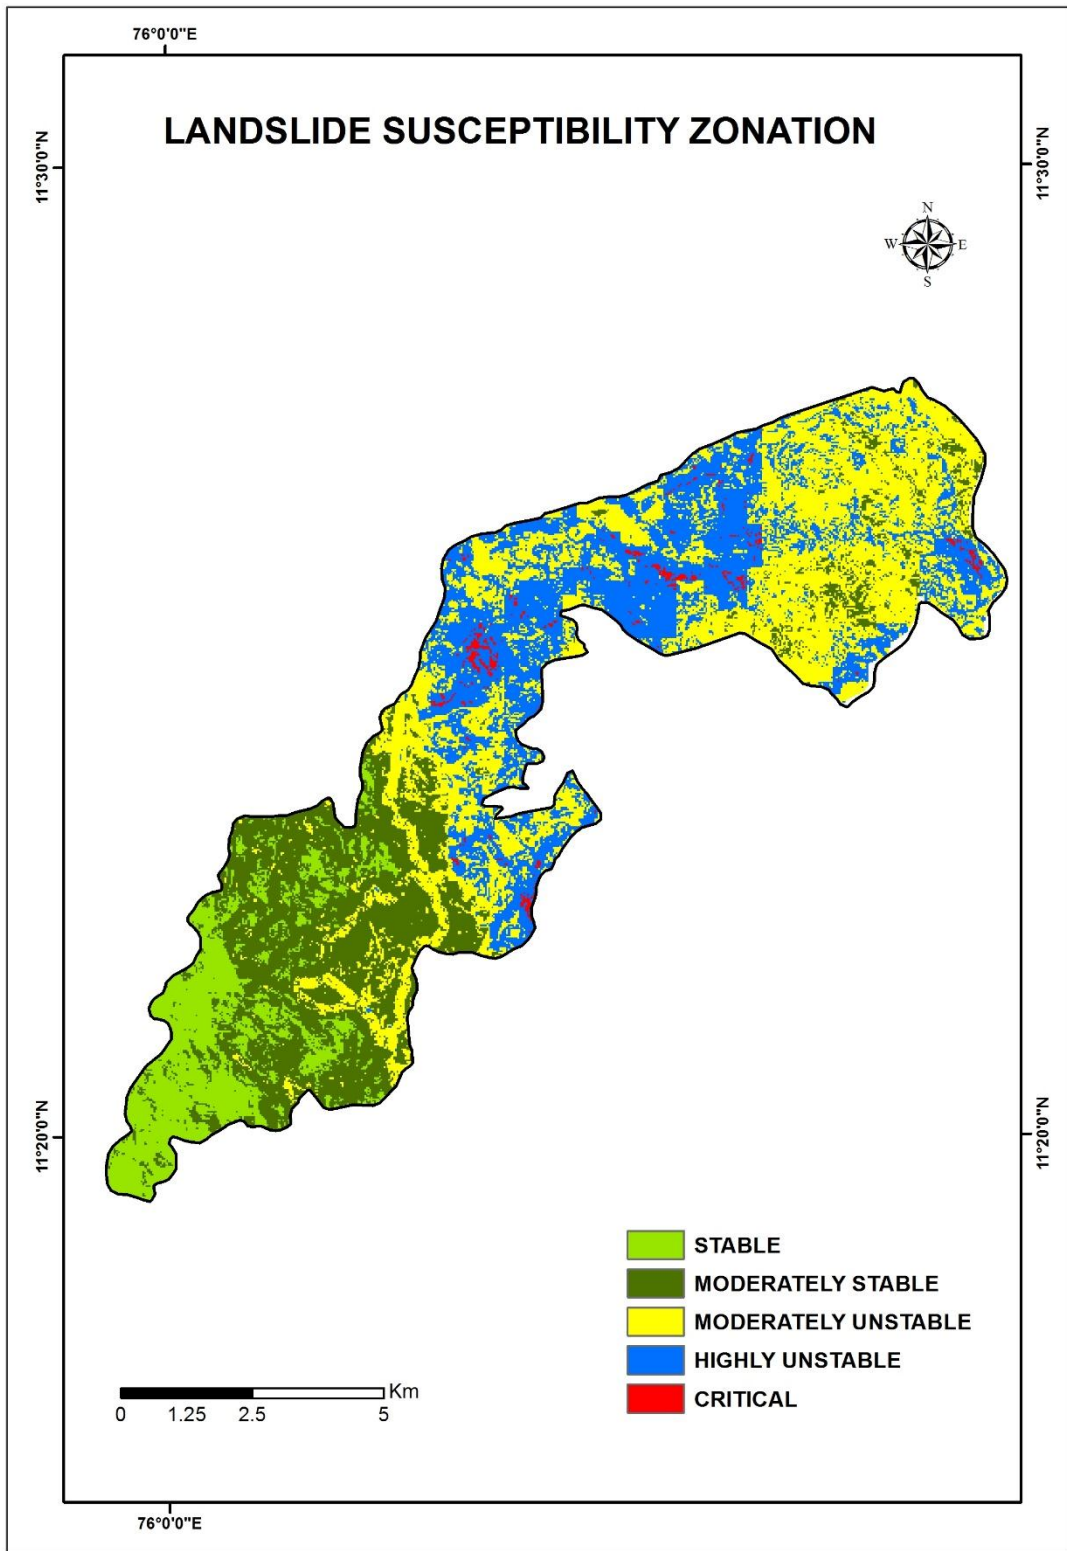
Fig. 4.10. Landslide susceptibility map of Thiuvambaadi Grama Panchayath.

Class	Area (Km ²)	Area %
Stable	10.14	12.08
Moderately stable	20.78	24.75
Moderately unstable	29.95	35.67
Highly unstable	22.28	26.54
Critical	0.81	0.96
Total	83.96	100

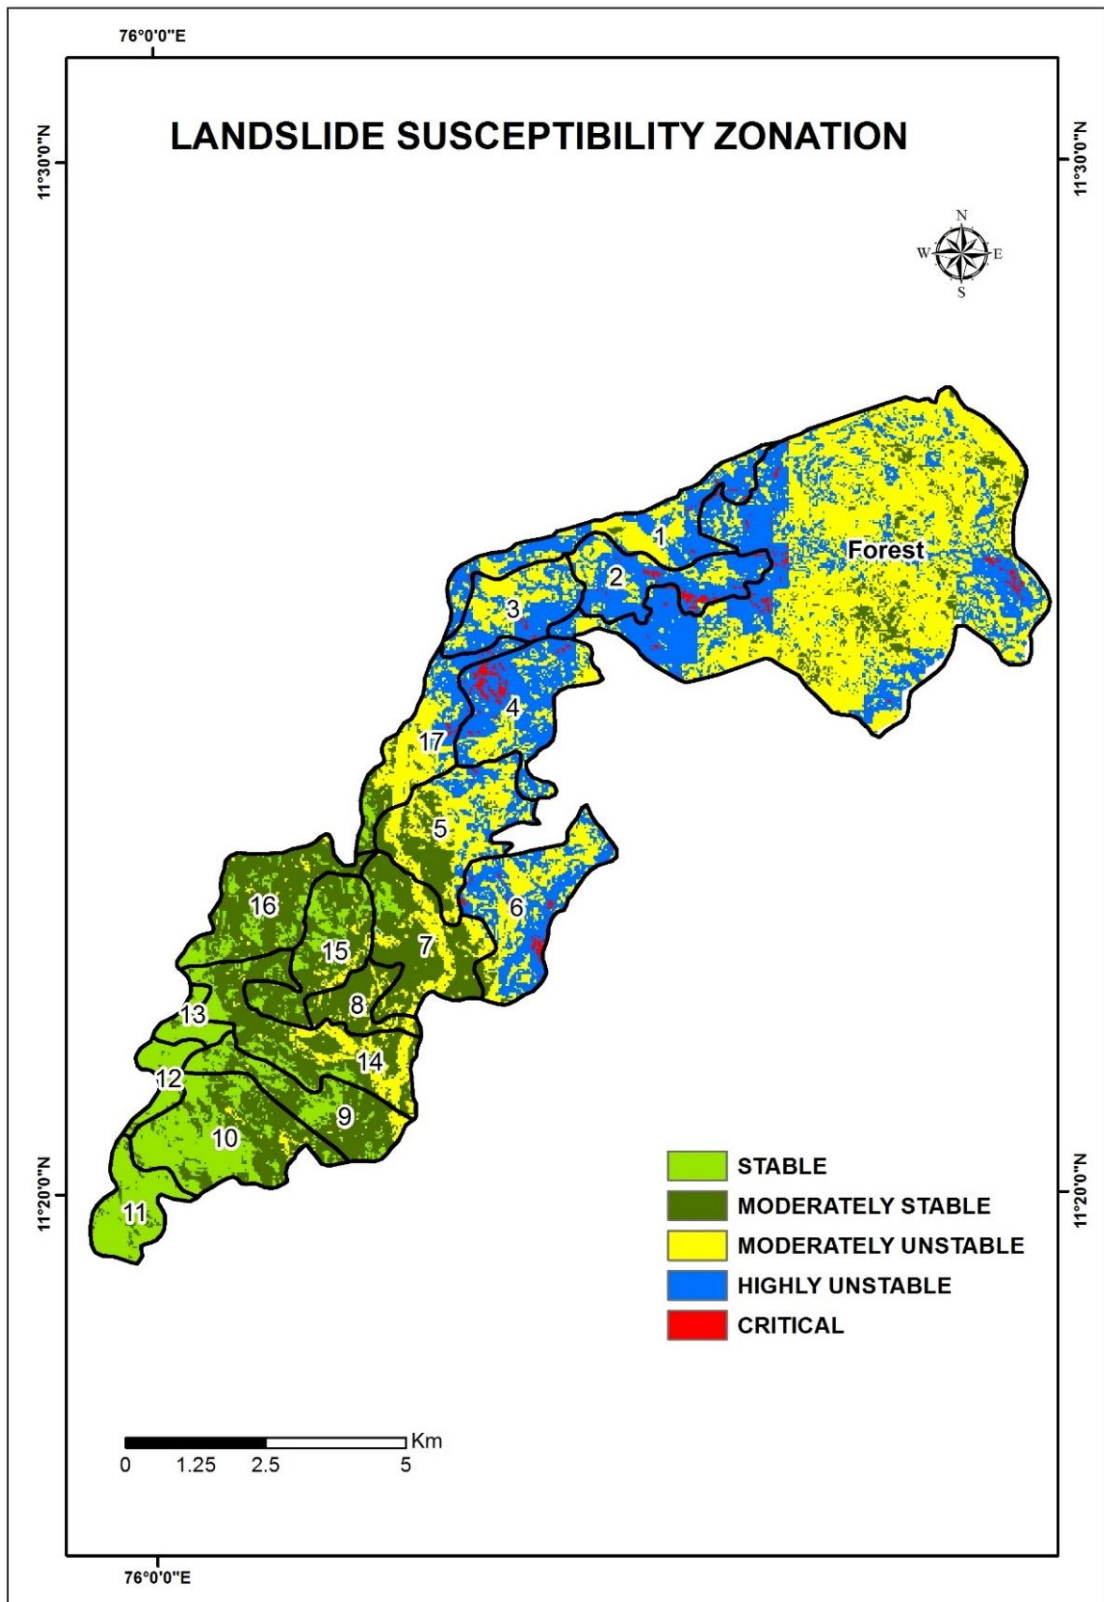
Fig. 4.11. Ward level susceptibility map of Thuvambaadi Grama Panchayath.

Landslide Susceptibility of 17 wards were calculated. In this panchayath, 23.69 % of the total area falls under moderately unstable areas and 23.79 % of the area falls under highly unstable area. 1.04 % of the area is identified as critical (Table 4.11 and Fig.4.11). ward 1 and & 2 have maximum area under highly unstable and critical category.

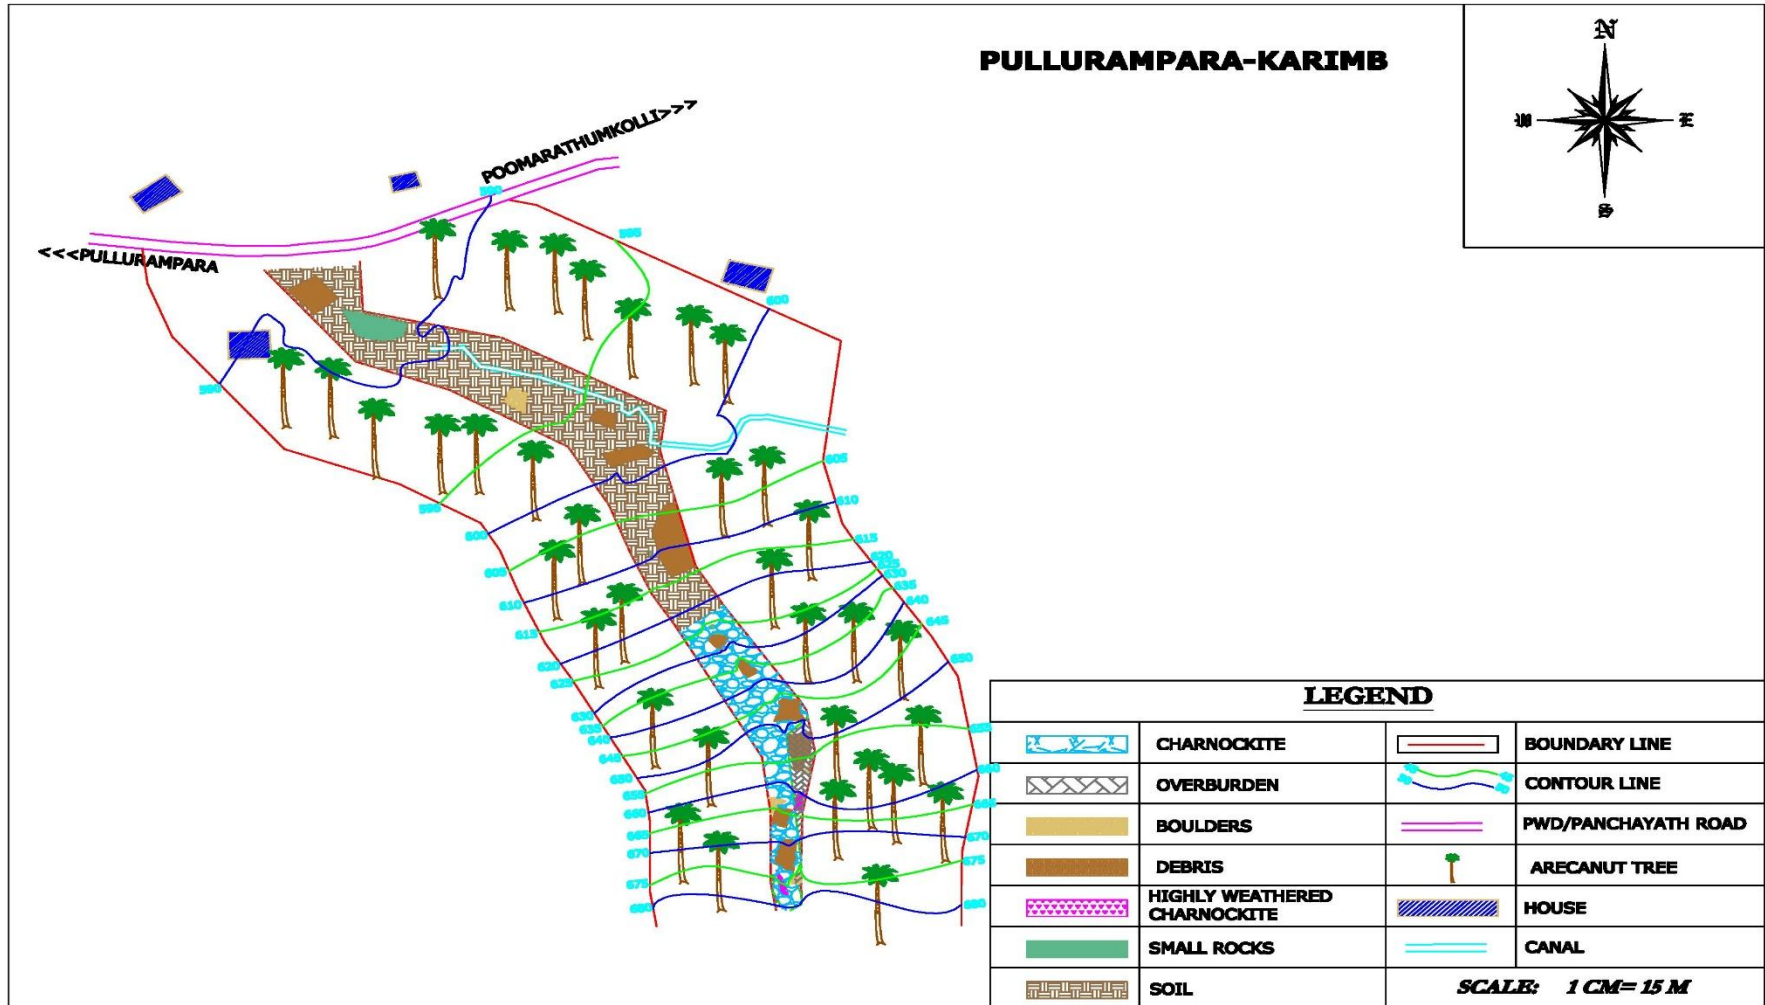
FIG 5.5 TTS KARIMB

It is located on N 11° 25' 51.63" E 076° 05' 6.63". General hill slope of the area is 40. The debris flow occurred in private land which was cultivated by cocco, jathi and arecanut. The debris run off distance of debris is 500 meters (Plate 7). Loss of 300 arecanut trees were reported. the road was damaged due to the debris flow. The width of the scar varied, 5 m at the top, 18m at the middle part and toe portion 30 m. Isolated rock espousers are observed in scar face. The detailed geological map was prepared for the location (Fig. 5.5). Charnockite is the basic rock type of the area. Lateratisation at different degrees are observed. The soil is light brown with clay content slightly plastic when wet. Highly weathered charnockite was observed on scar face. Large rock boulders are also seen resting on the scar face. The total volume of debris flowed through the scar is calculated as 6340 m³.

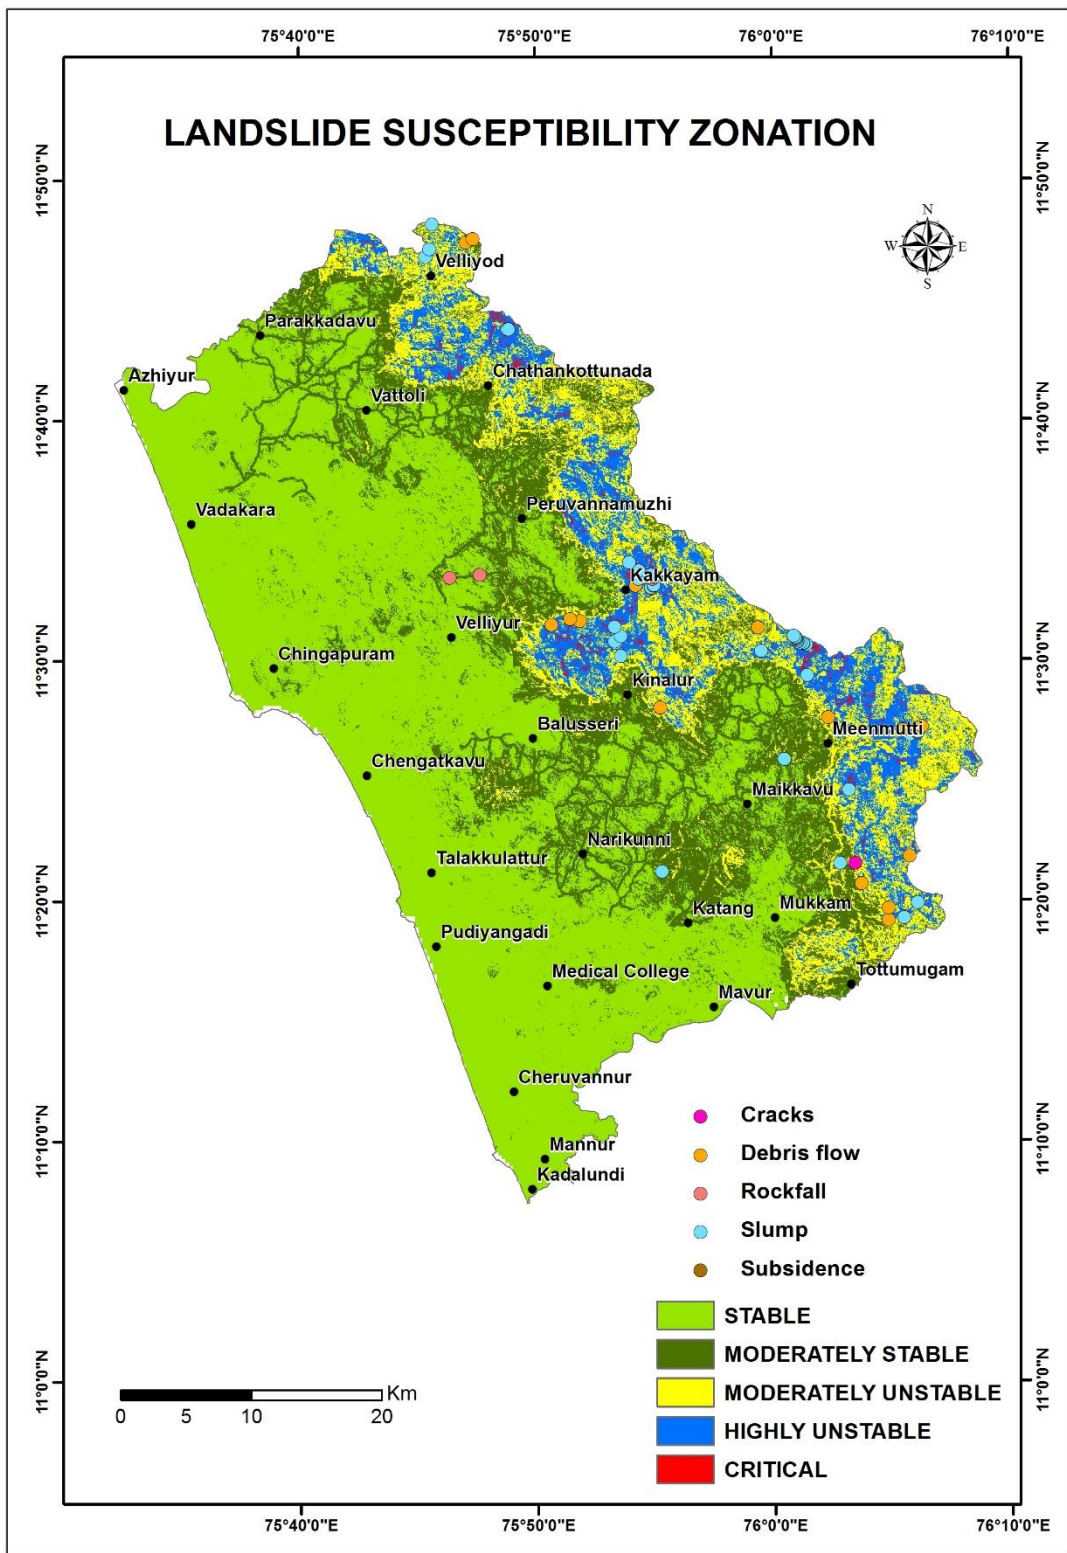
Fig. 6.1. Validation hazard zonation map (Kozhikode district)

GPS location of all the slope failures are incorporated in the hazard zonation map in order to examine the validity of the map (Fig. 6.1 and Table 6.1). Different types of failures and their distribution in different zones are presented in table 6.2. It is found that majority of the slope failures are falling in highly unstable zones. 70.15 % of total events comes under the highly unstable and critical zones. 22.39 % of the total events was falls under moderately unstable category. The GPS location of the past events are incorporated in the map prepared by NCESS, 2010 (Fig. 6.2.). it is found that 62% of the locations fall under the high hazard and medium hazard zone.
